Aviation Investigation Final Report

| Location: | Galliano, Louisiana | Accident Number: | CEN16LA401 |
| Date & Time: | April 7, 2016, | Registration: | N639NA |
| Aircraft: | AGUSTAWESTLAND PHILADELPHIA AW139 | Aircraft Damage: | Substantial |

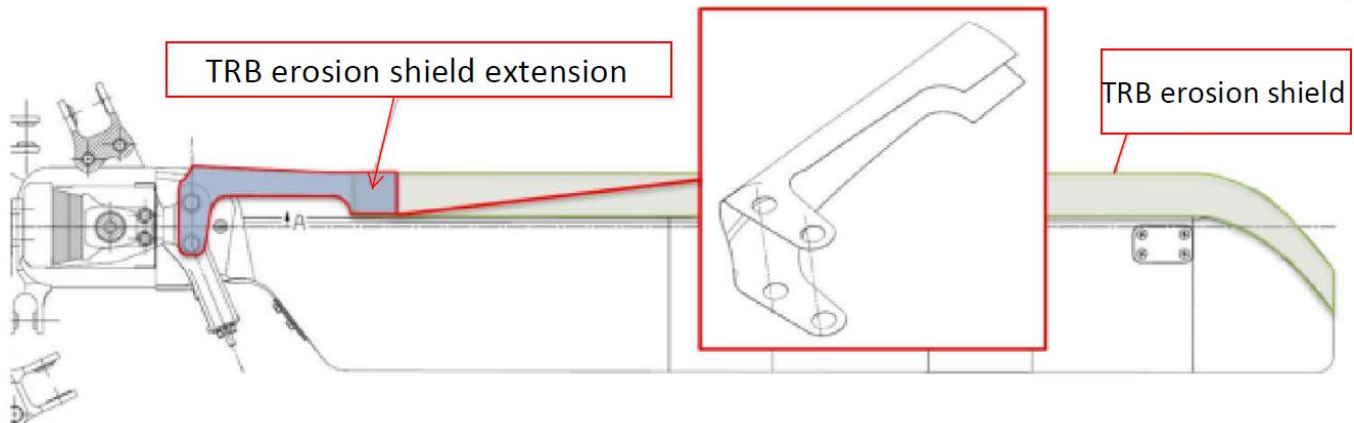
Figure 1 – TRB erosion shield extension diagram with notations (Courtesy of Leonardo)

On May 9, 2018, the Chevron aviation department reported the accident to the NTSB and stated that during the flight the crew felt a slight vibration of the tail rotor. After landing at GAO during a post flight inspection, one of the tail rotor blade (TRB) erosion shield extensions (figure 1) commonly known as a lightning strip (LS) was missing and only its side tabs remained attached to the blade. Additionally, a main rotor blade (MRB) tip was damaged.

The separated LS was identified as part number (p/n) 3G6410L00152 that was manufactured in electroplated nickel.

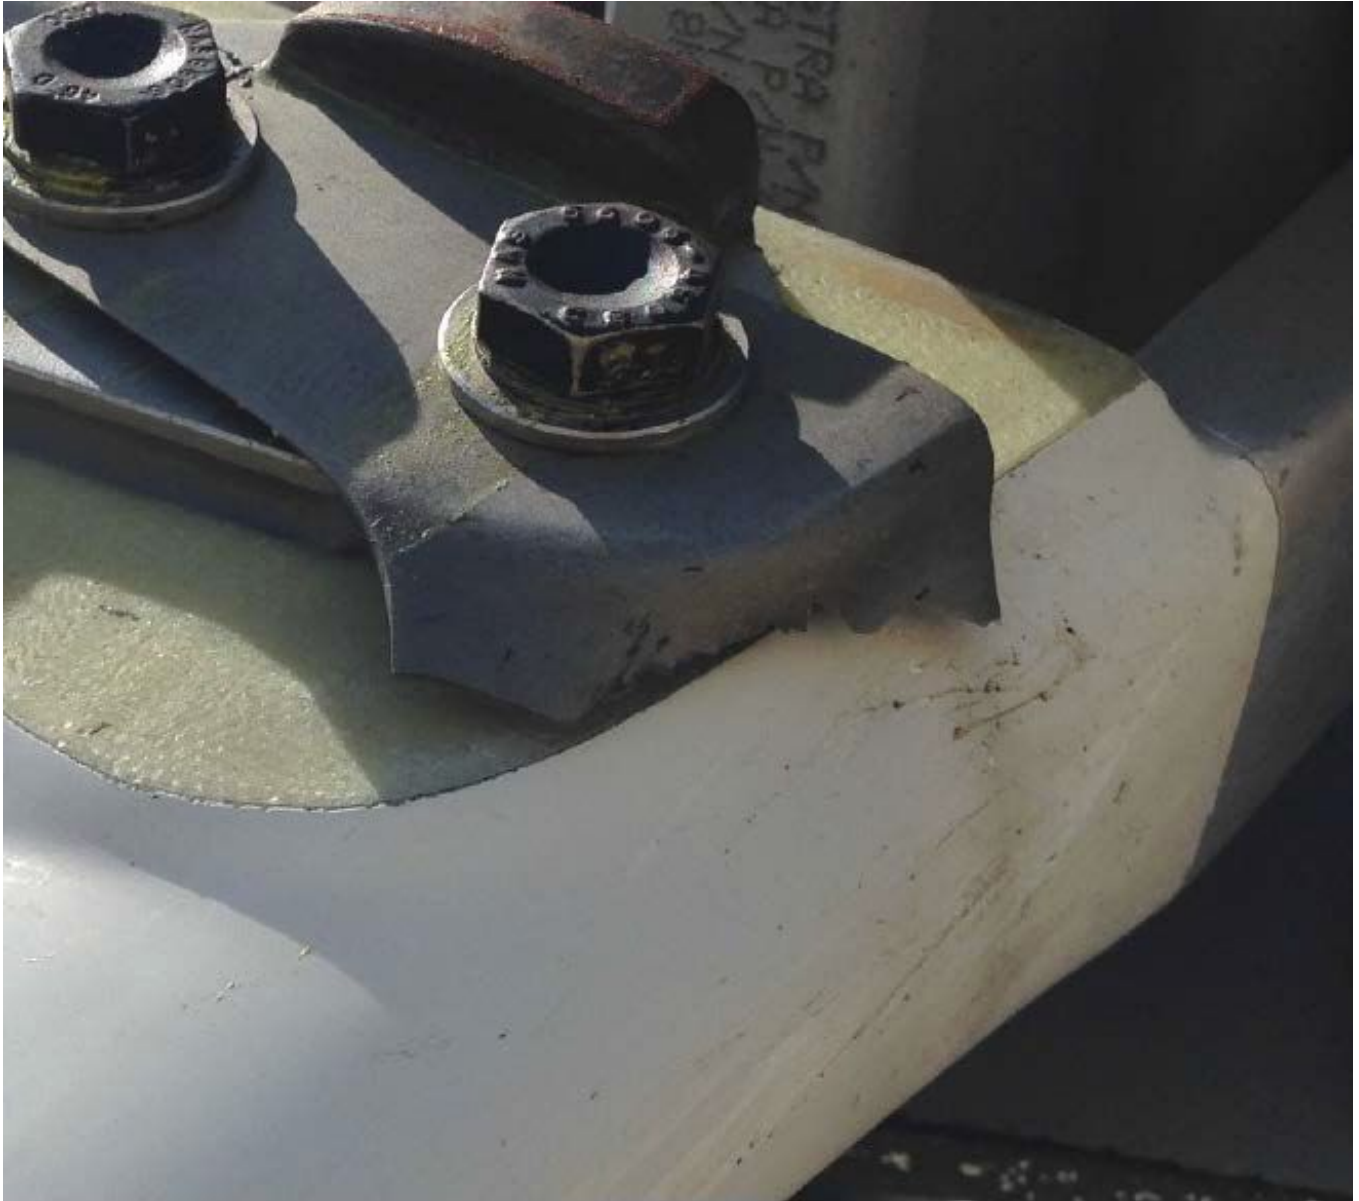
Figure 2 – Damaged Tail Rotor Erosion Shield Extension (Courtesy of Chevron)

The National Transportation Safety Board determines the probable cause(s) of this accident to be:
The fatigue failure of a tail rotor blade erosion shield extension, which resulted in in-flight damage to a main rotor blade.

A Chevron post flight inspection of the helicopter revealed that the LS on the white TRB was fractured and most of the component was missing. Only the side tabs, where the tail rotor damper bracket bushings pass through, remained attached (figure 2).

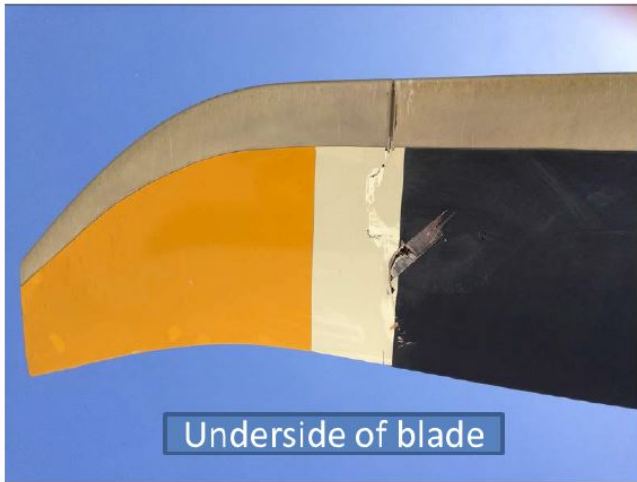
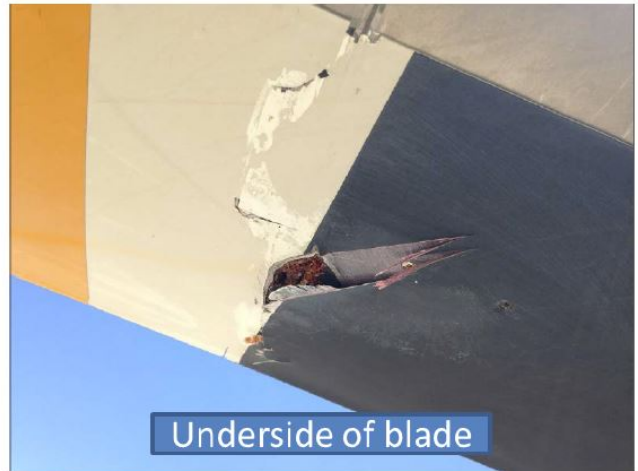
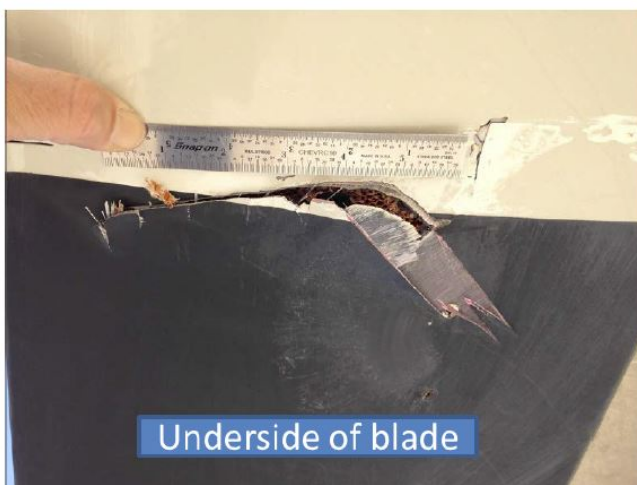
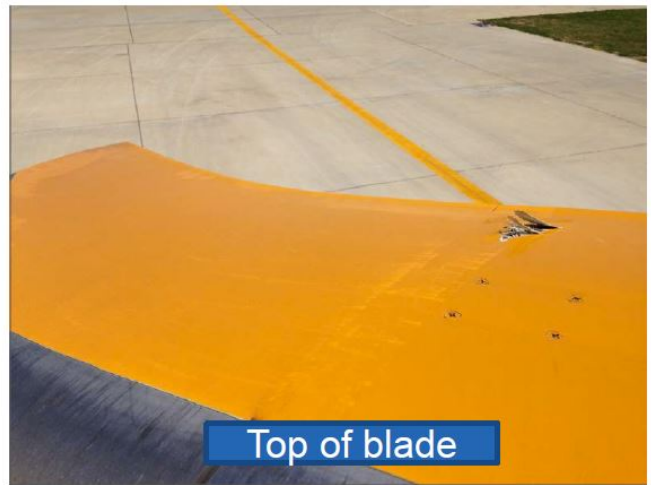
Figure 3 – Damaged Main Rotor Blade (Courtesy of Chevron)

The inspection also found damage to one of the main rotor blades; the blue MRB tip sustained damage mostly on the under side of the blade (figure 3). No additional damage was observed on the remainder of the helicopter.

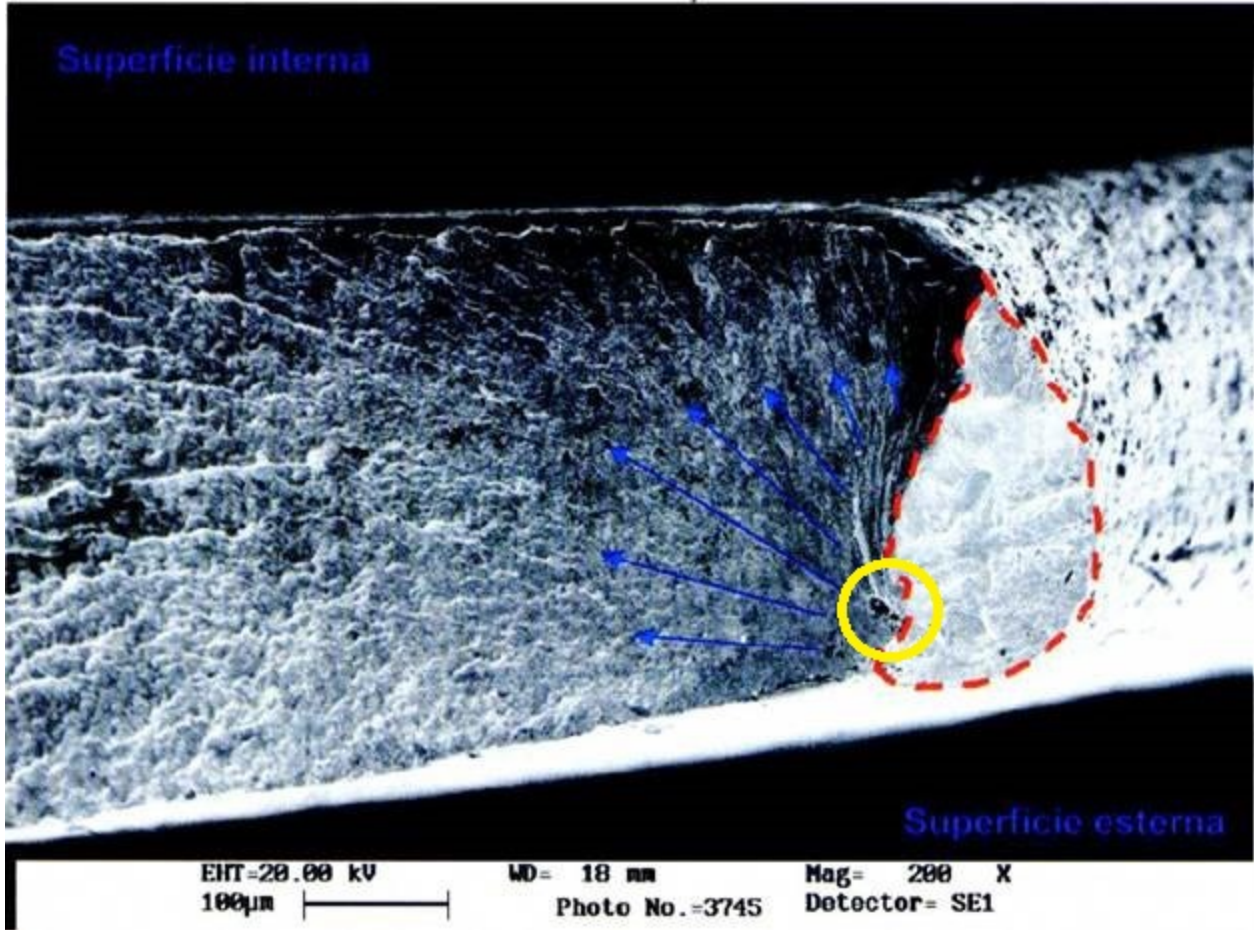
Figure 4 – SEM image of the fatigue propagation from a micro-cavity, yellow circle (Courtesy of Leonardo)

Leonardo, the current AW139 helicopter manufacturer, performed a failure analysis on the remaining portion of the LS, using a scanning electron microscope (SEM), which revealed the presence of microcavity spots or porosity on the surface of the fractured section. Leonardo concluded that the microcavities were a direct result of the electroplating manufacturing process. In figure 4, the area circled in yellow is the microcavity, the red dashes indicate the crack initiation, and the blue arrows indicate the direction of the fatigue crack propagation.

Finite element modeling (FEM) of an exemplar LS was completed to determine the expected inflight stress values, to include the influence of the centrifugal force and the bending moment due to the deformation of the TRB under beam bending loads. The simulation showed that the maximum stress values in the crack initiation area were considerably lower than the fatigue limit specified for the electroplated nickel material. Of note, the FEM model considered the geometric and fitting stress concentrations without the presence of a material flaw (such as a microcavity). Although the microcavity observed on the accident LS could not be replicated by the FEM model, Leonardo concluded that the presence of a microcavity could adversely influence the in-flight stresses and reduce the overall strength of the LS.

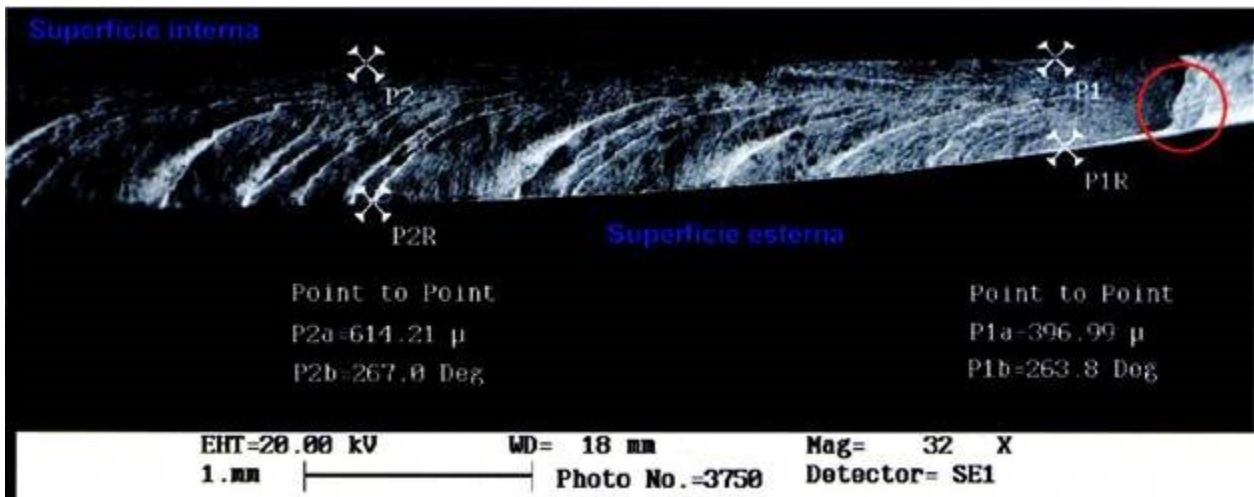
Figure 5 – SEM image, wide view of fracture surface (Courtesy of Leonardo)

Figure 5 shows a wide view of the fracture surface with the crack origination circled in red.
