Aviation Investigation Final Report

Location:	Jasper, Alabama	Accident Number:	WPR18LA144
Date & Time:	May 21, 2018, 12:30 Local	Registration:	N4356K
Aircraft:	Ryan Navion	Aircraft Damage:	Substantial
Defining Event:	Midair collision	Injuries:	2 None
Flight Conducted Under:	Part 91: General aviation - Personal

Location:	Jasper, Alabama	Accident Number:	WPR18LA144
Date & Time:	May 21, 2018, 12:30 Local	Registration:	N8995H
Aircraft:	North American Navion	Aircraft Damage:	Minor
Defining Event:	Midair collision	Injuries:	1 None
Flight Conducted Under:	Part 91: General aviation - Personal

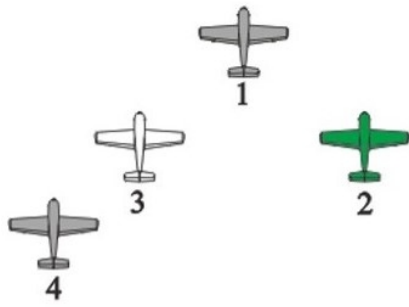
Figure 1a.

The white Navion's pilot reported that when they were about five miles north of JFX, with "two airplanes" length separation of approximately 80 ft, the lead pilot called for the flight to maneuver to "parade" and the flight closed separation to approximately 40 ft. The lead pilot then called for the flight to change to an echelon right formation, see figure 1b. The pilot of the white Navion stated that he initiated a right bank and descended and decelerated to pass below and behind the green Navion, however due to sun glare he lost sight of the green Navion. He asked his passenger if she could see the green Navion. She told him it was right above them. He immediately pushed the nose down when the collision occurred.

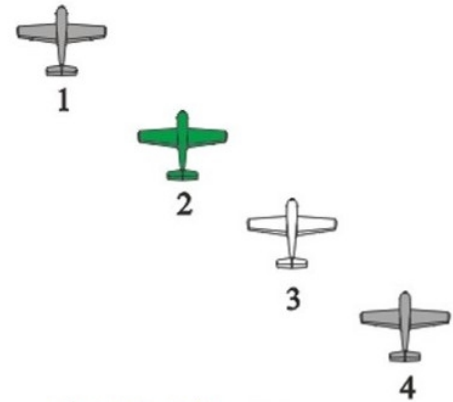
Figure 1b.

The pilot in the #4 position stated it initially appeared the white Navion was not low enough to pass underneath the green Navion. He thought to transmit a warning to the pilot of the white Navion but changed his mind when he saw the airplane had clearance. He further stated just as the white Navion passed underneath the green Navion, the white Navion climbed into the green Navion. After the collision, all four airplanes continued to JFX and landed without further incident.

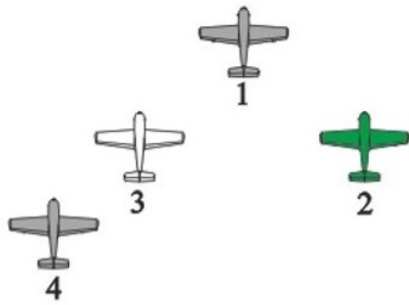
Figure 1a.

The white Navion's pilot reported that when they were about five miles north of JFX, with "two airplanes" length separation of approximately 80 ft, the lead pilot called for the flight to maneuver to "parade" and the flight closed separation to approximately 40 ft. The lead pilot then called for the flight to change to an echelon right formation, see figure 1b. The pilot of the white Navion stated that he initiated a right bank and descended and decelerated to pass below and behind the green Navion, however due to sun glare he lost sight of the green Navion. He asked his passenger if she could see the green Navion. She told him it was right above them. He immediately pushed the nose down when the collision occurred.

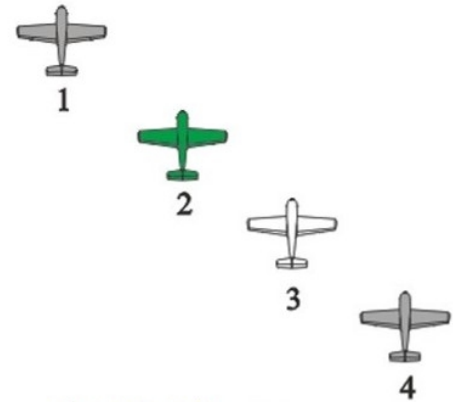
Figure 1b.

The pilot in the #4 position stated it initially appeared the white Navion was not low enough to pass underneath the green Navion. He thought to transmit a warning to the pilot of the white Navion but changed his mind when he saw the airplane had clearance. He further stated just as the white Navion passed underneath the green Navion, the white Navion climbed into the green Navion. After the collision, all four airplanes continued to JFX and landed without further incident.
