# Aviation Investigation Final Report

<b>Location:</b>	Mountain Home, Idaho	<b>Accident Number:</b>	WPR18LA163
<b>Date &amp; Time:</b>	June 2, 2018, 13:38 Local	<b>Registration:</b>	N62073
<b>Aircraft:</b>	North Wing Pulse	<b>Aircraft Damage:</b>	Substantial
<b>Defining Event:</b>	Loss of control in flight	<b>Injuries:</b>	1 Fatal
<b>Flight Conducted Under:</b>	Part 91: General aviation - Air race/show

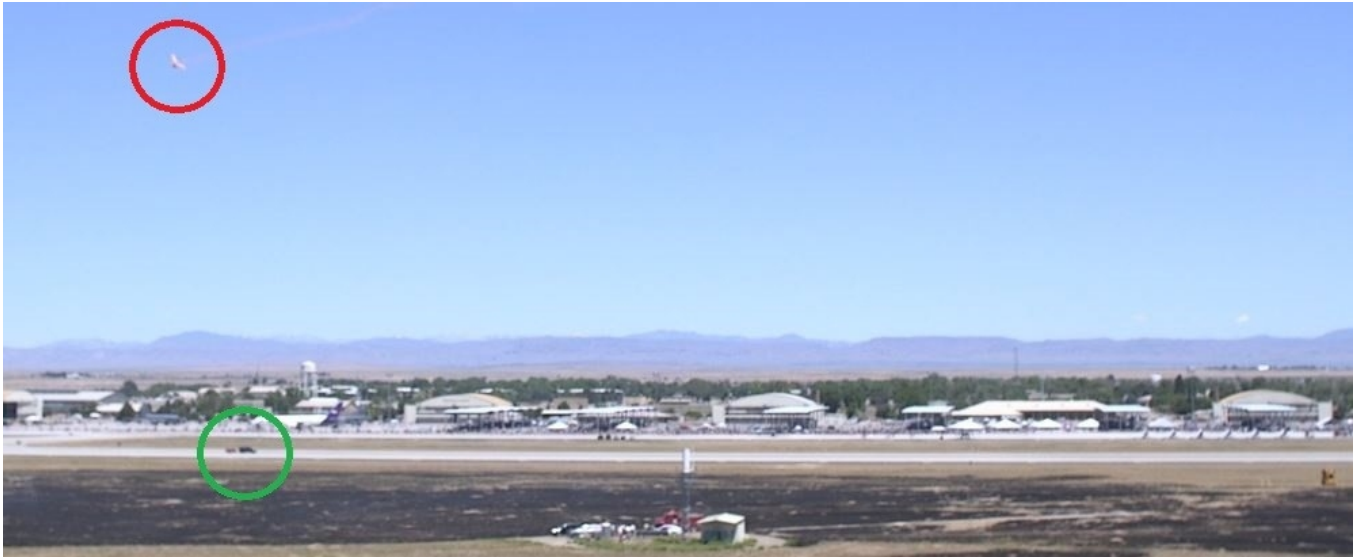
Figure 1. Hang glider (red circle) and tow truck (green circle) beginning the final pass along runway 12

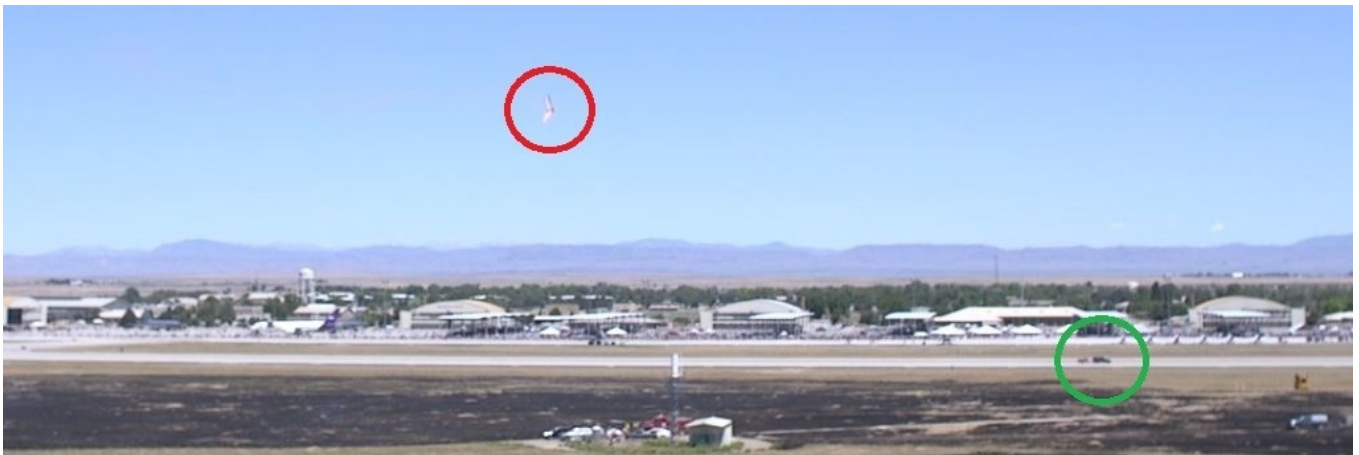
Figure 2. Hang glider performing aggressive turning maneuver

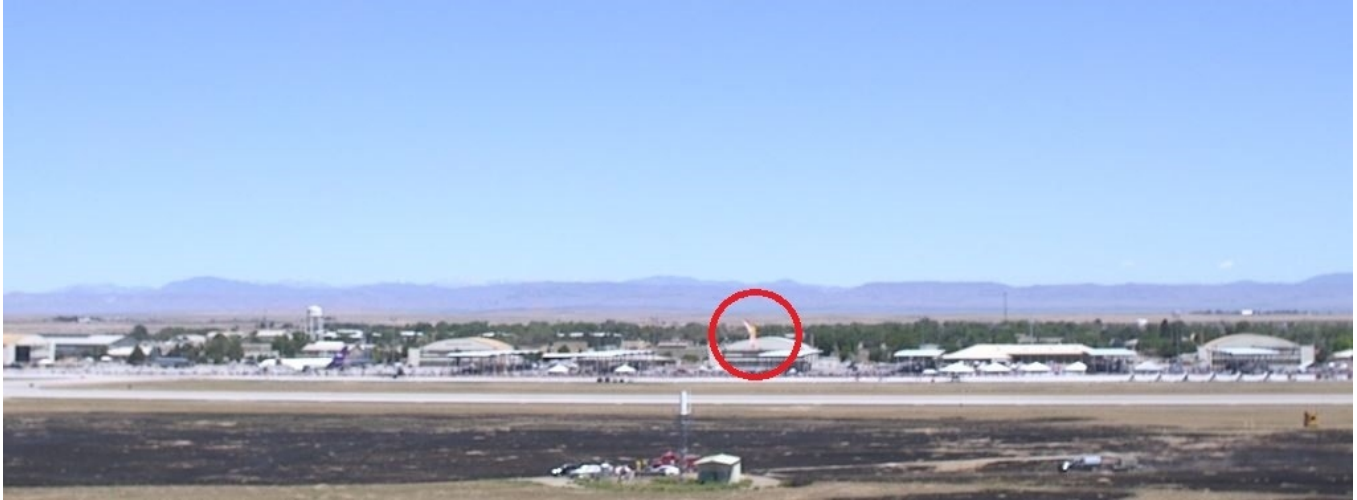
On the day of the accident, the performance began and progressed uneventfully until the end of the truck and winch trailer's second runway pass. After being given the all-clear by the hang glider pilot, the truck and winch trailer turned around as planned and began to accelerate along runway 12 in anticipation of the pilot releasing the line. (See figure 1.) The winch operator stated that, a few seconds after the turn, he looked up and noticed that the hang glider was about 500 ft below the altitude at which he would typically expect to see it. The hang glider then performed an aggressive turning maneuver (see figure 2) and descended another 500 ft. The winch operator then released the winch pressure to supply the hang glider with more slack and prevent it from being impeded by line tension. The hang glider then entered a climb, rolled to the left, descended, and impacted the ground in a nose-down attitude. (See figures 3 and

Figure 3. Hang glider rolling left

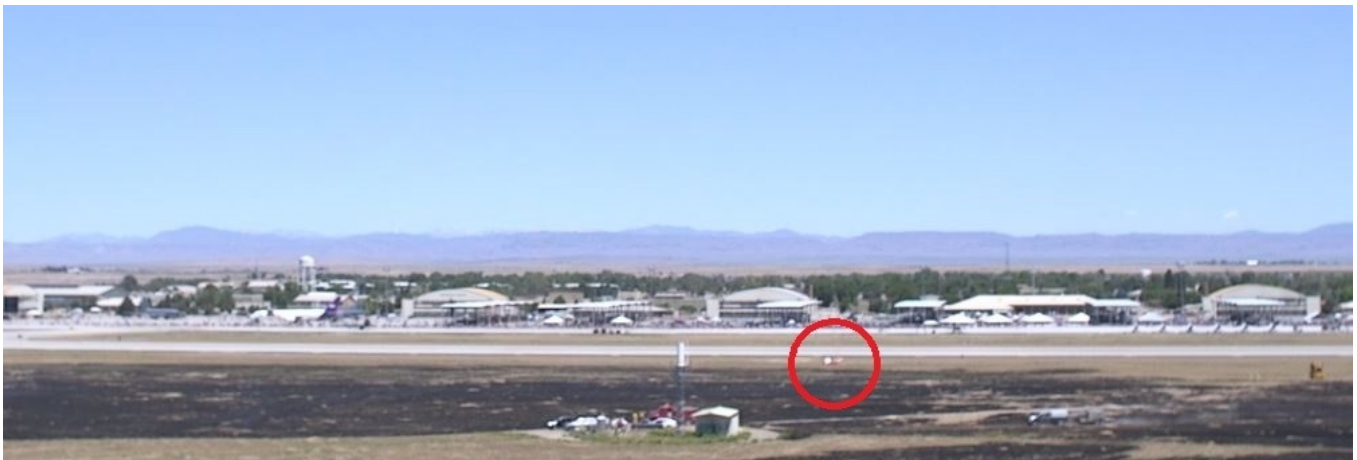
Figure 4. Hang glider striking the ground
