Aviation Investigation Final Report

Location:	Mountain Home, Idaho	Accident Number:	WPR18LA163
Date & Time:	June 2, 2018, 13:38 Local	Registration:	N62073
Aircraft:	North Wing Pulse	Aircraft Damage:	Substantial
Defining Event:	Loss of control in flight	Injuries:	1 Fatal
Flight Conducted Under:	Part 91: General aviation - Air race/show

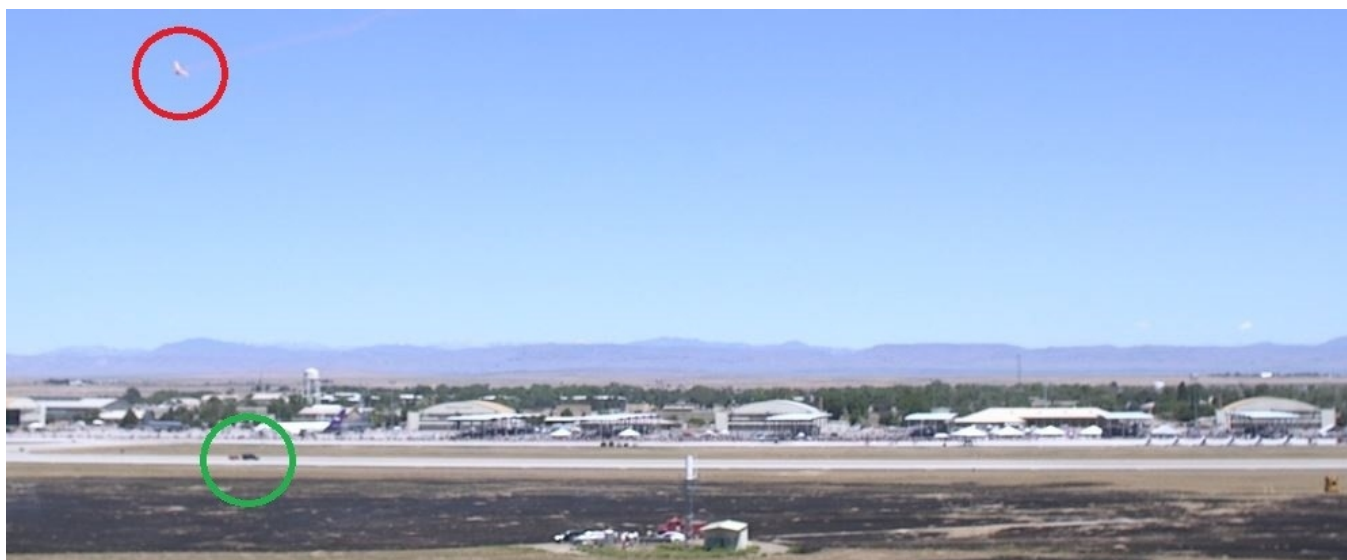
Figure 1. Hang glider (red circle) and tow truck (green circle) beginning the final pass along runway 12

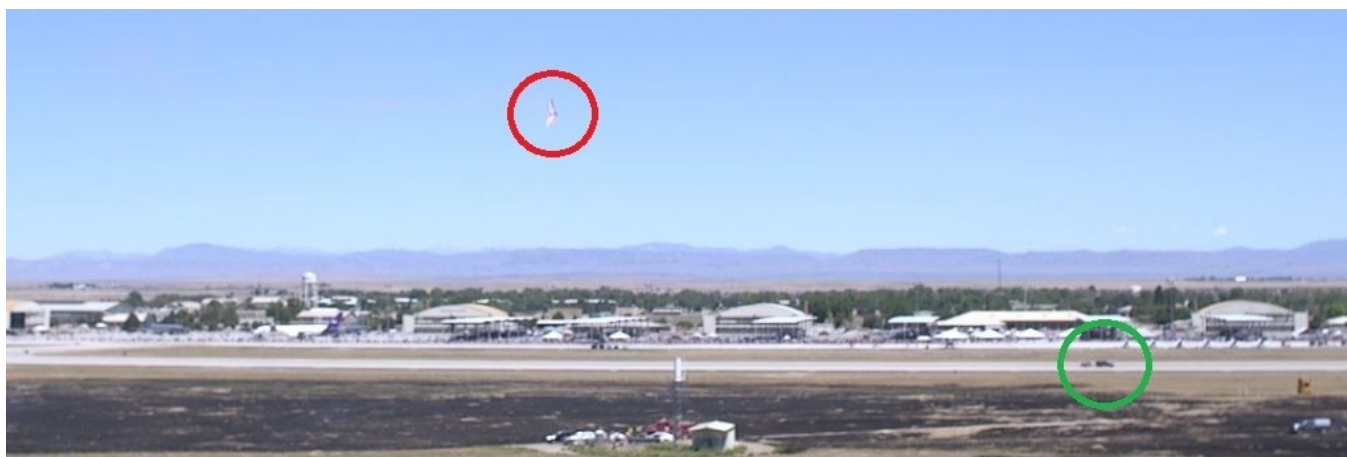
Figure 2. Hang glider performing aggressive turning maneuver
