Aviation Investigation Final Report

Location:	Ramona, California	Accident Number:	ANC18LA043
Date & Time:	June 1, 2018, 11:18 Local	Registration:	N9410M
Aircraft:	Cessna 210	Aircraft Damage:	Substantial
Defining Event:	Landing gear collapse	Injuries:	2 None
Flight Conducted Under:	Part 91: General aviation - Personal

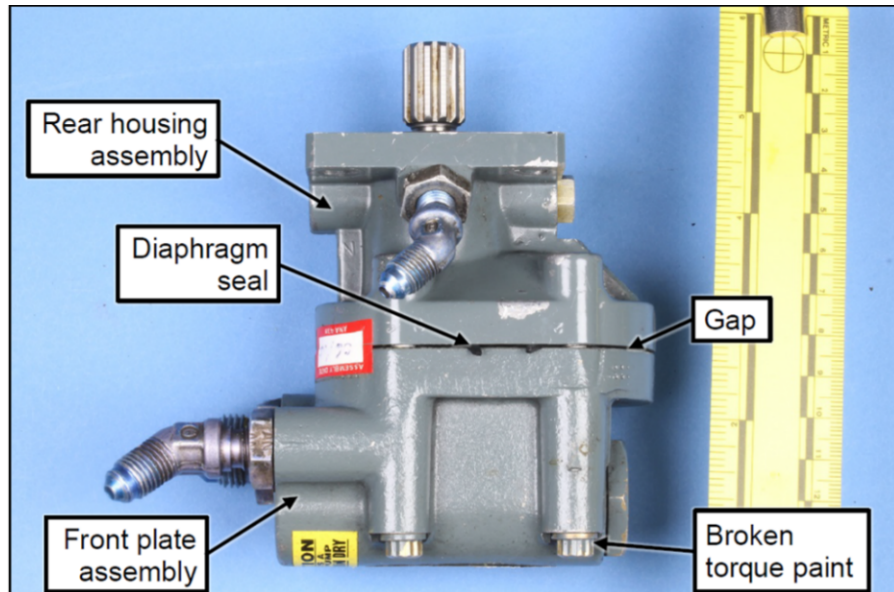
The airplane’s engine-driven hydraulic pump was mounted on an external electric-driven system, and when the hydraulic system was pressurized, fluid started leaking from a gap in the diaphragm seal between the rear housing assembly and front plate assembly, and fractured pieces of the diaphragm seal were visible in the gap (see figure 1). The right MLG would not cycle when powered by the leaking pump. When an airworthy pump was used to test the MLG, it functioned properly.

Figure 1. A photograph showing the engine-driven hydraulic pump before disassembly.

Four cap screws were installed and holding the assembly together; however, the two front plate cap screws on the side with the leaking seal gap were loose and could not be tightened. The screws only had three or four threads engaged with the rear assembly, and the one screw's shank length was .173 inch shorter than the manufacturer's specified minimum shank length, and the other was .158 inches shorter than the minimum shank length. The corresponding rear housing internal threads were sheared and displaced. All four of the screws had evidence of locking compound on the threads, which was inconsistent with the aircraft service manual instructions. Only two of the four cap screws had torque markings present.
