Aviation Investigation Final Report

Location:	Chicago, Illinois	Incident Number:	OPS18IA015
Date & Time:	June 21, 2018, 09:58 Local	Registration:	B-18711
Aircraft:	Boeing 747	Aircraft Damage:	None
Defining Event:	Miscellaneous/other	Injuries:	4 None
Flight Conducted Under:	Non-U.S., commercial

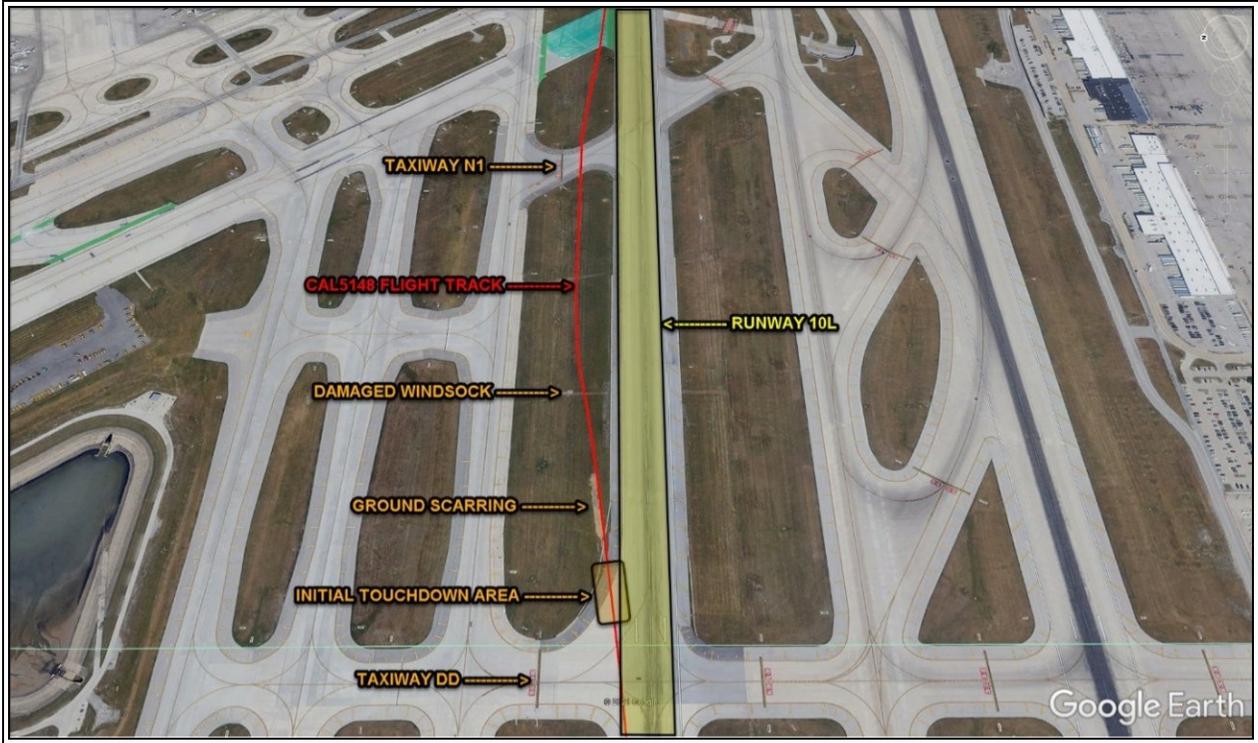
While on short final and attempting to land, CAL5148 drifted left of the runway centerline and the left main landing gear touched down left of the runway, but still on the paved surface. The airplane then traveled into the grass between taxiway DD and taxiway N1 leaving deep ground scarring and damaging a windsock. Figure 1 shows the accident airplanes flight track overlaid on satellite imagery in which the ground scarring can still be seen. CAL5148 executed a go-around and subsequently returned to the airport, landing on runway 9R without further incident at about 1020.

Figure 1. Figure showing a portion of CAL5148’s flight track, with initial touchdown area and other pertinent information also illustrated.

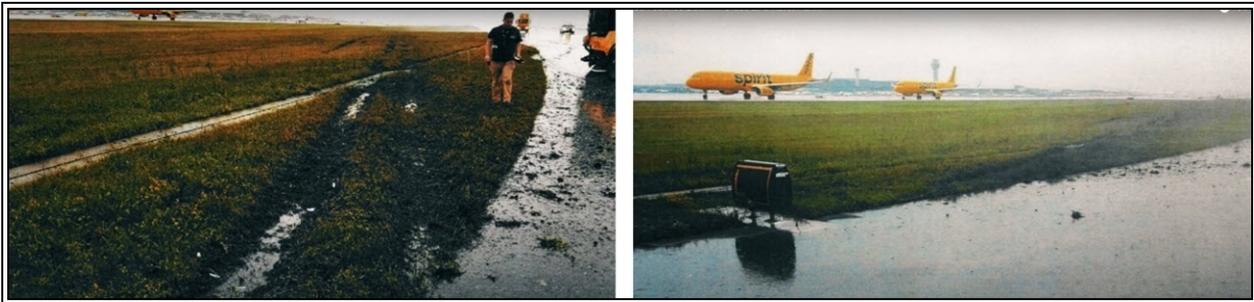
Deep ground scarring was visible near where the aircraft had touched down left of the runway on the paved surface and extending into the grass between taxiway DD and taxiway N1 (see figure 3).

Figure 3. Photographs of the ground scarring caused by the left main landing gear of CAL5148. [Source: FAA]

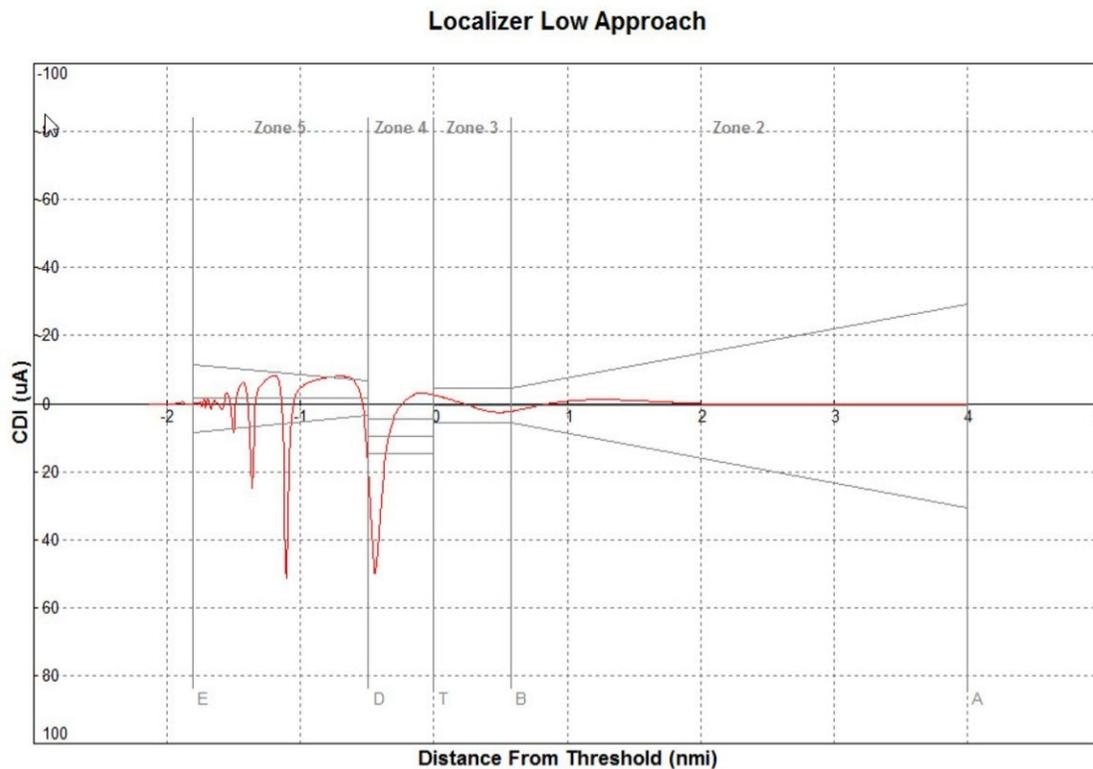
Math modelling of this event was conducted by the FAA’s National Resource Engineer for Navigation. The FAA applied a model that could consider if objects, like buildings and aircraft, could affect localizer and glide slope quality; however, this model was not capable of assessing the effects of an aircraft flying directly over the antenna. Therefore, an analysis was performed with ENY3544 located 2,800 feet from the localizer and 450 feet above the runway. Using several assumptions for aircraft orientation, the model’s output was consistent with the localizer deviations determined from the CAL5148 FDR data (see figure 4).

Figure 4. Graph displaying the simulation results of the math modelling conducted by the FAA.

The graph in figure 4 illustrates modelling simulation results of the effect of a regional jet [ENY3544] departing and overflying the runway 10L localizer at KORD. The location of the Regional Jet simulated was based on Airport Surface Detection Equipment – Model X (ASDE-X) surveillance data of the regional jet and B747 [CAL5148] positions around the time of the runway excursion. On the graph, the red line represents predicted deviations of the aircraft course deviation indicator for the localizer. The vertical scale is the predicted deflection in micro-amps. For an aircraft course deviation indicator, 150 micro-amps would produce full-scale deflection of the indicator. The horizontal scale is the B747 position referenced to runway threshold. The distance labels “0” and “T” are at the threshold. The numerical values are in nautical miles. The letters are used to illustrate flight inspection areas of interest. Point “D” is 3,000 feet down the runway from the threshold and is the end of the touchdown zone. The deviation beginning 0.25 mile from threshold would lead the aircraft to turn left to continue to

follow the localizer course line during an autoland approach. Upon completion, the National Resource Engineer for Navigation who performed the modelling wrote, *“I am 90% confident that the location of departing ENY3544 caused sufficient Multipath (signal reflection) to produce a fly left indication to arriving CAL5148.”*
