# Aviation Investigation Final Report

<b>Location:</b>	Ashland, Ohio	<b>Accident Number:</b>	CEN18LA245
<b>Date &amp; Time:</b>	June 29, 2018, 20:00 Local	<b>Registration:</b>	N717FN
<b>Aircraft:</b>	Kubicek BB30	<b>Aircraft Damage:</b>	Minor
<b>Defining Event:</b>	Loss of control on ground	<b>Injuries:</b>	1 Fatal, 3 Minor
<b>Flight Conducted Under:</b>	Part 91: General aviation - Personal

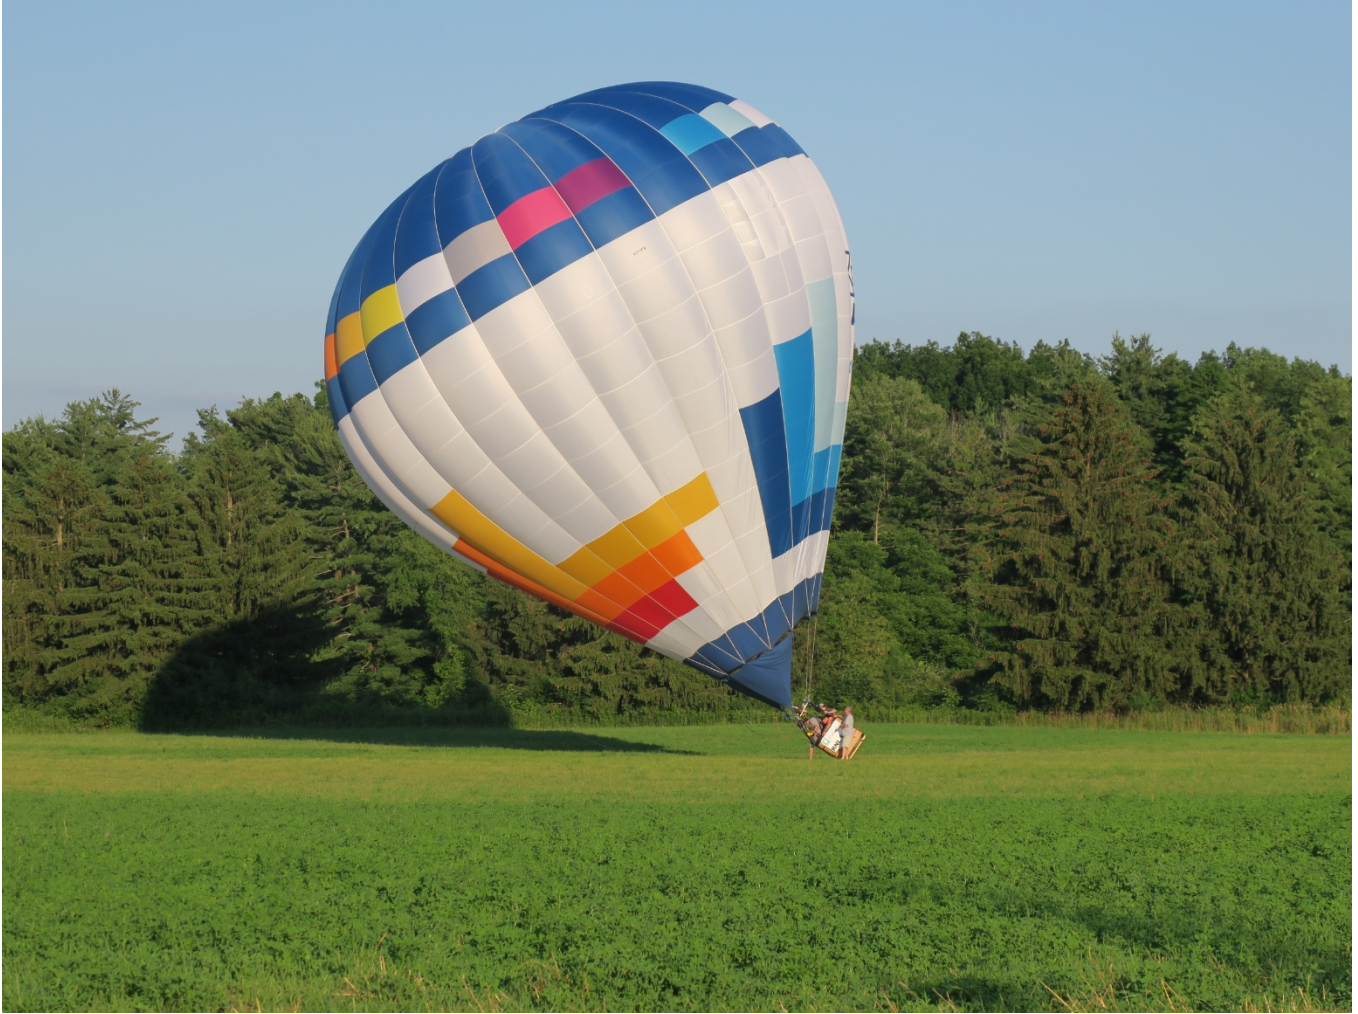
Figure 1 Accident balloon

A witness photographed the balloon when it first landed in the field. Figure 1 shows a photo in which the balloon is on the ground, the balloon and basket are both tipped over about 45°, and a land owner/neighbor is standing next to the basket.

The student pilot and the passengers stated that the pilot was not crouched down during the landing and was also not actively pulling on the vent line to deflate the envelope.
