Aviation Investigation Final Report

Location:	Arlington, Indiana	Accident Number:	CEN18FA258
Date & Time:	July 6, 2018, 17:20 Local	Registration:	N96195
Aircraft:	Bell 47G	Aircraft Damage:	Substantial
Defining Event:	Part(s) separation from AC	Injuries:	1 Fatal
Flight Conducted Under:	Part 137: Agricultural

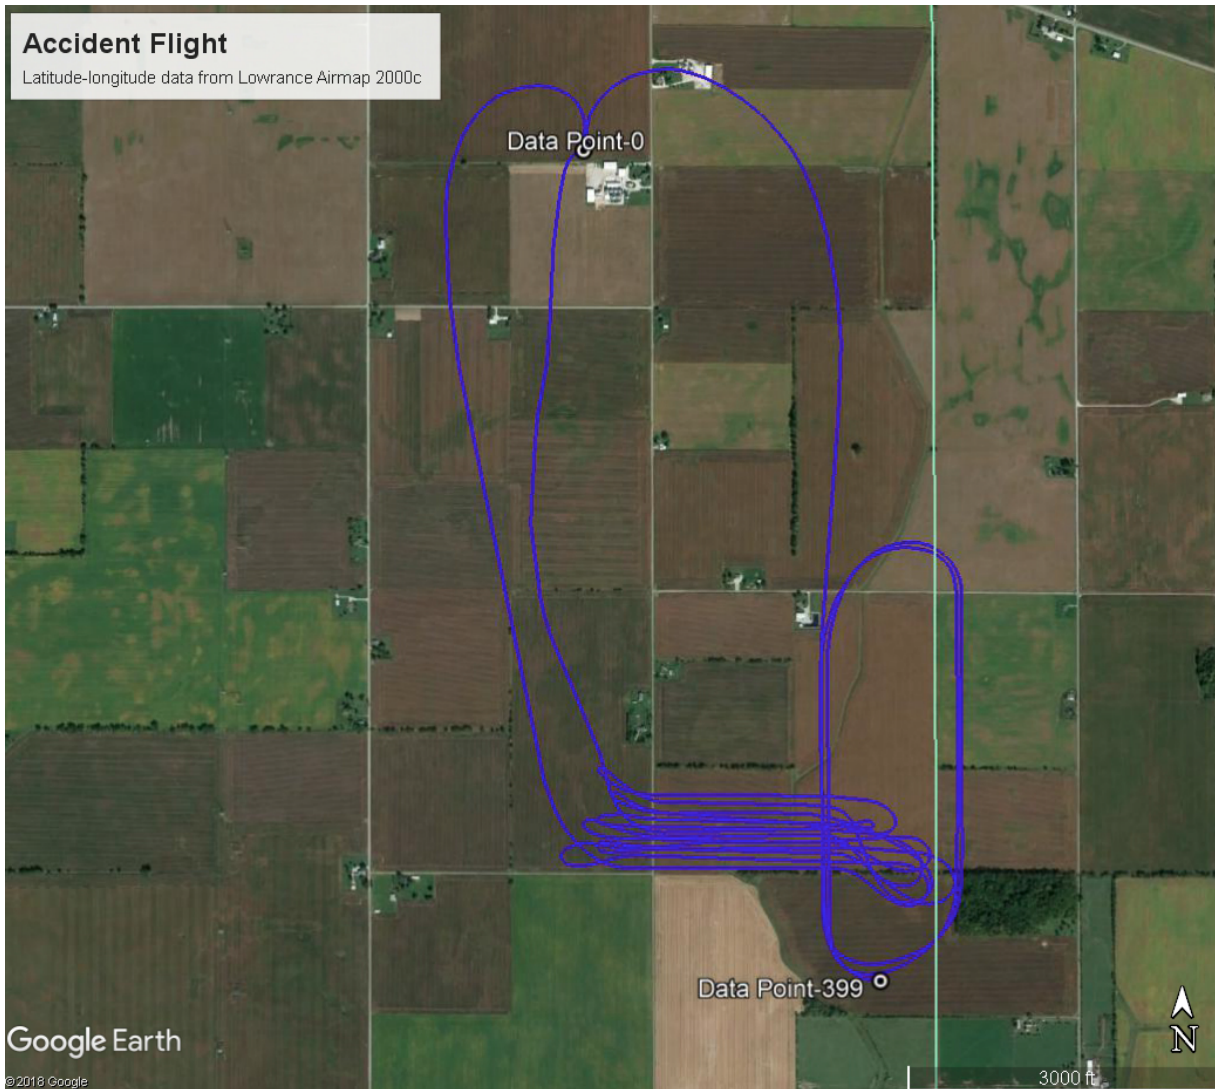
Figure 1. Accident Flight Track from Lowrance Airmap

Figure 1 shows the flight track for the accident flight based on GPS latitude and longitude data recovered from a Lowrance AIRMAP 2000c device installed on the helicopter. The device contained data from three flight tracks; one of which was the accident flight. The data did not contain altitude or time data, so the time lengths of the track are not known. The last data point of the final flight recorded was consistent with the wreckage location.

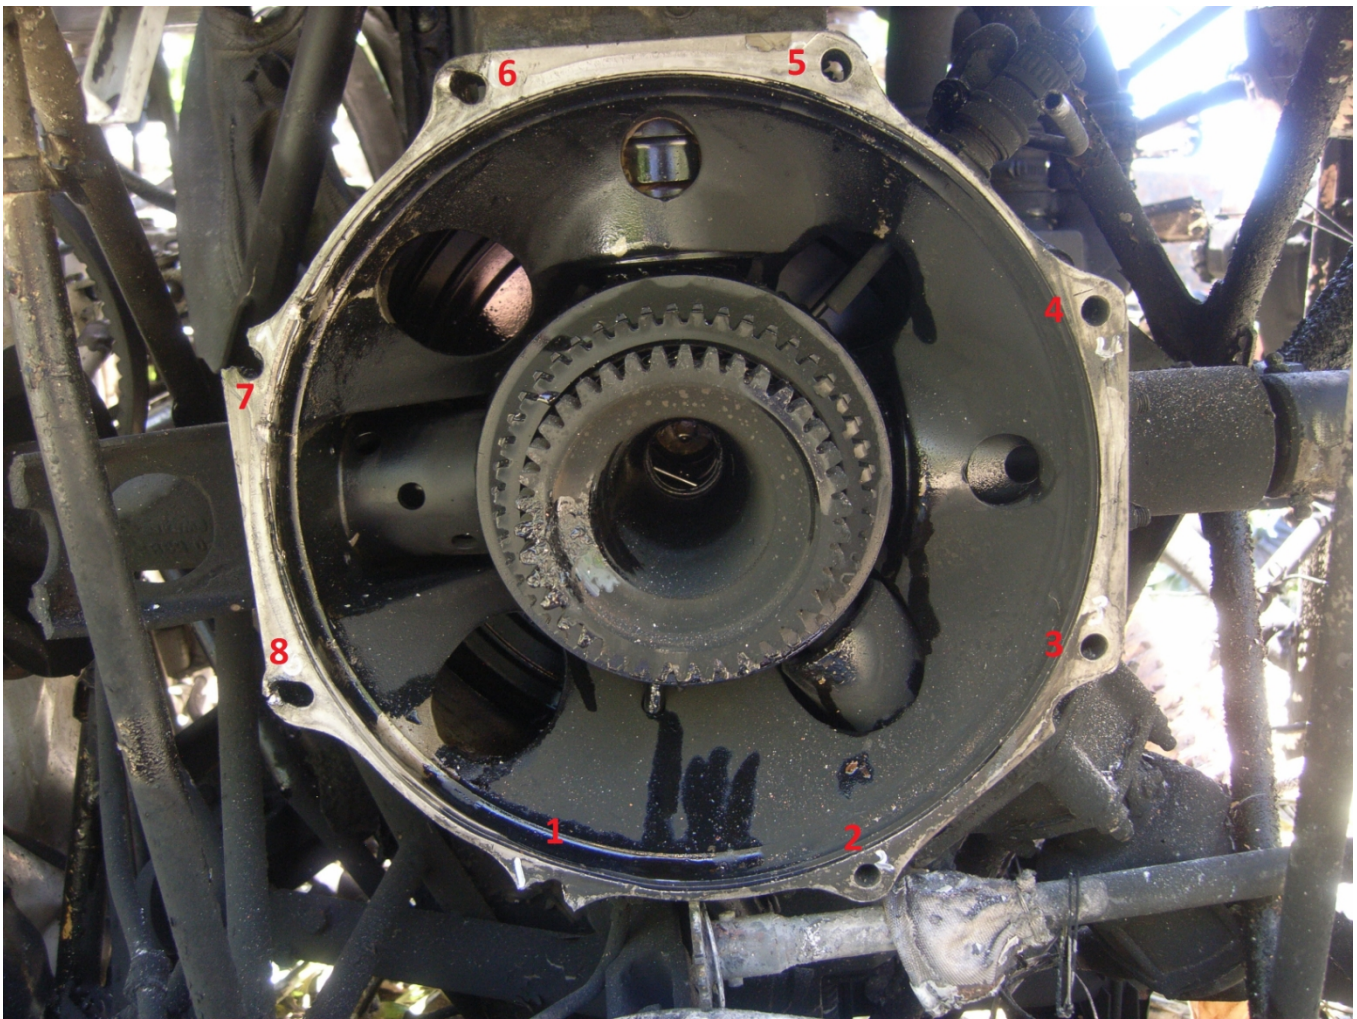
Figure 2. Lower Transmission With Labels 1 through 8

Postaccident examination of the lower transmission housing found elongation of four of the bolt holes and tearing of two of the bolt holes; two of the bolt holes were unremarkable.

The lower portion of the transmission assembly remained attached to the engine. The internal gears of the transmission rotated freely when actuated at the engine and the tail rotor spline. A large scar/witness mark was observed on the inside well of the transmission. The mounting holes on the lower housing of the transmission were labeled Nos. 1 through 8 for identification purposes (Figure 2). The Nos. 1 and 7 holes were torn and partially separated. The Nos. 2 and 3 holes were unremarkable. The Nos. 4 and 5 holes were elongated. The Nos. 6 and 8 holes were elongated, and the hole material exhibited tearing on the outer edge. No fasteners remained in any of the holes.
