Aviation Investigation Final Report

Location:	Chicago, Illinois	Accident Number:	CEN18FA259
Date & Time:	July 7, 2018, 21:23 Local	Registration:	N312SA
Aircraft:	EUROCOPTER DEUTSCHLAND GMBH EC135 P1	Aircraft Damage:	Substantial
Defining Event:	Miscellaneous/other	Injuries:	3 Serious, 1 None
Flight Conducted Under:	Part 135: Air taxi & commuter - Non-scheduled - Air Medical (Medical emergency)

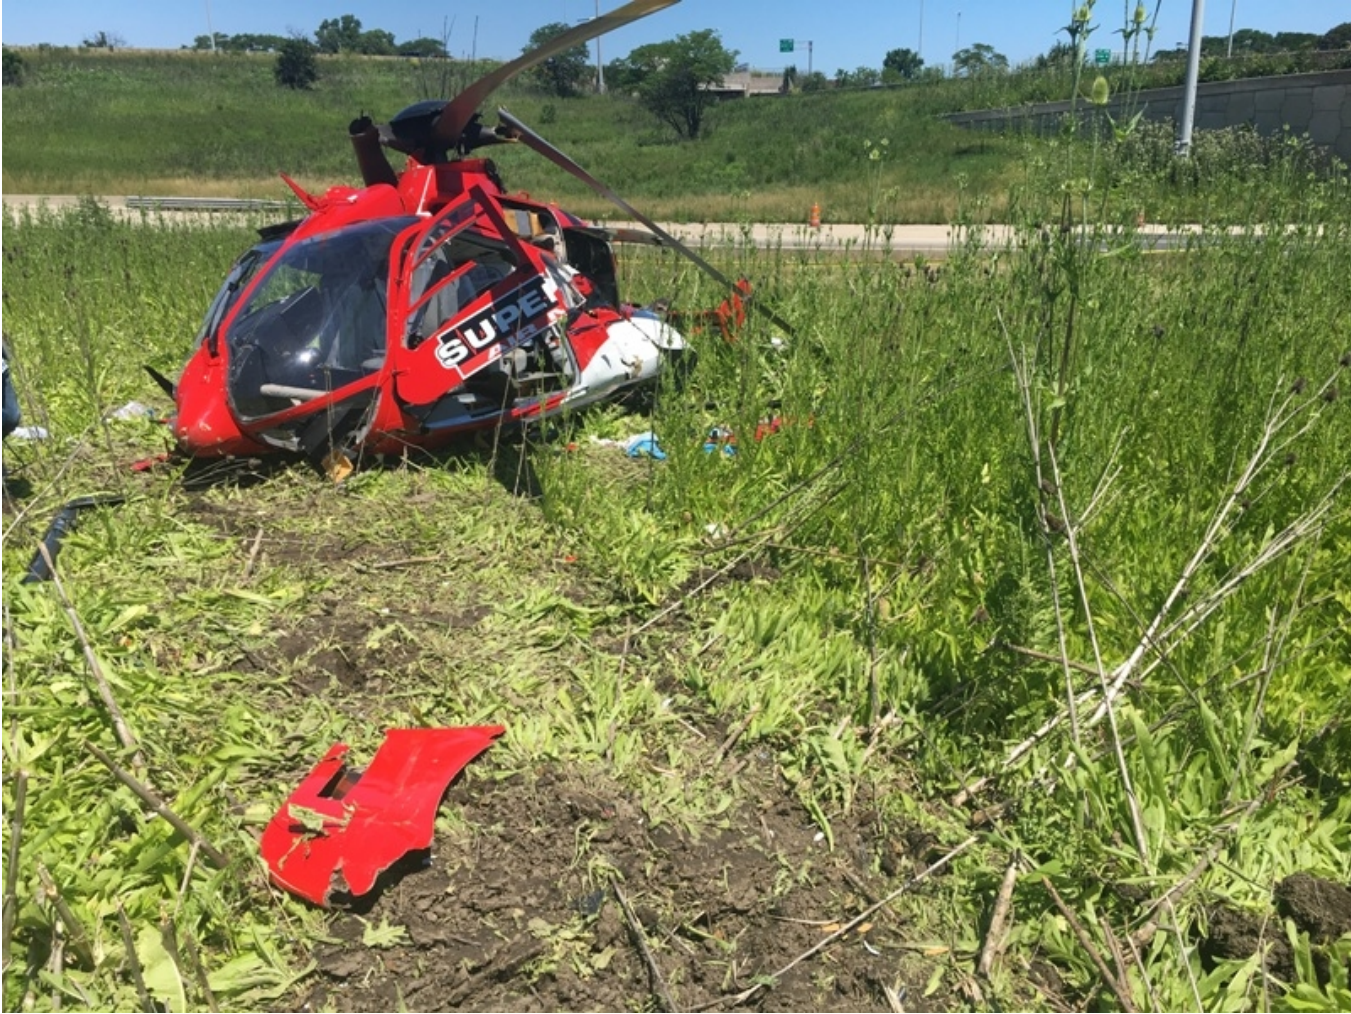
Figure 2. Main Wreckage

Examination of the accident site revealed the initial impact was consistent with the tail bumper contacting the terrain, followed by the landing gear skids and fuselage. The left landing gear skid was separated and came to rest near the ground scar that was consistent with the fuselage impact. The fuselage was crushed upward, and the fenestron structure was separated near the tailboom attachment location. The helicopter had rotated 180° from the direction of impact and came to rest upright. Three main rotor blades displayed fractures near the root, and one blade was relatively undamaged. The pilot seat (right front) and paramedic seat (left aft, aft-face) were found fully attenuated. The flight nurse seat (right aft, forward-face) two floor legs were fractured, and the seat back was separated from the aft wall brackets.

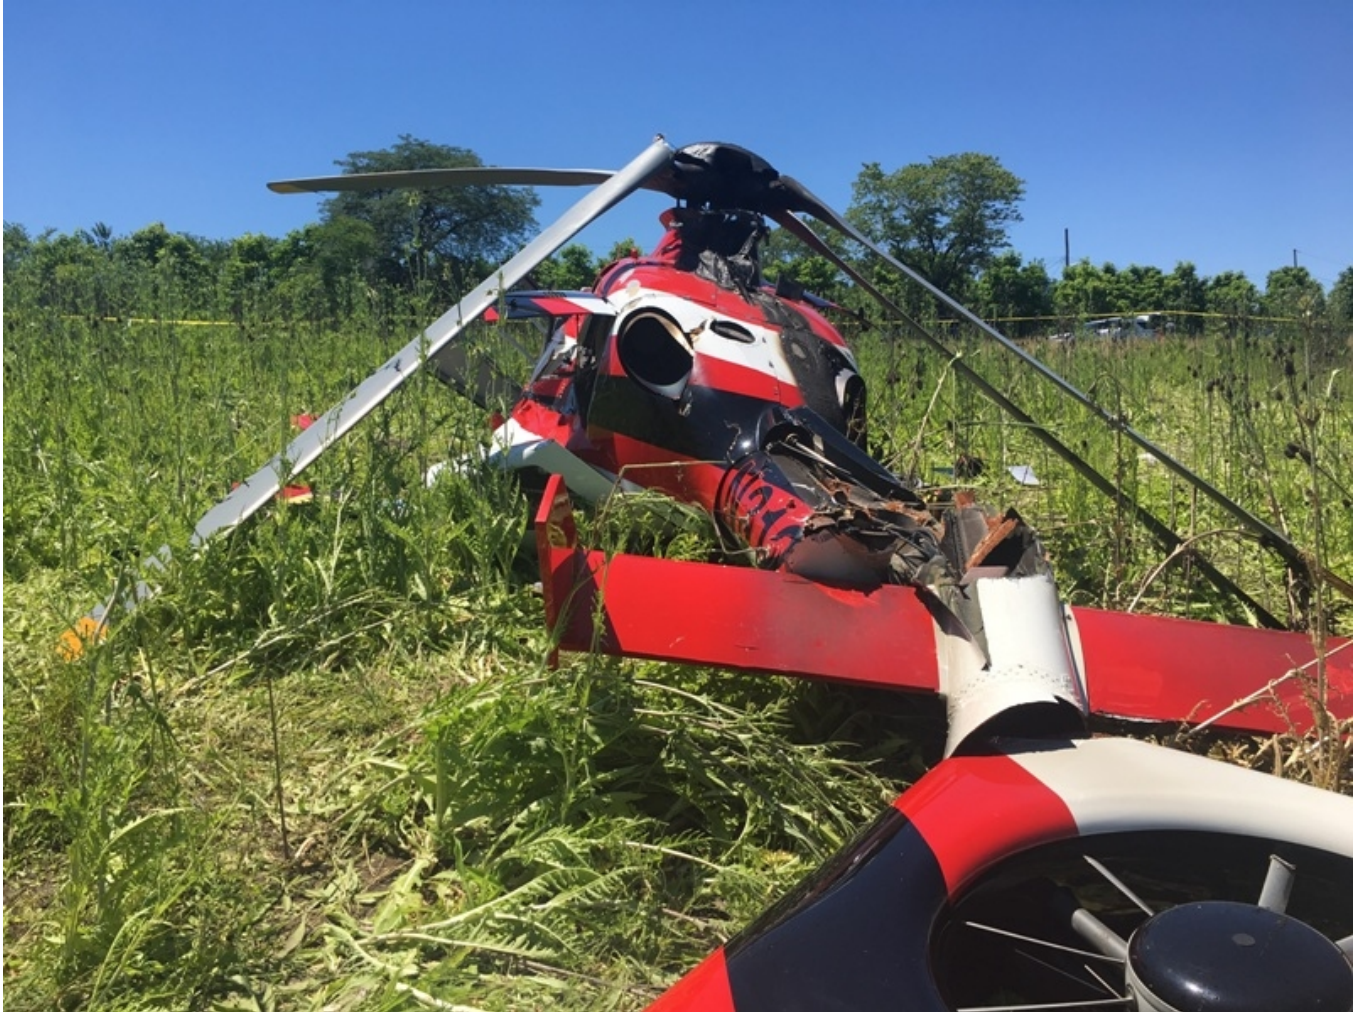
Figure 3. Main Wreckage

Thermal damage was noted on the No. 2 engine and main transmission cowling. Both engines power

turbine wheel blades were missing the outer halves of the blades. Multiple impact dents, consistent with the fractured turbine blades, were noted inside the exhaust stubs of both engines. The No. 1 engine had a 1/2" by 1/2" hole in the exhaust stub at the 1 o'clock position forward of the aft firewall, and the No. 2 engine had a 2" by 1" hole in the exhaust stub at the 10 o'clock position forward of the aft firewall. The engines and FADEC components (Electronic Engine Controls (EECs) and Data Collection Units (DCUs)) were removed and shipped to Pratt & Whitney Canada (PWC) for further examination.
