# Aviation Investigation Final Report

<b>Location:</b>	Deer Park, Washington	<b>Accident Number:</b>	WPR18FA195
<b>Date &amp; Time:</b>	July 13, 2018, 10:21 Local	<b>Registration:</b>	N24442
<b>Aircraft:</b>	Cessna 172	<b>Aircraft Damage:</b>	Substantial
<b>Defining Event:</b>	Birdstrike	<b>Injuries:</b>	3 Fatal
<b>Flight Conducted Under:</b>	Part 91: General aviation - Instructional

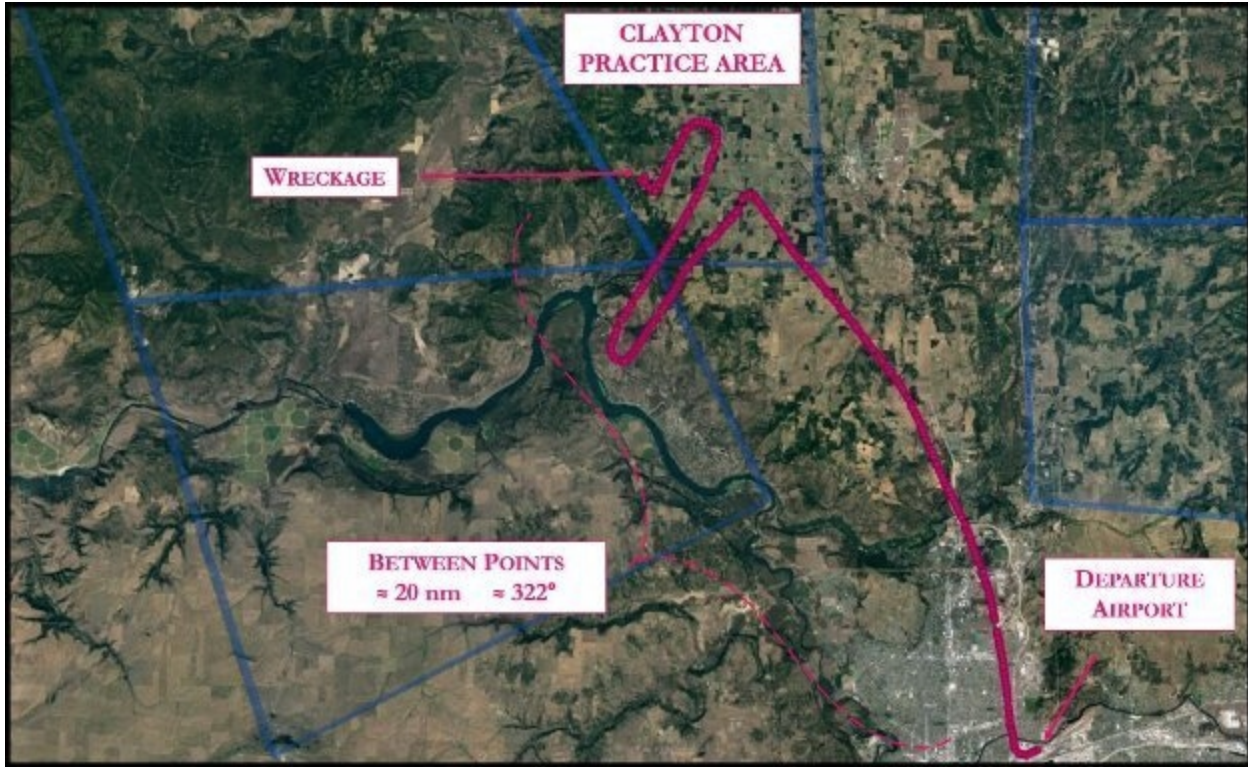
Figure 1: Radar Data from Departure Airport to Accident Site.

A review of the radar track data indicated that, after entering the practice area at 1010, (Figure 1) the airplane began a gradual 90° left turn and continued in a southwesterly direction, temporarily leaving the Clayton boundary. The airplane continued in a gradual climb to about 7,000 ft mean sea level (msl) and then made a 180° right turn. The flight track remained on a northeasterly heading until about 1018, at which point the airplane made another 180° left turn to a heading of 208°. The airplane proceeded about 2.5 miles at altitudes varying between about 7,000 to 7,450 ft msl. At 1020:53, the data indicated the airplane was at an altitude of 7,000 ft msl and an estimated ground speed of 77 knots. The airplane then made a sharp 90° right turn (Figure 2) and continued on a 305° heading for about 14 seconds. The airplane then made another sharp 90° right turn, and the last recorded track data, at 1021:18, indicated an estimated ground speed of 117 knots.

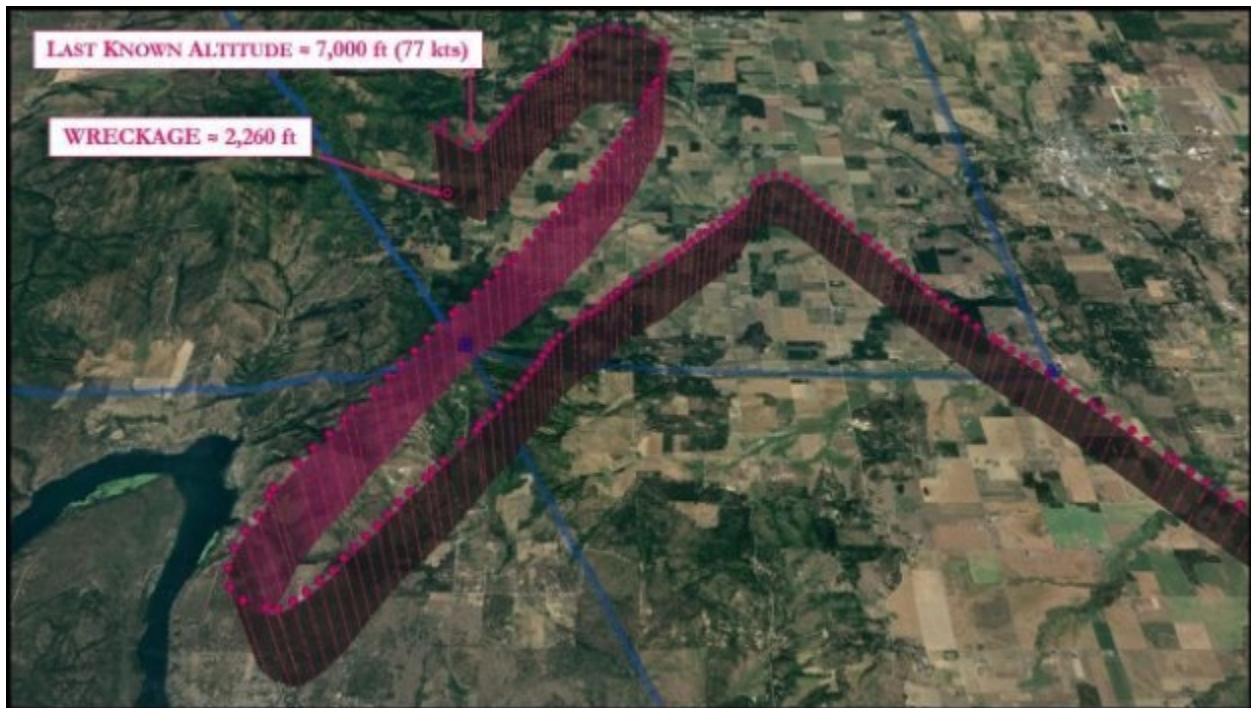
Figure 2: Radar Data Prior to Accident (showing altitude profile)

The accident site was located about 740 ft southwest of the last recorded track data (Figure 2). Witnesses reported that the airplane banked hard, then descended in a steep dive toward terrain. During the descent, the wings departed the airplane before ground impact.

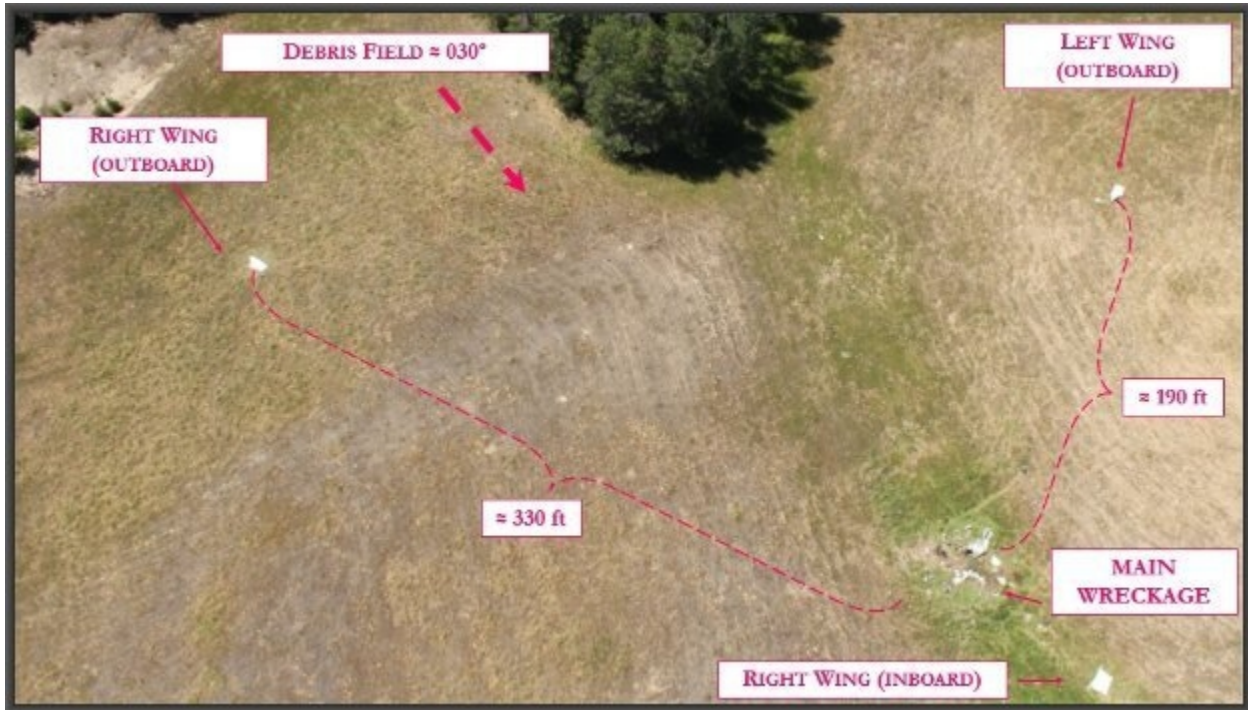
Figure 3: Accident Site

The wreckage was distributed over a 400 ft distance on a median magnetic bearing of about 030°. The outboard sections of both the right and left wings were located at the beginning of the debris field about 330 and 190 ft from the main wreckage, respectively (Figure 3). The debris between the outboard wing

sections and the main wreckage consisted of left-wing pieces. All control surfaces and their associated mass balance weights were accounted for in the debris field.
