Aviation Investigation Final Report

| Location: | Fort Rice, North Dakota | Accident Number: | CEN18FA277 |
| Date & Time: | July 17, 2018, 14:23 Local | Registration: | N24515 |
| Aircraft: | Cessna 152 | Aircraft Damage: | Substantial |

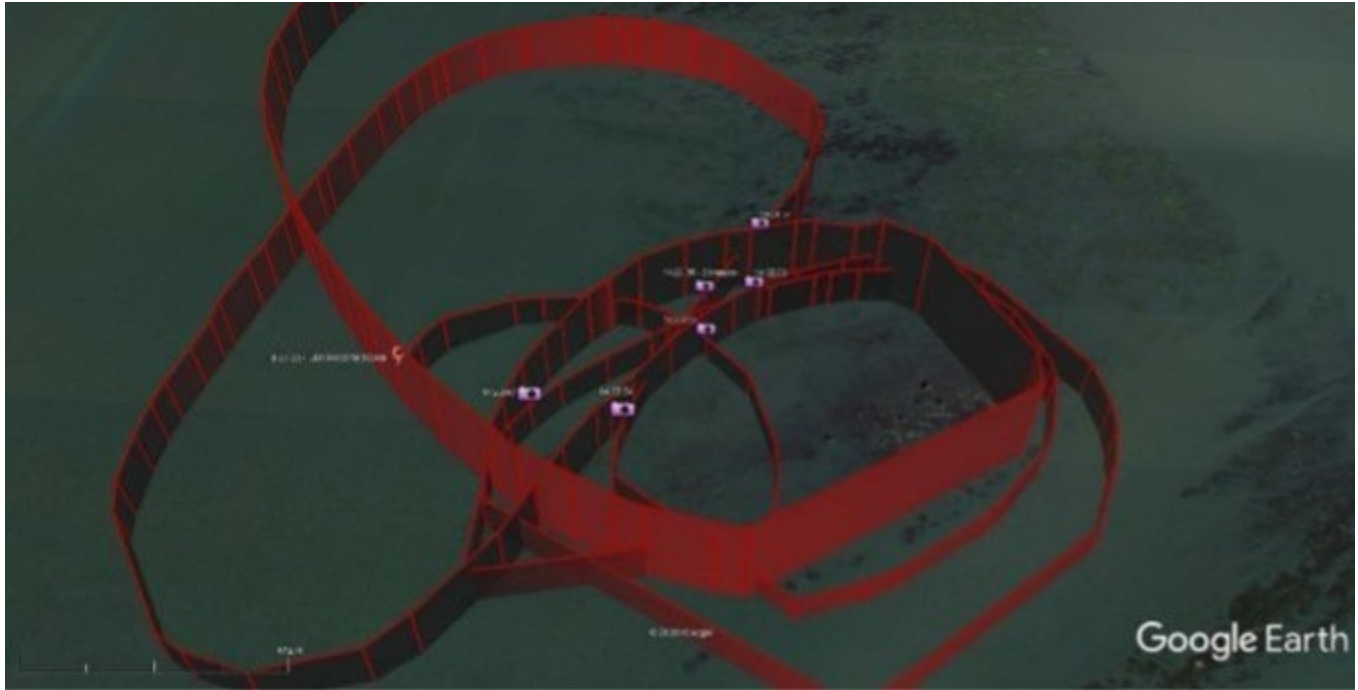
The accident flight departed about 1337. Federal Aviation Administration (FAA) surveillance data showed that the airplane followed the Missouri River on a southeast path toward Huff, North Dakota. Once established south of Huff, the airplane performed multiple turns throughout the area at an average altitude of 2,500 ft mean sea level (msl) before traveling east toward Fort Rice. The last segment of data showed that the airplane made several low-level turns over the Missouri River, as shown in figure 1. Most of the turns were to the left. The last recorded data point showed that the airplane at 1,700 ft msl and a groundspeed of 49 knots. About 1442, the Morton County Sheriff's Office received notification that a witness observed the airplane located in the Missouri River.

Figure 1. Last segment of flight over the Missouri River. The image is oriented to the north. The times and locations of the last several aerial images captured by the pilot are shown.

The images from the pilot's digital camera were extracted. Most of the images were of farms and farm equipment taken at a low angle. Between 1421:57 and 1423:12, seven images of the river were captured at a high angle and an almost-straight-down orientation. The metadata associated with all of the recovered images did not contain any GPS data.
