Aviation Investigation Final Report

Location:	Fort Rice, North Dakota	Accident Number:	CEN18FA277
Date & Time:	July 17, 2018, 14:23 Local	Registration:	N24515
Aircraft:	Cessna 152	Aircraft Damage:	Substantial
Defining Event:	Loss of engine power (total)	Injuries:	1 Fatal
Flight Conducted Under:	Part 91: General aviation - Aerial observation

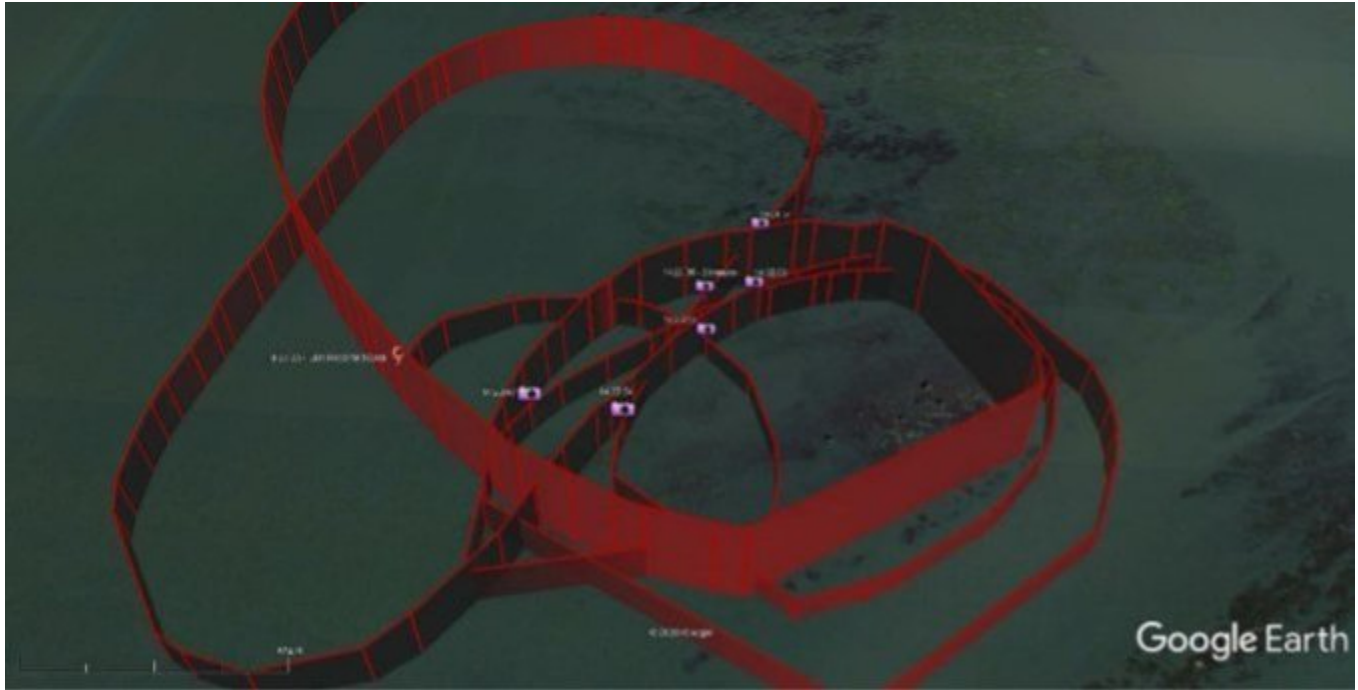
Figure 1. Last segment of flight over the Missouri River. The image is oriented to the north. The times and locations of the last several aerial images captured by the pilot are shown.

The images from the pilot's digital camera were extracted. Most of the images were of farms and farm equipment taken at a low angle. Between 1421:57 and 1423:12, seven images of the river were captured at a high angle and an almost-straight-down orientation. The metadata associated with all of the recovered images did not contain any GPS data.

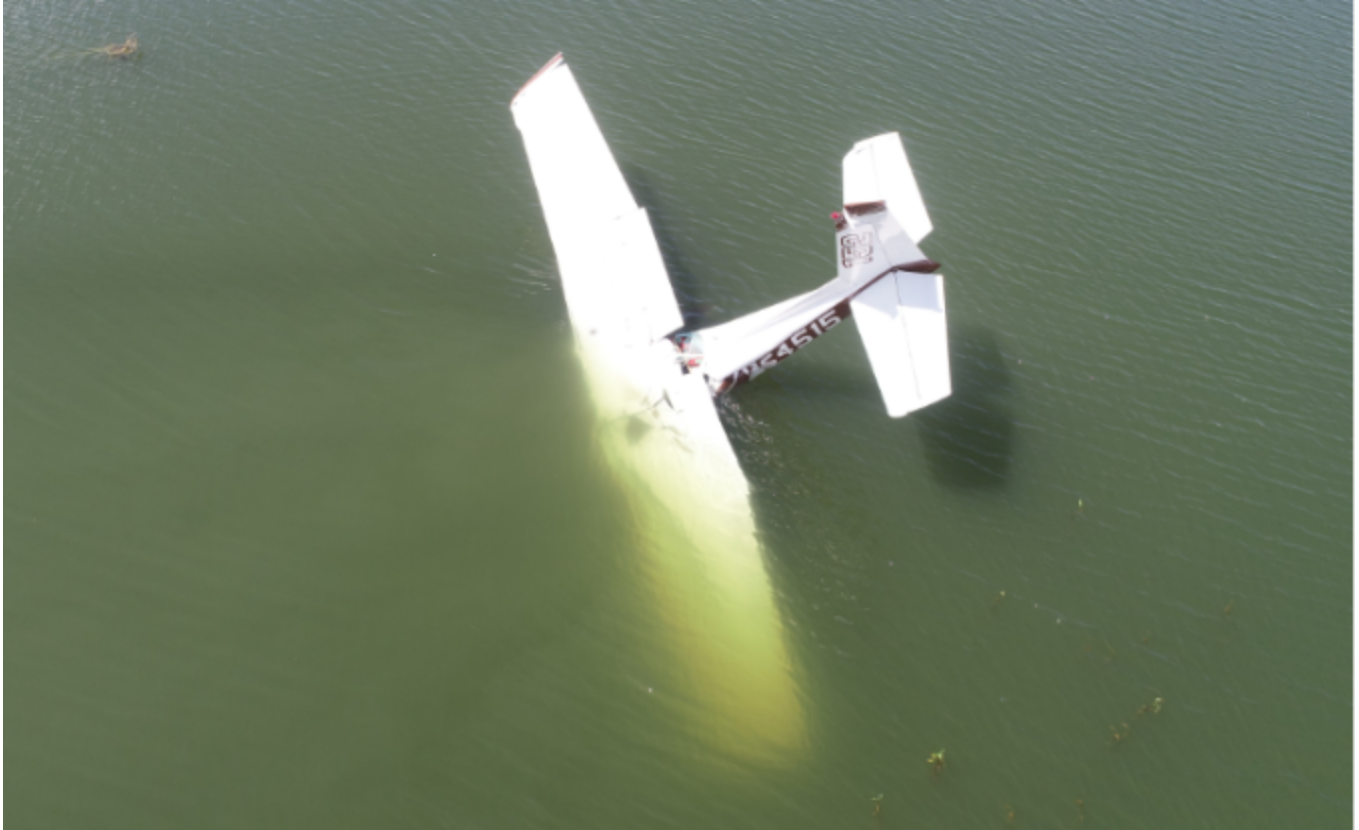
The airplane was discovered nose down with its empennage elevated, in about 5 ft of water, and about 75 ft west of a sandbar in the middle of the Missouri River, as shown in figure 2. The front of the airplane was oriented about 190°.

Figure 2. Aerial view of the airplane at the accident site. (Courtesy of the Morton County Sheriff's Office.)

The airplane sustained substantial damage to the fuselage and aft crushing to the leading edges of both wings. The propeller spinner was crushed aft and showed no evidence of rotation. One of the two propeller blades was bent slightly aft. The carburetor heat was found in the off position (at both the cockpit and engine locations). The carburetor temperature system was found to be installed correctly from the cockpit to the carburetor. The switch for the carburetor temperature system was found in the "Carb Temp" position.
