Aviation Investigation Final Report

Location:	Fort Rice, North Dakota	Accident Number:	CEN18FA277
Date & Time:	July 17, 2018, 14:23 Local	Registration:	N24515
Aircraft:	Cessna 152	Aircraft Damage:	Substantial
Defining Event:	Loss of engine power (total)	Injuries:	1 Fatal
Flight Conducted Under:	Part 91: General aviation - Aerial observation

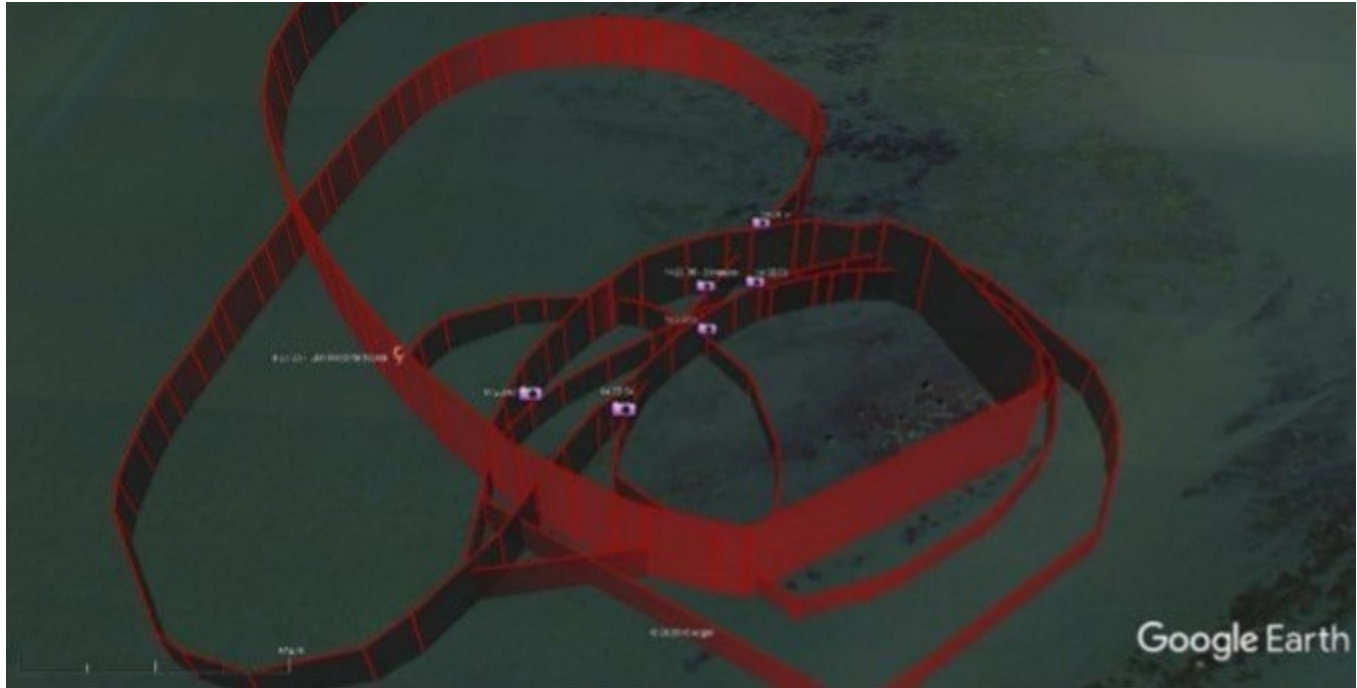
Figure 1. Last segment of flight over the Missouri River. The image is oriented to the north. The times and locations of the last several aerial images captured by the pilot are shown.

The images from the pilot's digital camera were extracted. Most of the images were of farms and farm equipment taken at a low angle. Between 1421:57 and 1423:12, seven images of the river were captured at a high angle and an almost-straight-down orientation. The metadata associated with all of the recovered images did not contain any GPS data.
