# Aviation Investigation Final Report

<b>Location:</b>	Willow, Alaska	<b>Accident Number:</b>	ANC18FA055
<b>Date &amp; Time:</b>	July 18, 2018, 19:00 Local	<b>Registration:</b>	N9878R
<b>Aircraft:</b>	De Havilland DHC-2	<b>Aircraft Damage:</b>	Destroyed
<b>Defining Event:</b>	Aerodynamic stall/spin	<b>Injuries:</b>	1 Fatal, 2 Serious
<b>Flight Conducted Under:</b>	Part 135: Air taxi & commuter - Non-scheduled

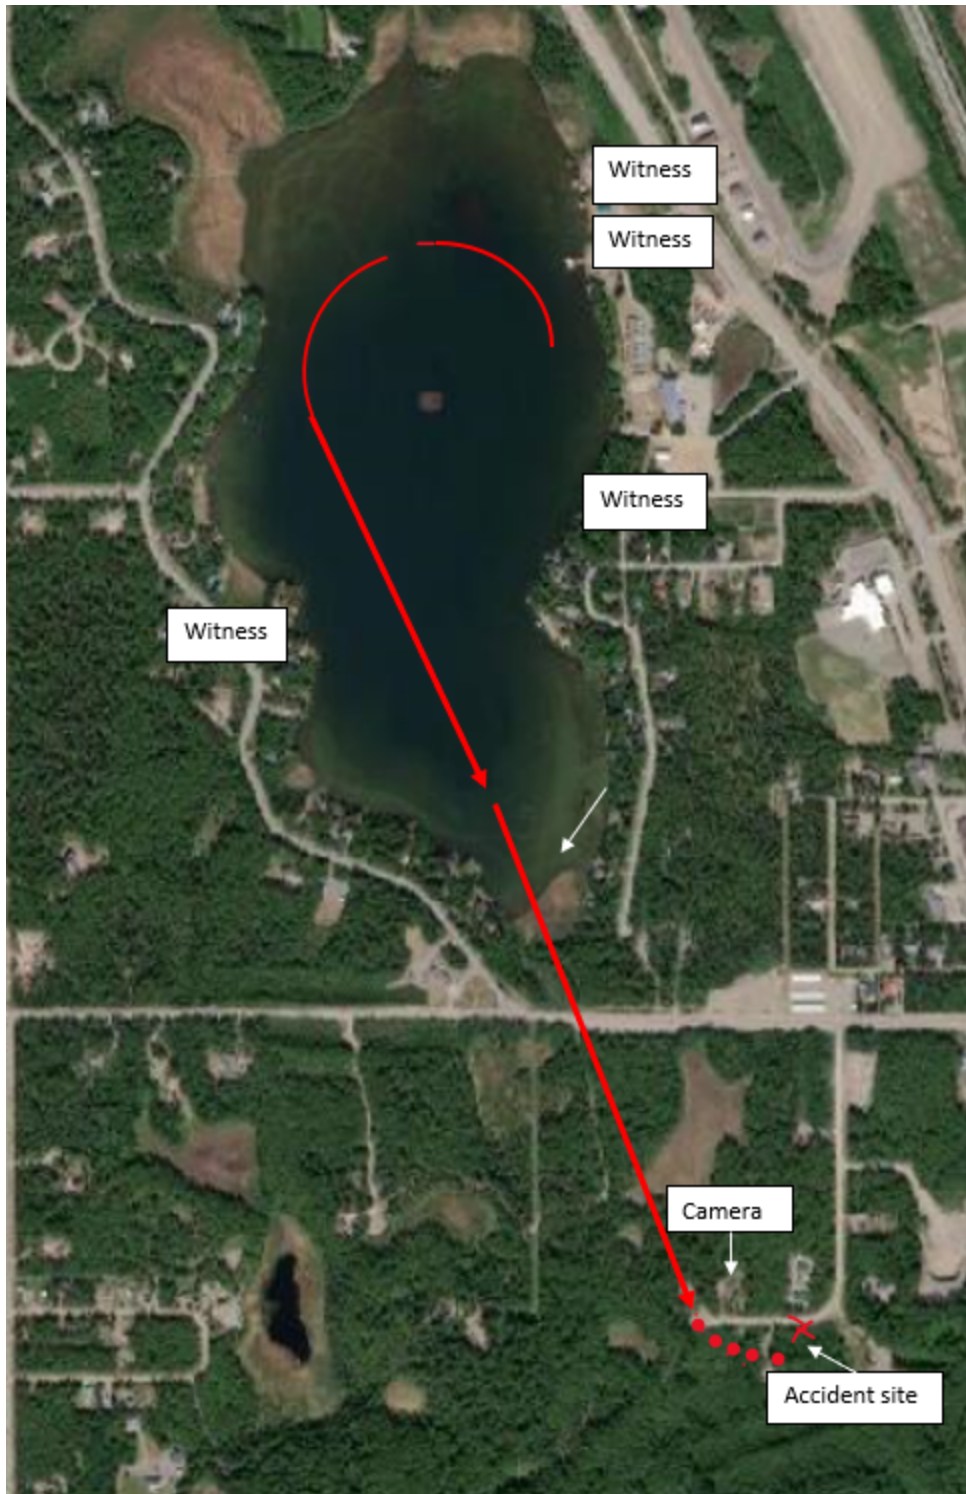
Figure 1. Willow Lake with approximate water and flight tracks based on witness videos.

the flaps up, and finally performed a step taxi takeoff with the flaps in the takeoff position, heading south-southeast. One witness stated that the pilot did not use the entire length of the lake for takeoff but rather started the takeoff with 1,300 ft of waterway behind the airplane at the north end of the lake.

According to the witnesses, the airplane slowly lifted off and attained a nose high attitude as it barely climbed over trees at the southeast end of the lake (see figure 1). The passenger stated that after takeoff, as the airplane turned left in the direction of the destination, it rolled left and crashed. After the impact, she noted that the pilot was unresponsive as the airplane became engulfed in fire, and she immediately evacuated with her son.

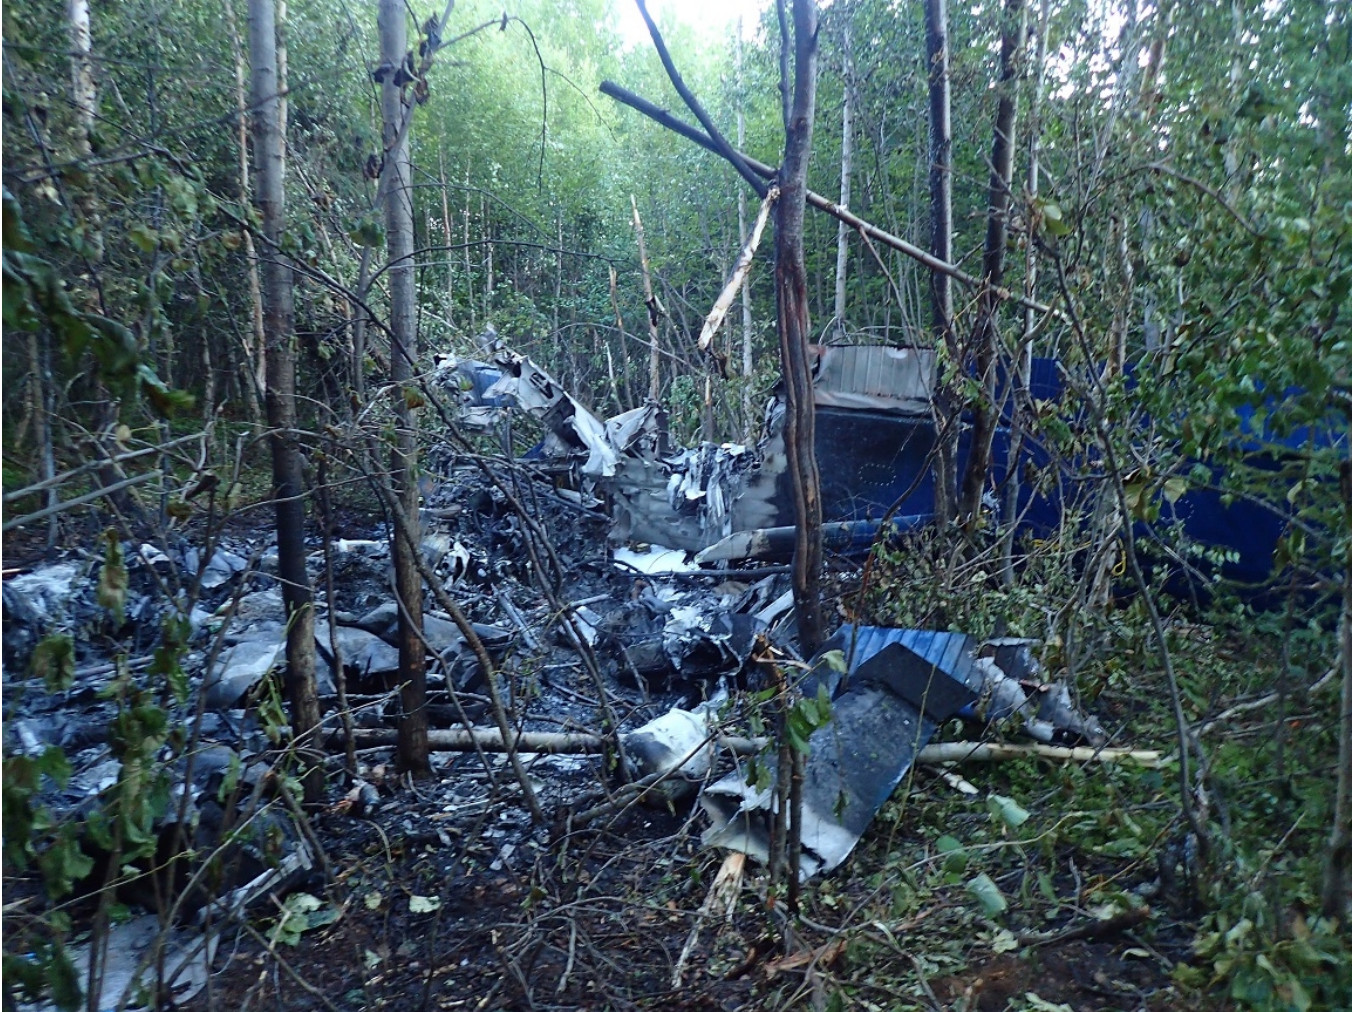
Figure 2. Accident airplane at the accident scene.

The airplane came to rest in a level, wooded, residential lot in a nose-down attitude, on a heading of about 300°. The postcrash fire incinerated the fuselage, cockpit instruments, empennage, floats, engine components, and cargo (see figure 2.)

The wreckage consisted primarily of the wings, forward fuselage frame, floor structure and engine with propeller attached. The wreckage exhibited either soot, charring, oxidized metal, or melted aluminum. Hardened masonry mortar was intermixed with the airframe and engine components. The right wing was mostly intact with some fore-to- aft buckling on the outboard leading edge and the flap and aileron were attached. The left wing had significant leading edge buckling near the outer edge. The left flap and aileron were attached, but the flap control rod was disconnected at the C clamp. The left aileron inboard edge had impact damage that matched the adjacent flap edge damage with the flaps extended about 30°, which indicated the flaps were likely at or near the takeoff position at the time of impact.
