Aviation Investigation Final Report

| Location: | Burnet, Texas | Accident Number: | WPR18FA201 |
| Date & Time: | July 21, 2018, 09:15 Local | Registration: | N47HL |
| Aircraft: | Douglas DC3 | Aircraft Damage: | Destroyed |

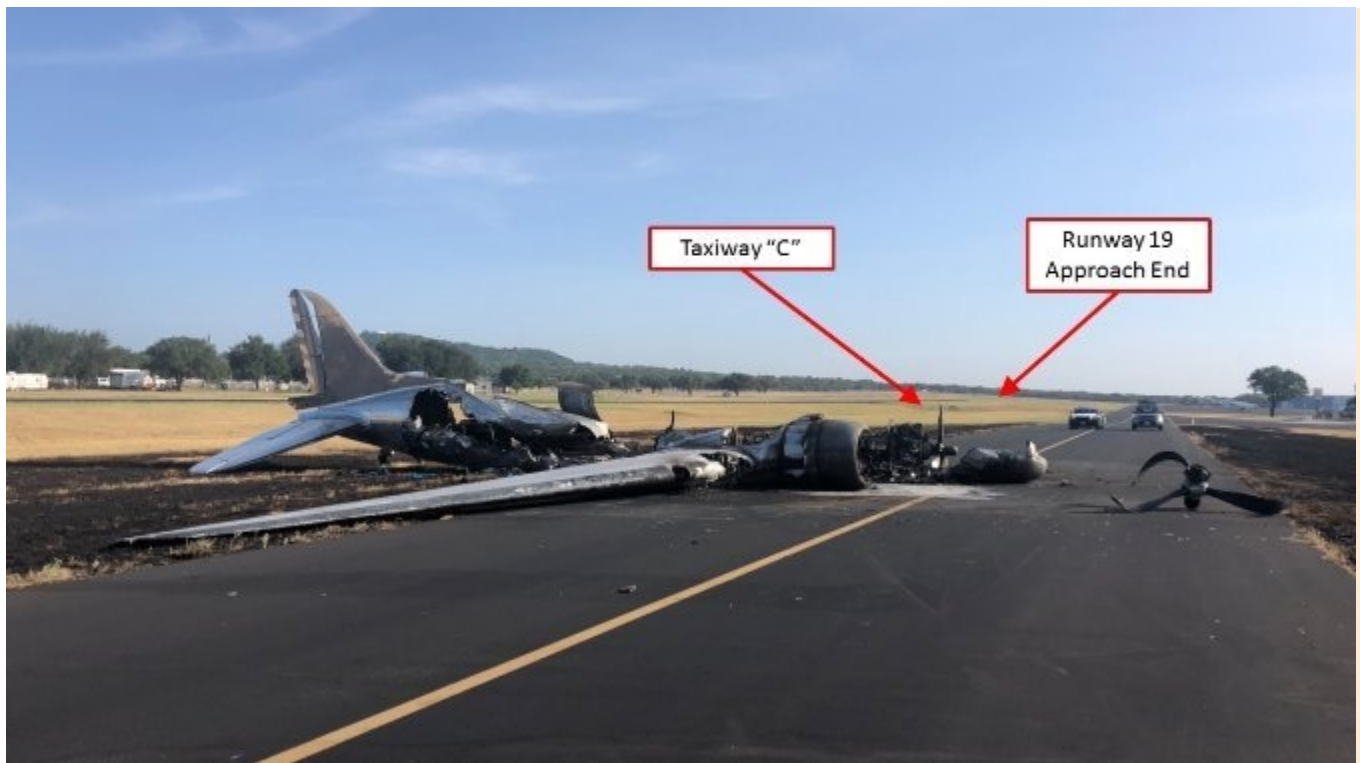
Examination of the accident site revealed that the airplane came to rest upright on a heading about 113° magnetic, about 145 ft east of the left side of runway 19, partially on the taxiway. (Figure 1)

Figure 1. A photograph showing the main wreckage in relation to runway 19 and taxiway C.

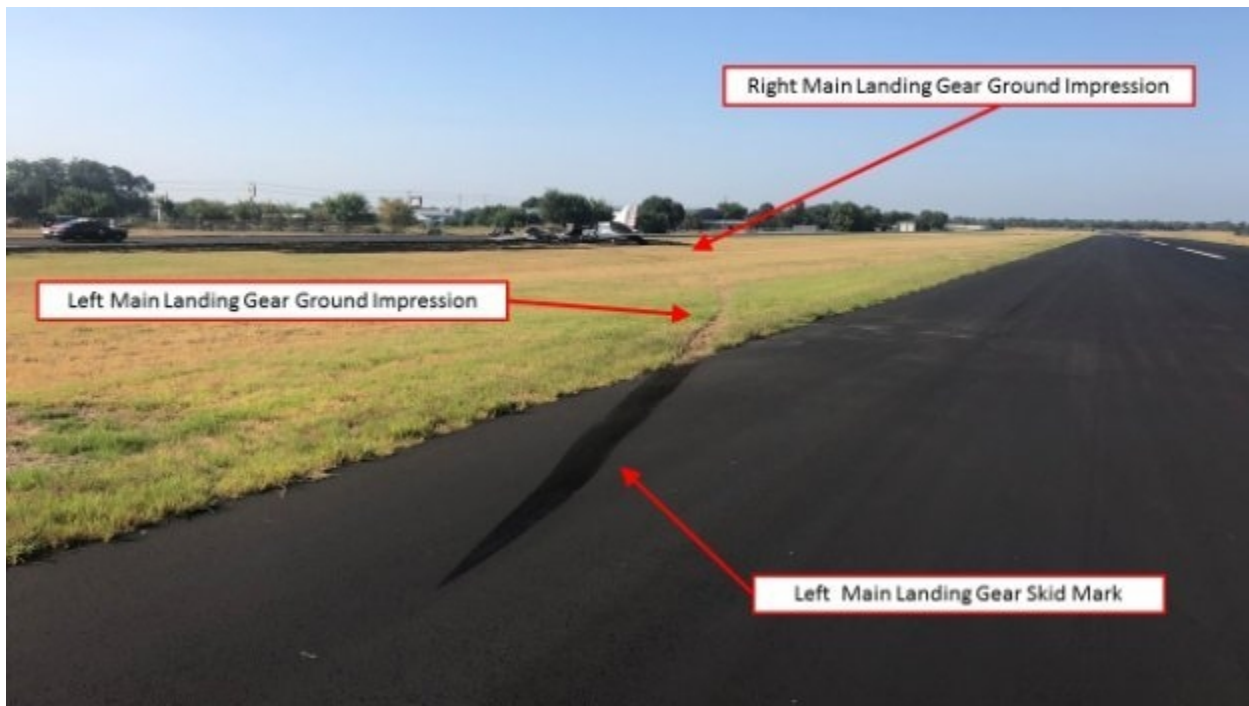
A ground impression was observed left of the runway about 1,566 ft from its approach end, consistent with the right MLG exiting the left side of the runway. The impression then continued almost parallel to the runway until it reached a runway light, slightly beyond which the impression stopped. Another ground impression was observed about 2,111 ft from the approach end and extended parallel to the runway for about 200 ft, consistent with impact by the left wing.

Another ground impression was observed about 2,377 ft from the approach end of the runway, which extended from the wheel skid mark toward the main wreckage, consistent with the left MLG exiting the left side of the runway. See figure 2 for a photograph showing the wheel skid mark on the runway and the ground impressions left of the runway.

Figure 2. A photograph showing the left MLG wheel skid mark on the runway and the left MLG ground impressions left of the runway.

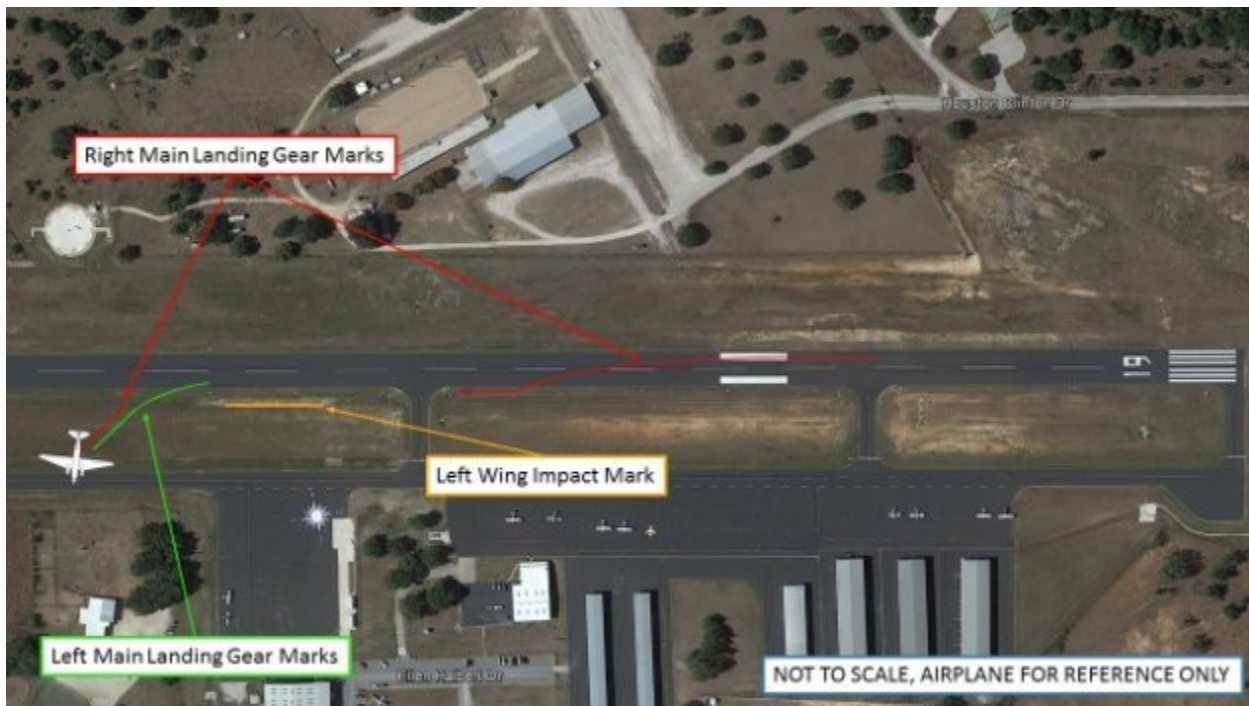
During examination of the runway, a skid mark consistent with the right MLG tire, was observed about 843 ft from the approach end of the runway. The mark extended from slightly right of the runway centerline toward the 1,000-ft markers and moved progressively toward the right side of the runway. Beginning about 1,106 from the approach end of the runway, the skid mark began to move progressively left, and its angle toward the left side of the runway started increasing.

Another ground impression was observed about 2,436 ft from the approach end of the runway, consistent with the right MLG. The main wreckage came to rest about 2,638 ft from the approach end of the runway. (See figure 3 for an overhead view of the left MLG wheel skid mark, right and left MLG wheel impressions, and the left-wing impact mark locations.)

Figure 3. An overhead image of the right MLG wheel skid mark, the right and left MLG ground impressions, and the left-wing impact mark locations observed at the accident site.

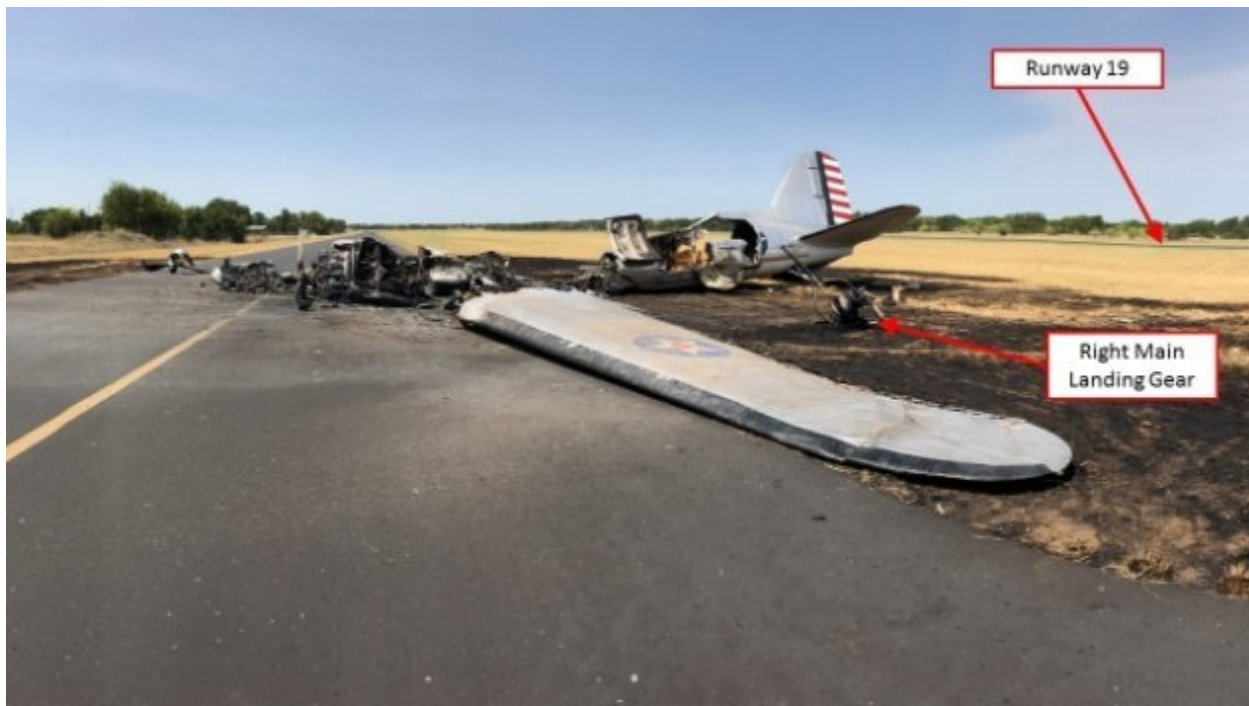
Grass within about 200 ft of the main wreckage was burnt by postimpact fire, which consumed the fuselage from the nose cone aft to about 3 ft forward of the left cargo door. The wing center section of the fuselage was mostly consumed by fire and extended outboard to the right-wing attachment point and about 2 ft outboard of the left-wing attachment point. (See figure 4 for a photograph showing the main wreckage and postimpact fire damage.) All cables in the throttle quadrant remained attached but exhibited thermal or fire damage. The tailwheel lock engagement handle was not found.

Figure 4. A photograph showing the main wreckage and postimpact damage.
