Aviation Investigation Final Report

Location:	Loma, Colorado	Accident Number:	CEN18LA303
Date & Time:	July 31, 2018, 11:30 Local	Registration:	N125TY
Aircraft:	Buchanan Kitfox IV	Aircraft Damage:	Substantial
Defining Event:	Loss of control in flight	Injuries:	1 Minor
Flight Conducted Under:	Part 91: General aviation - Personal

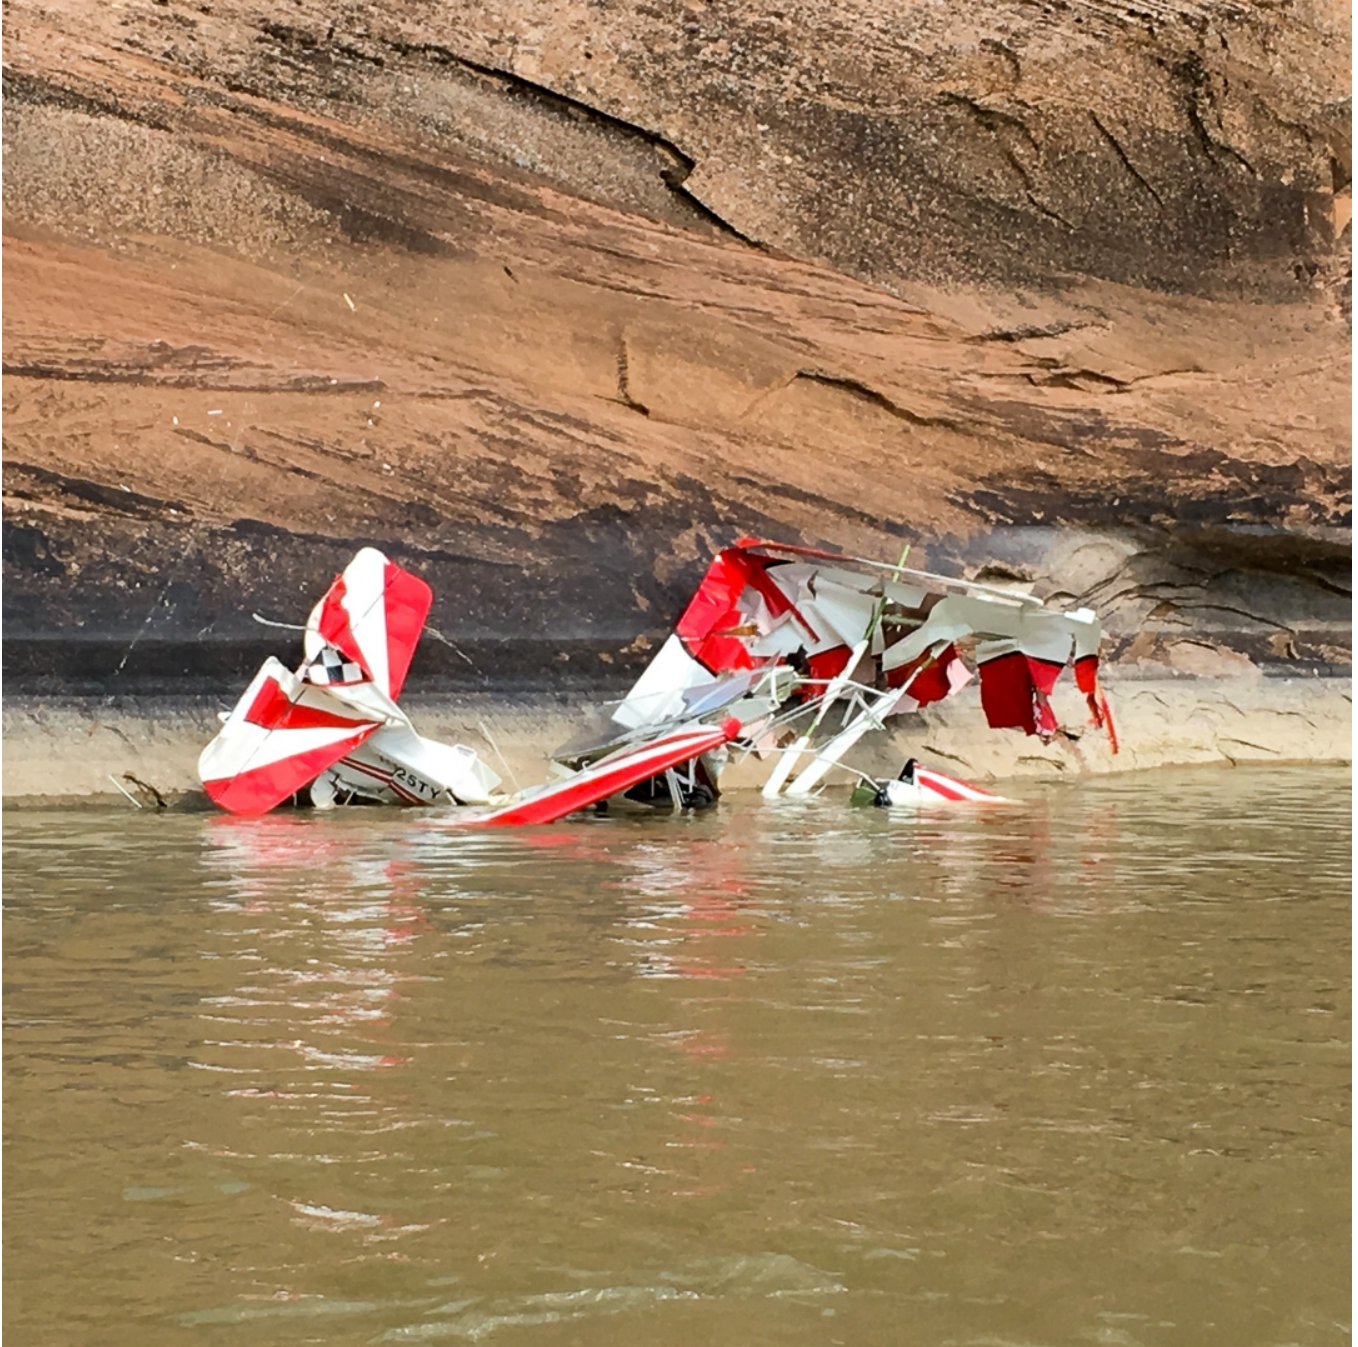
According to the pilot, he departed GJT and elected to fly at low altitude over the Colorado River. After over passing a group of river rafters about 500 ft above ground level, the pilot "dropped [the airplane] low to the river." Shortly after descending, the airplane's vertical stabilizer struck a cableway (owned and maintained by the US Geological Survey (USGS)) that crossed over the river. The pilot lost control of the airplane, and the airplane impacted the side of the river canyon. The airplane came to rest partially submerged in the river, and the pilot was rescued by passing river rafters (Figure 1).

Figure 1 - Accident Site (photo provided by Mesa County Sheriff's Office)

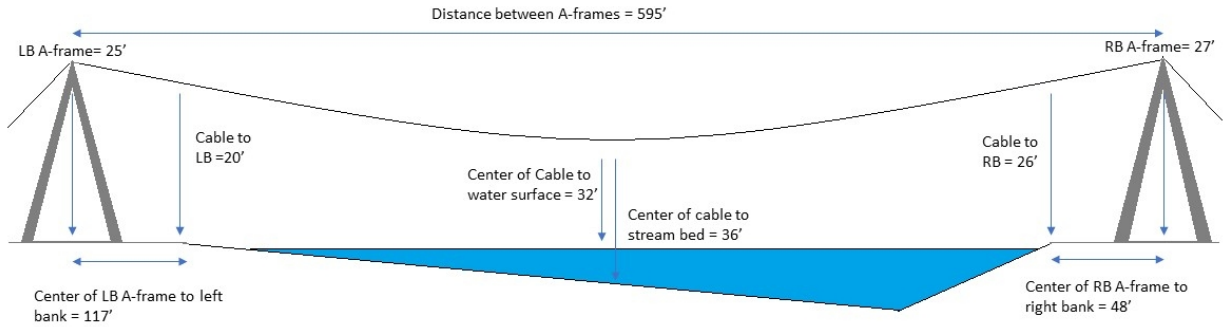
09163500 Colorado River Near Colorado Utah Stateline
(As of 08/27/2018)

The cableway was supported by two fixed A-frame structures located on the sides of the riverbank, and the cable height at its center above the water's surface was 32 ft. The pilot likely was not properly monitoring the environment during the low-altitude operation, which resulted in his failure to see and avoid the cableway.

According to the USGS, the cableway is supported by two fixed A-frame structures located on the sides of the riverbank. The center of the cable to the water surface is 32 ft (Figure 2).

Figure 2 - Cableway dimensions (USGS)
