# Aviation Investigation Final Report

<b>Location:</b>	Lopez Island, Washington	<b>Accident Number:</b>	WPR18FA210
<b>Date &amp; Time:</b>	August 2, 2018, 17:05 Local	<b>Registration:</b>	N56039
<b>Aircraft:</b>	Mooney M20J	<b>Aircraft Damage:</b>	Substantial
<b>Defining Event:</b>	Aerodynamic stall/spin	<b>Injuries:</b>	2 Fatal
<b>Flight Conducted Under:</b>	Part 91: General aviation - Personal

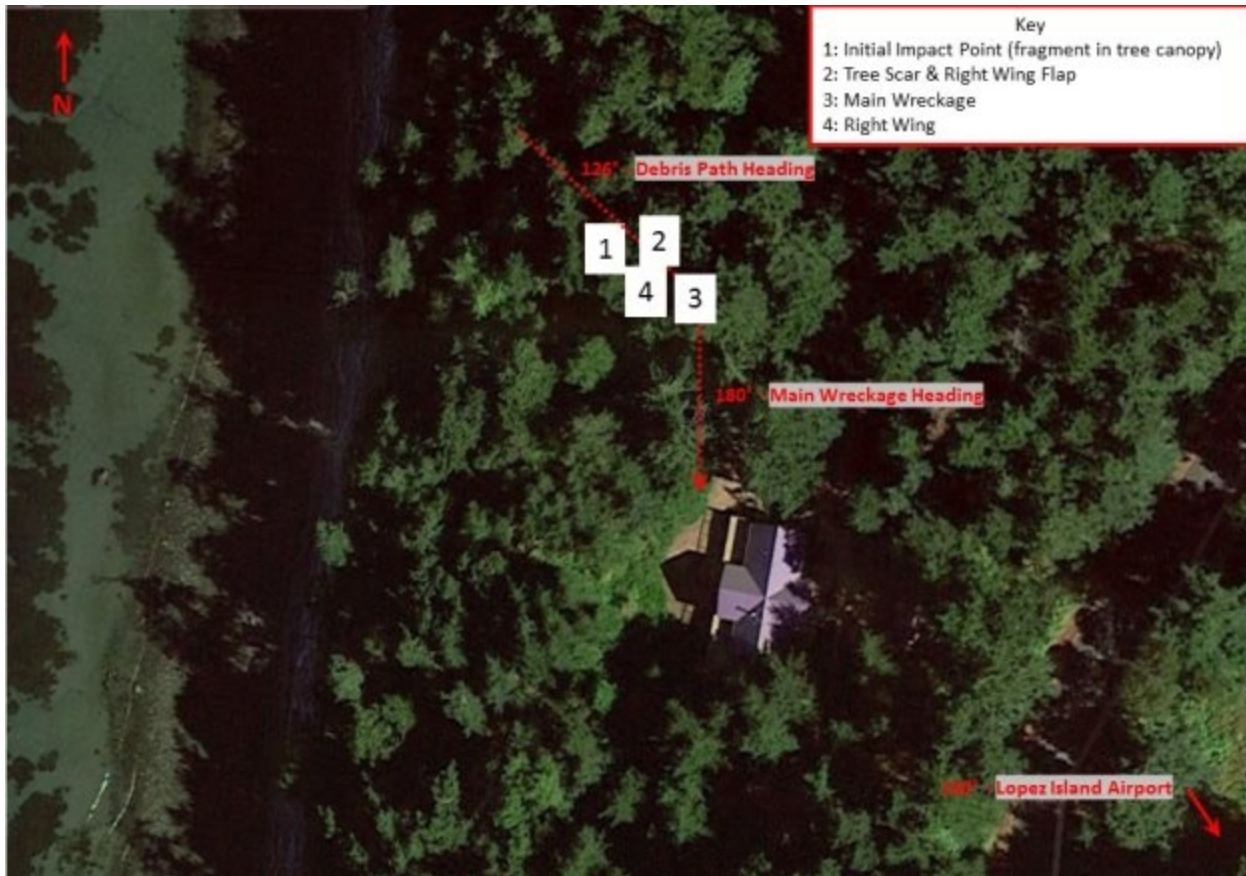
Figure 1: Wreckage Diagram

The airplane came to rest in wooded area about 400 ft from the western shore of Lopez Island and about one half nm northeast of S31. An initial impact point (IIP) was identified by an airframe fragment in the canopy of a tall tree. A tree scar that measured about 5 ft was observed about halfway up a 100-foot tall tree. The main wreckage, which comprised the empennage, left wing, right wing root, fuselage, and engine, was located a few feet forward of the scarred tree oriented on a magnetic heading of 180°, and marked the end of the debris path. The debris path was oriented on a heading of 126° magnetic and the distance between the IIP and the main wreckage was about 60 ft. The right wing separated at the wing root and was found in the debris path a few feet to the right of the main wreckage, also near the scarred tree. The inboard top skin of the right wing displayed brown and yellow transfer signatures consistent with tree contact. Both propeller blades remained attached to the propeller hub, which remained attached to the engine. Refer to Figure 1 for an illustration of the debris path.
