Aviation Investigation Final Report

Location:	Hartsel, Colorado	Accident Number:	CEN18LA309
Date & Time:	August 3, 2018, 08:15 Local	Registration:	N2025J
Aircraft:	Cameron A 250	Aircraft Damage:	None
Defining Event:	Cabin safety event	Injuries:	1 Fatal, 1 Serious, 9 None
Flight Conducted Under:	Part 91: General aviation

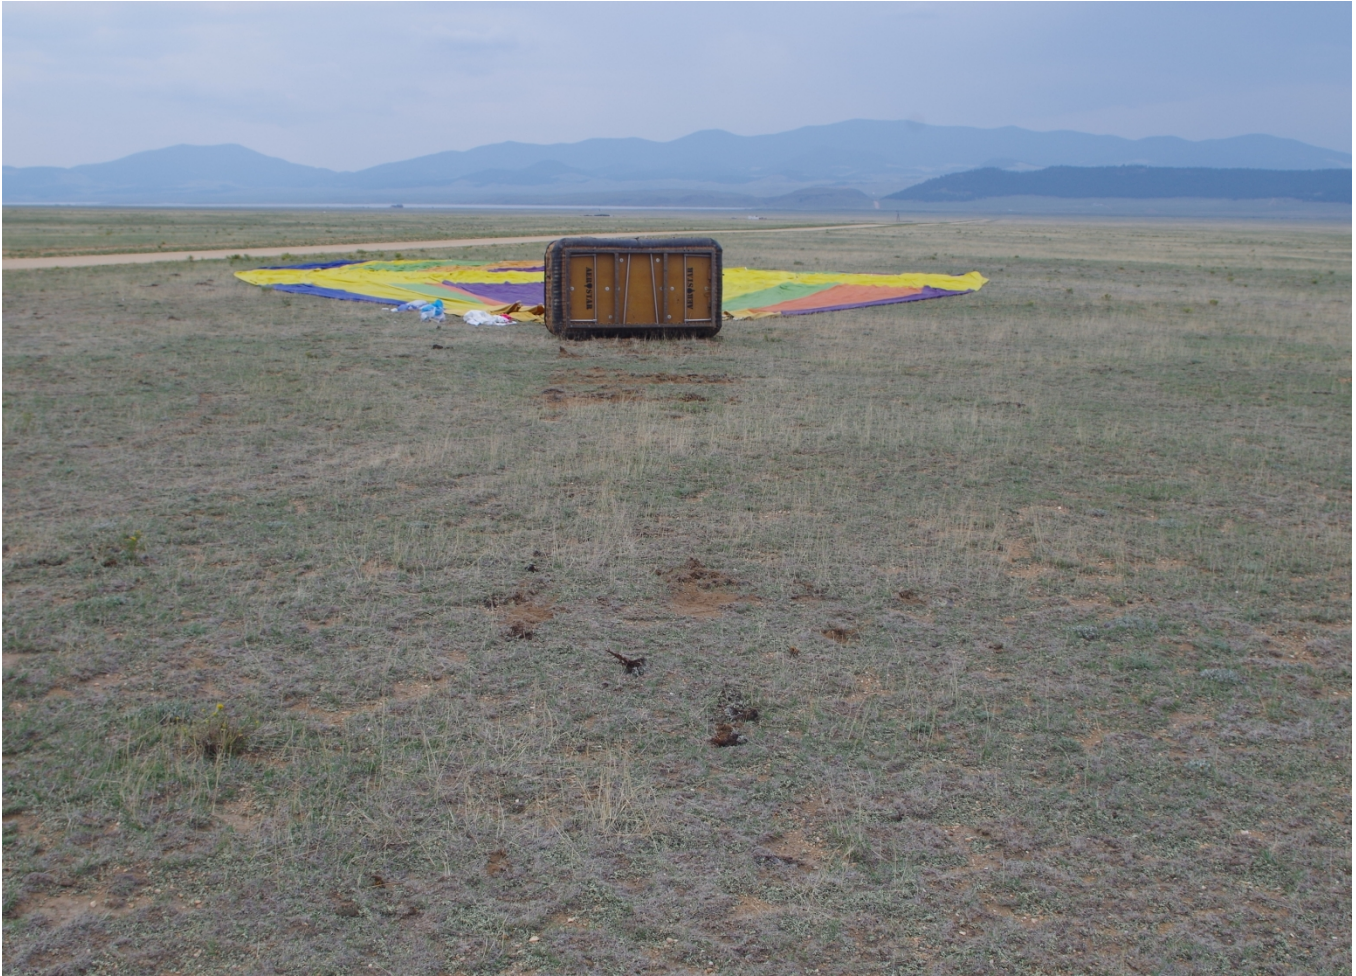
The responding Federal Aviation Administration (FAA) inspector reported that the balloon departed from a field about 6 miles northwest of the accident site. At the end of the sightseeing flight the pilot landed the balloon in a flat field; during the landing the basket bounced several times and tipped over (figure 1).

Figure 1 – Several ground scars leading up to the basket on its side

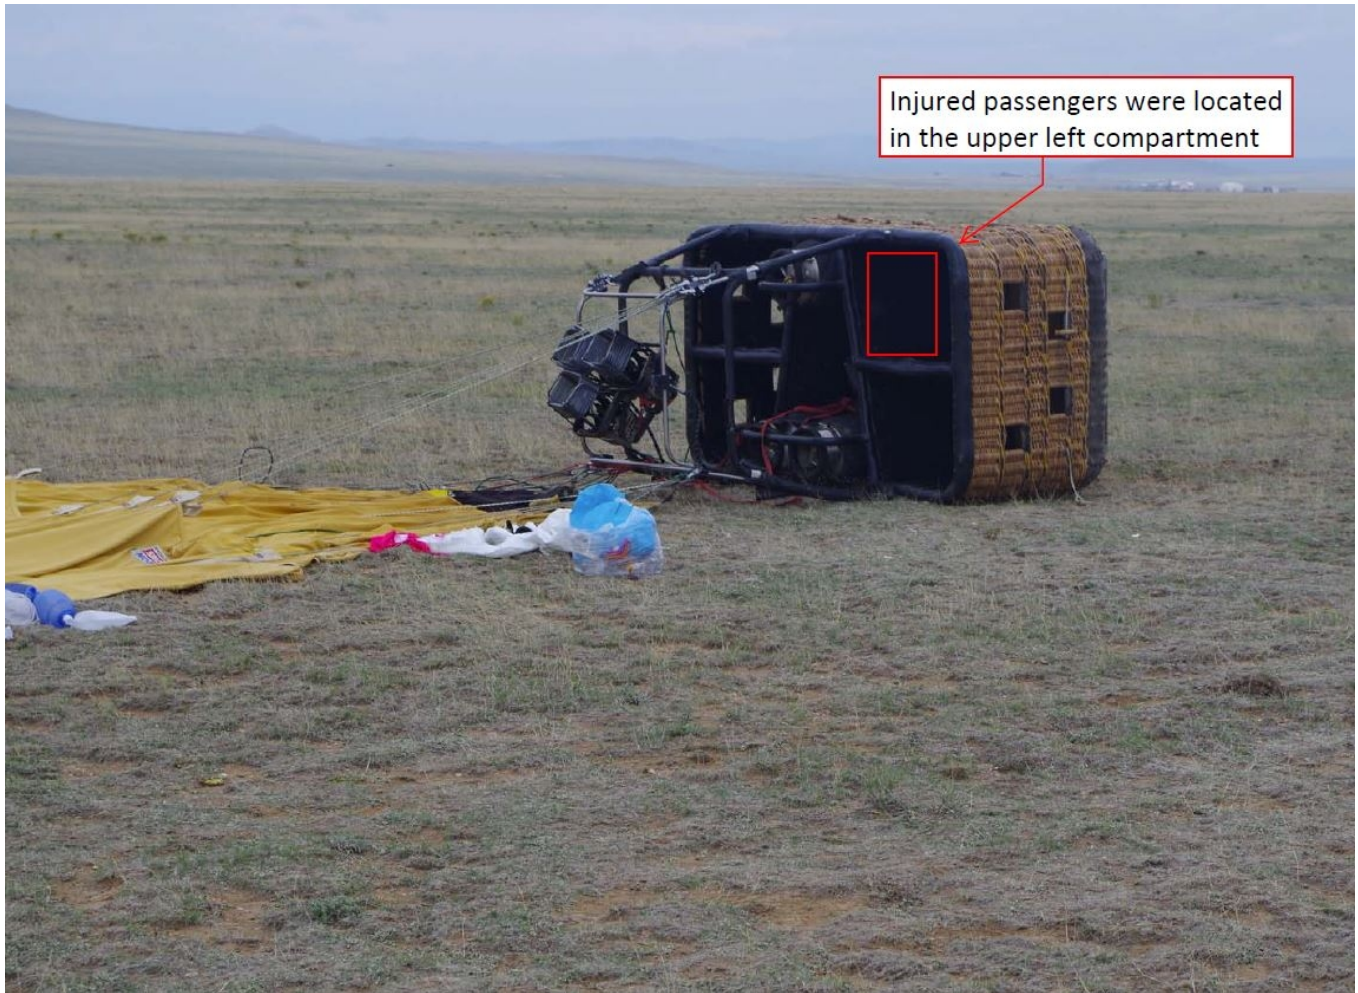
The passengers' fall from the basket after landing when the basket tipped over.

After the accident the pilot-in-command (PIC) stated that with the moderate wind they expected the basket to tip over after landing, which was typical for a moderate wind landing. After initial contact the basket dragged on the ground about 40 to 50 ft, then came to rest. The co-pilot then "pulled the top out" to release the hot air and deflate the envelope. The PIC stated that the basket had come to a complete stop, and during the deflation the basket tipped over on its side, came down hard, and the two passengers in the upper left compartment (figure 2) of the basket fell out.

Figure 2 – The basket on its side. The upper left compartment is noted in red.
