Aviation Investigation Final Report

| Location: | Driggs, Idaho | Incident Number: | DCA181A264 |
| Aircraft: | Lindstrand 105A | Aircraft Damage: | None |

| Location: | Driggs, Idaho | Incident Number: | DCA18IA264 |

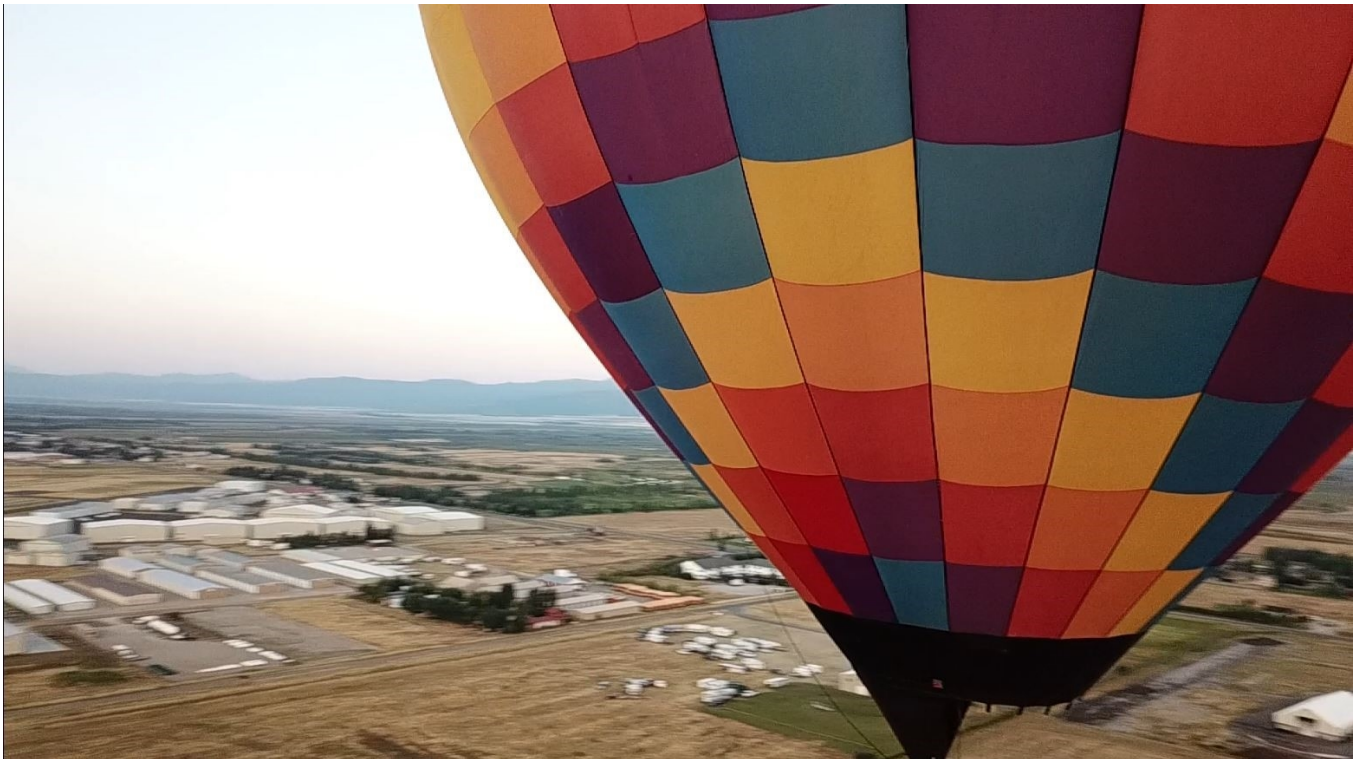
About one minute prior to the collision, the drone was at 225 feet agl, entered Active Track mode and followed the balloon, apparently tracking on the skirt and basket portions. Twenty-nine seconds prior to the collision, the video showed that the balloon was moving visibly closer to the drone, and the drone yawed left and climbed to 270 feet, then lost track and hovered. The balloon skirt and envelope filled approximately half of the drone's video frame.

Figure 2 - Video snapshot 29 seconds prior to collision

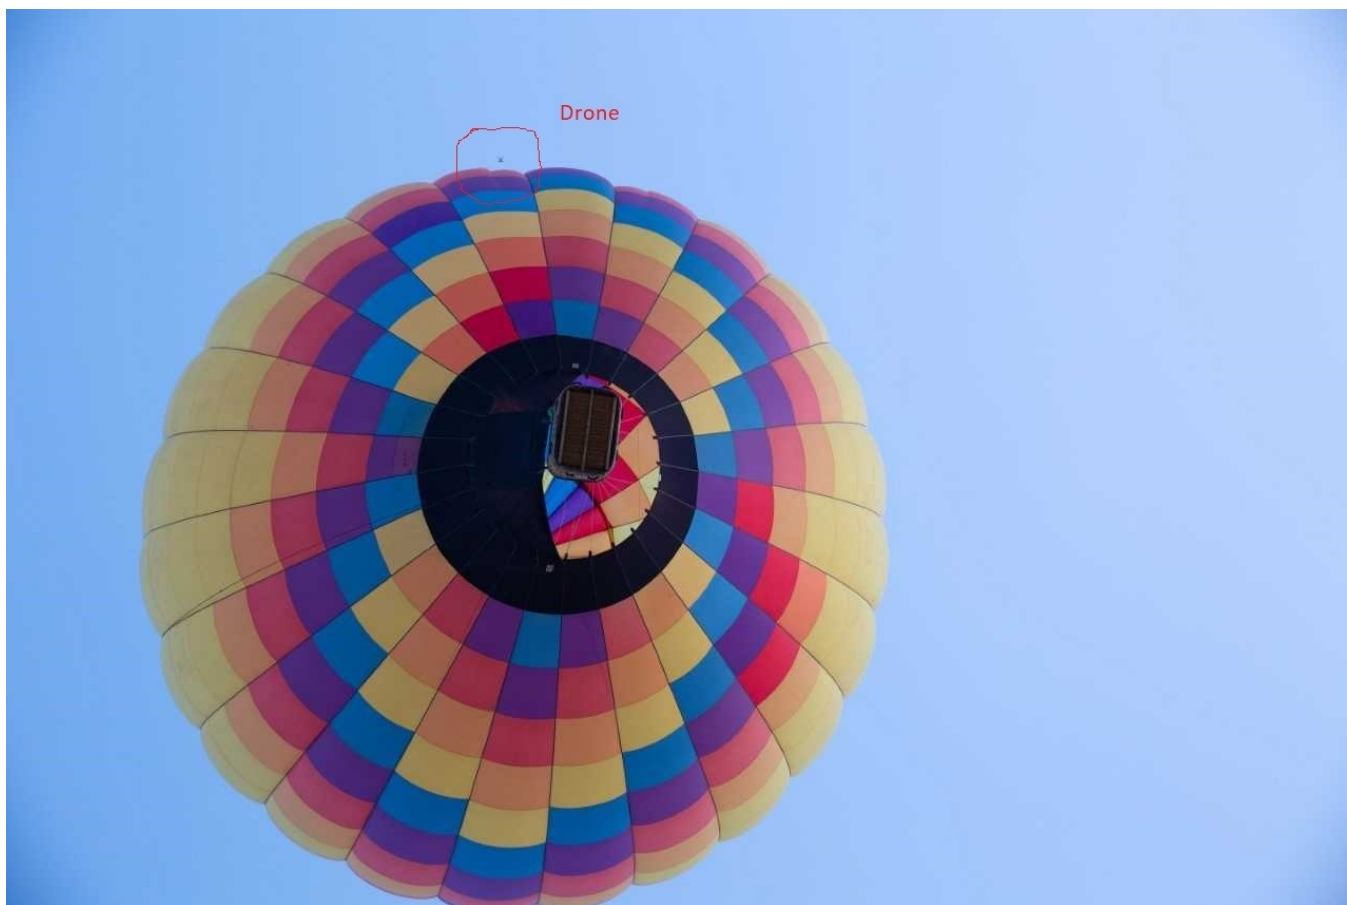
Figure 3 - Ground photo showing drone in proximity to balloon

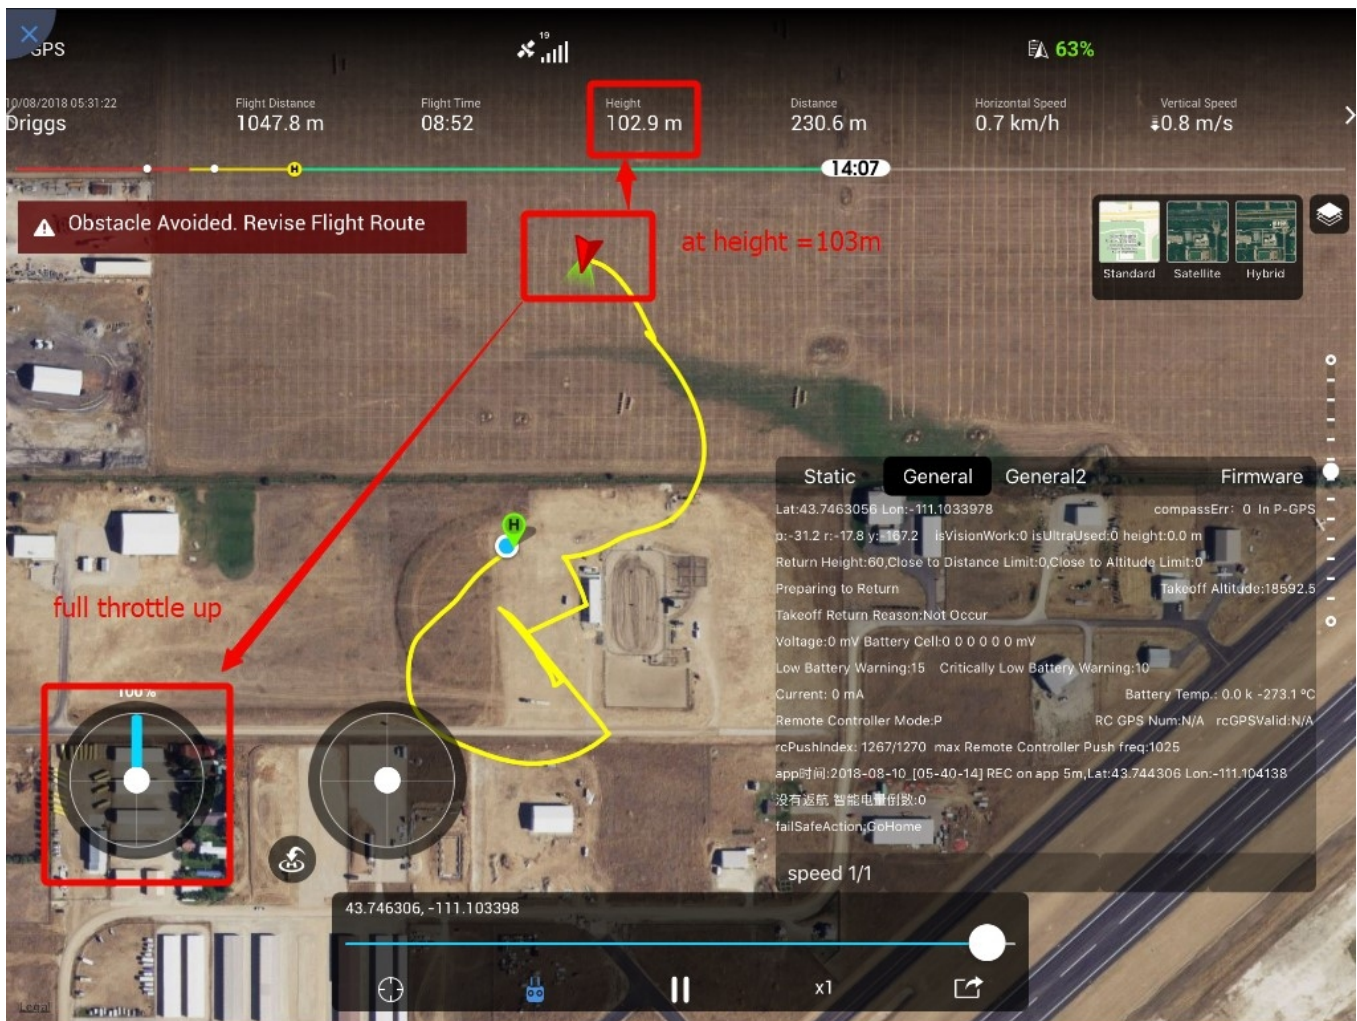
Twenty seconds prior to the collision, the balloon moved into the center of the video frame, and Active Track was reestablished briefly. The drone altitude was 310 feet agl. At four seconds prior to the collision, obstacle avoidance was again triggered and the drone's flight mode switched to GPS. The balloon envelope almost filled the entire video frame. The drone pilot reported that he had lost sight of the drone behind the balloon envelope and attempted to avoid the passengers with a full power climb command. The video and logs were consistent with the drone climbing into the outward tapering gore of the balloon envelope, colliding and tumbling, becoming briefly entangled in the balloon load lines. Data logs continued to record for 7 seconds after the collision and indicated the full throttle command remained, and the drone rotated in all axes and lost altitude. Data logs and video ended prior to ground impact.

Figure 4 - Snapshot of data log replay

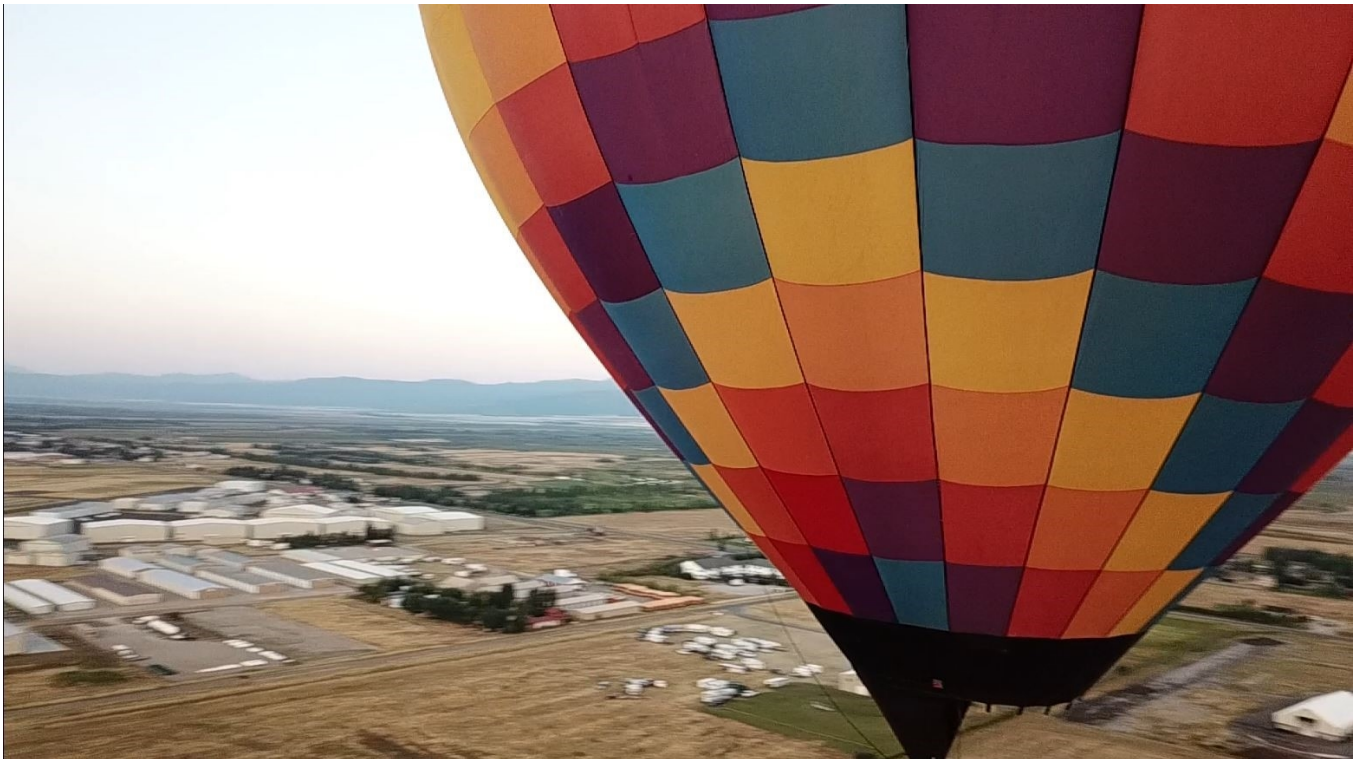
About one minute prior to the collision, the drone was at 225 feet agl, entered Active Track mode and followed the balloon, apparently tracking on the skirt and basket portions. Twenty-nine seconds prior to the collision, the video showed that the balloon was moving visibly closer to the drone, and the drone yawed left and climbed to 270 feet, then lost track and hovered. The balloon skirt and envelope filled approximately half of the drone's video frame.

Figure 2 - Video snapshot 29 seconds prior to collision

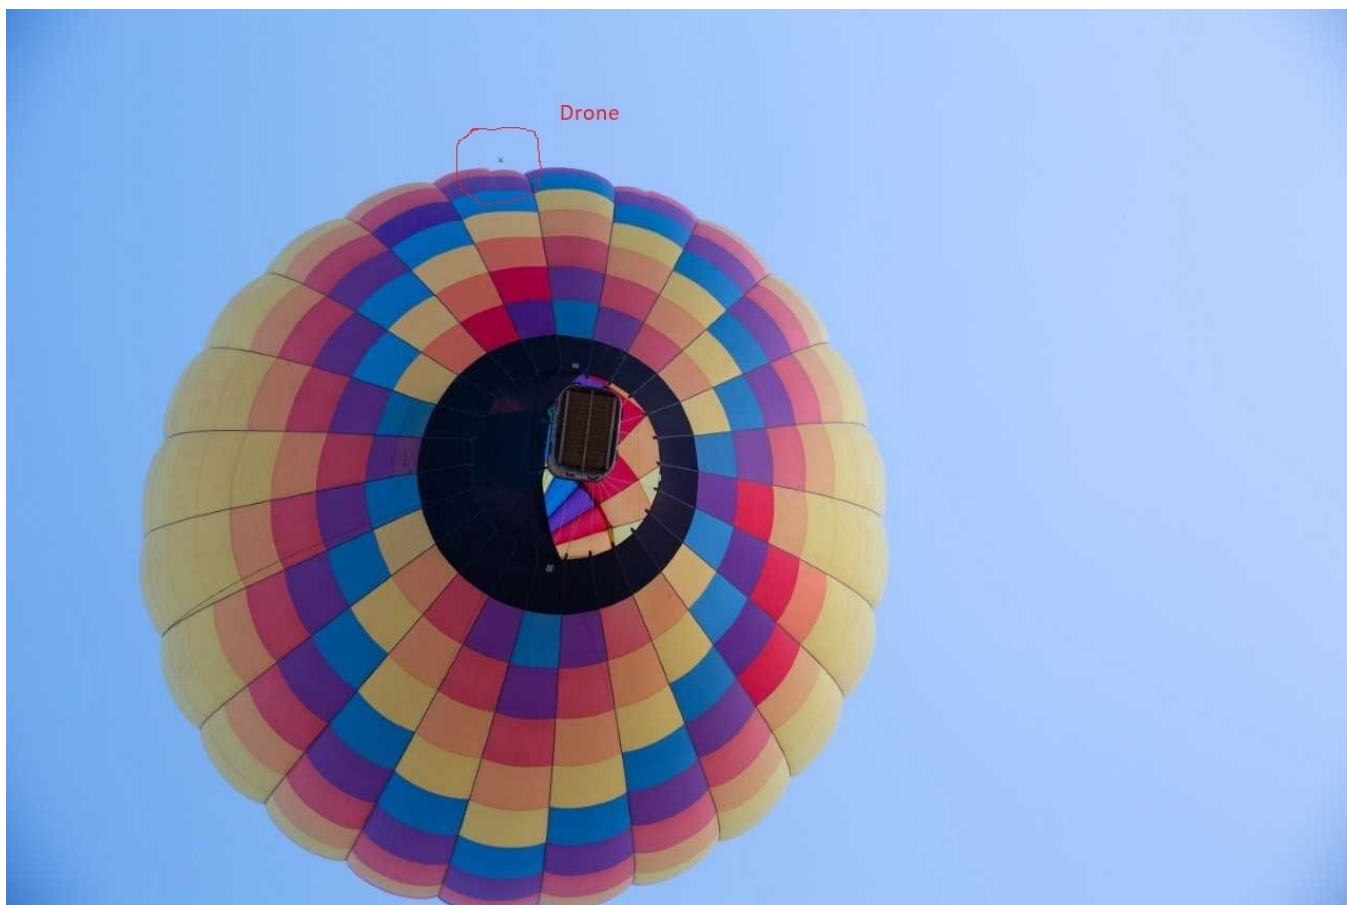
The data showed that the drone pilot manually re-entered Active Track mode, and the drone briefly followed the balloon, but, 5 seconds later, the drone's forward obstacle avoidance triggered, it lost track, briefly switched to GPS and back to Active Track. Data logs showed that the drone operator applied forward elevator and full throttle stick movements, which moved the drone toward the balloon and climbed it, and another obstacle avoidance braking maneuver activated, causing the drone to again switch out of Active Track.

Figure 3 - Ground photo showing drone in proximity to balloon

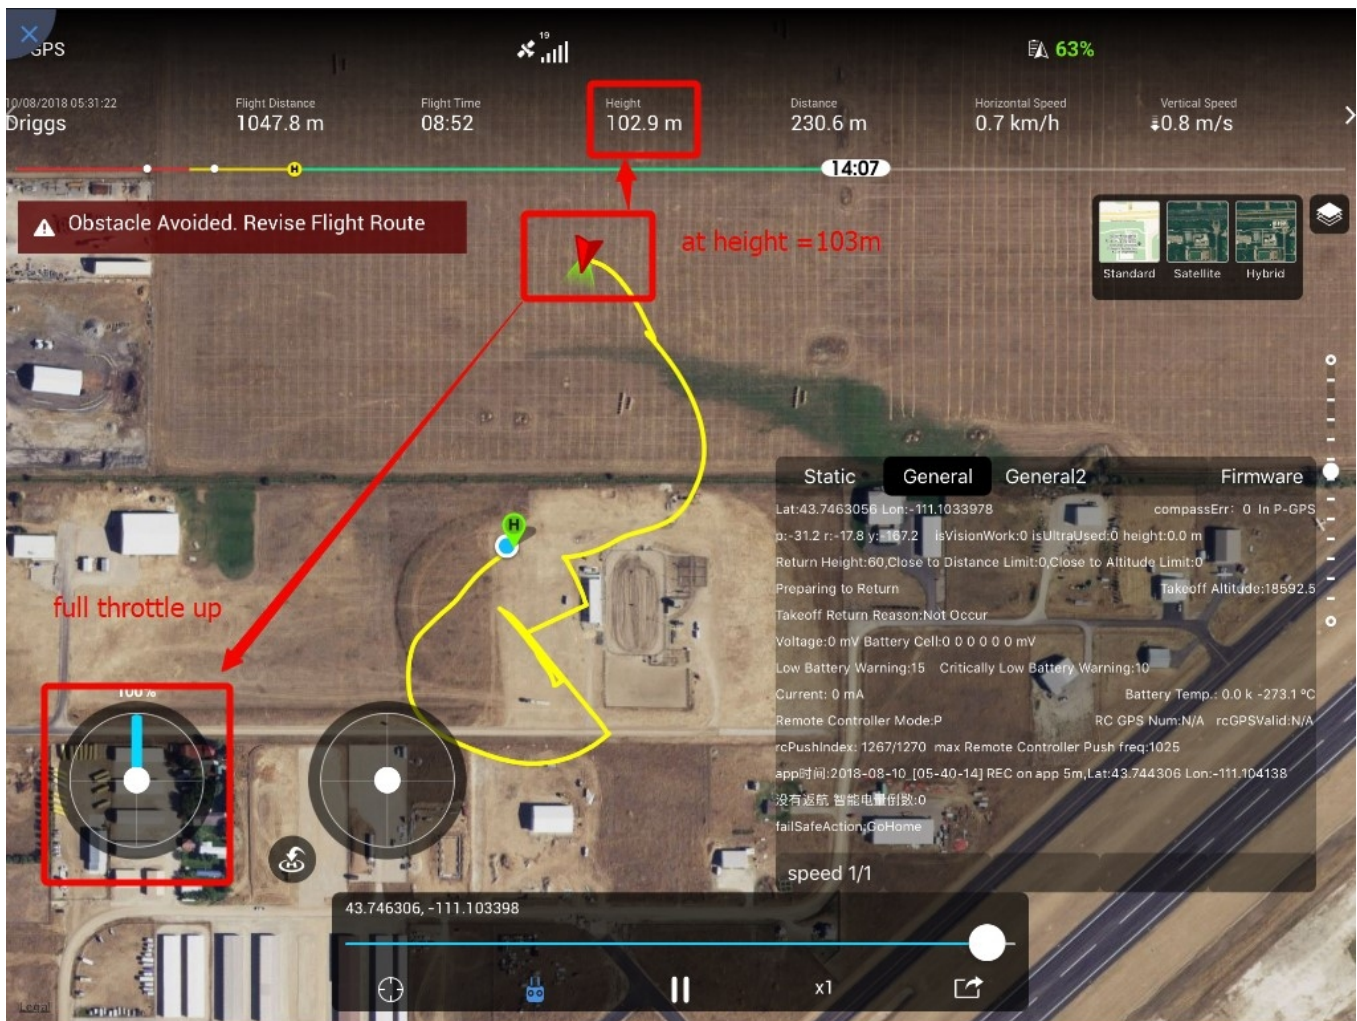
Twenty seconds prior to the collision, the balloon moved into the center of the video frame, and Active Track was reestablished briefly. The drone altitude was 310 feet agl. At four seconds prior to the collision, obstacle avoidance was again triggered and the drone's flight mode switched to GPS. The balloon envelope almost filled the entire video frame. The drone pilot reported that he had lost sight of the drone behind the balloon envelope and attempted to avoid the passengers with a full power climb command. The video and logs were consistent with the drone climbing into the outward tapering gore of the balloon envelope, colliding and tumbling, becoming briefly entangled in the balloon load lines. Data logs continued to record for 7 seconds after the collision and indicated the full throttle command remained, and the drone rotated in all axes and lost altitude. Data logs and video ended prior to ground impact.

Figure 4 - Snapshot of data log replay
