Aviation Investigation Final Report

Location:	Driggs, Idaho	Incident Number:	DCA181A264
Date & Time:	August 10, 2018, 06:40 Local	Registration:	N1410C
Aircraft:	Lindstrand 105A	Aircraft Damage:	None
Defining Event:	Midair collision	Injuries:	3 None
Flight Conducted Under:	Part 91: General aviation

Location:	Driggs, Idaho	Incident Number:	DCA181A264
Date & Time:	August 10, 2018, 06:40 Local	Registration:	UNREG
Aircraft:	DJI Mavic	Aircraft Damage:	Destroyed
Defining Event:	Midair collision	Injuries:	N/A
Flight Conducted Under:	Part 107: Small UAS

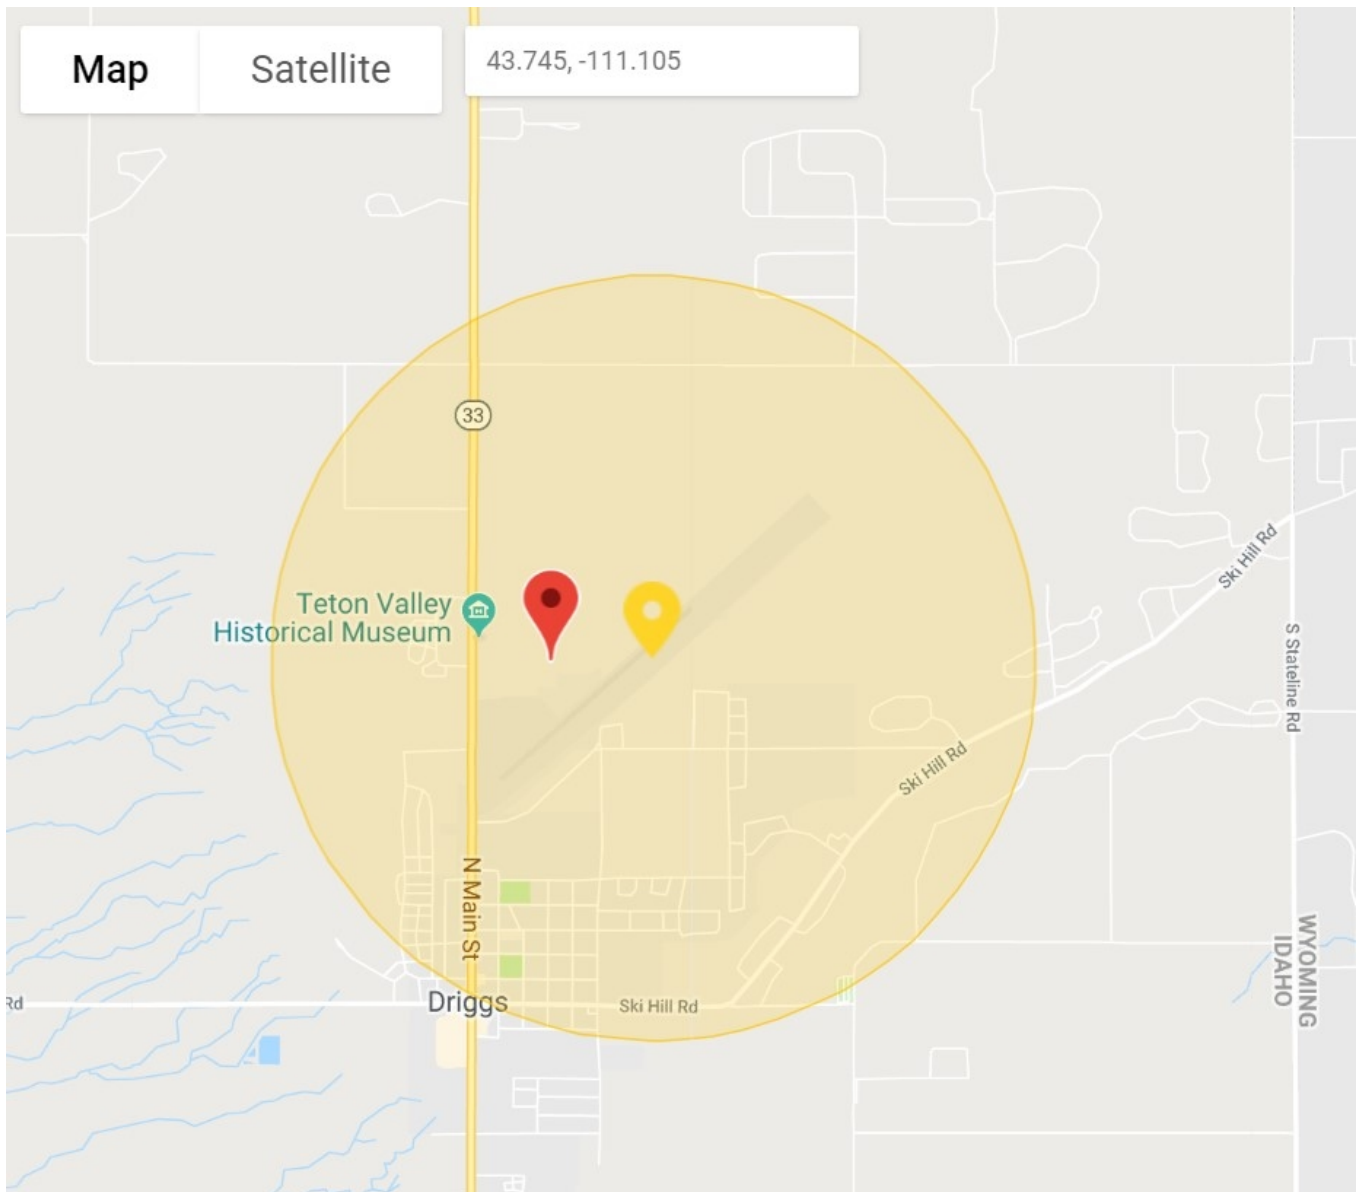
The drone pilot initiated his flight within 5 miles of an airport without notifying the airport authority, contrary to the provisions of 14 CFR 101.41.

Figure 1 - Map of DJI geofencing authorization zone for Driggs Airport. Red symbol is the location of the drone pilot

The balloon launch area was in an open field adjacent to a horse-riding ring, about 2,000 feet north of the KDIJ runway. Review of data logs and videos recovered from the drone, as well as pilot statements, revealed that the drone pilot launched the drone while the incident balloon was in the final stages of inflation then maneuvered it around the field taking video of the two balloons and scenery. The pilot reported that he intended to use a feature called "Active Track" in which the drone positions itself so that its camera can remain focused on a subject framed in the camera view. He reported that he easily maintained visual contact with the drone during his intended maneuver but lost sight of it in the moments prior to the collision when it was blocked by the balloon envelope. Data logs indicated that the drone reached a maximum of 200 yards away from the home point (near which the drone operator was located).

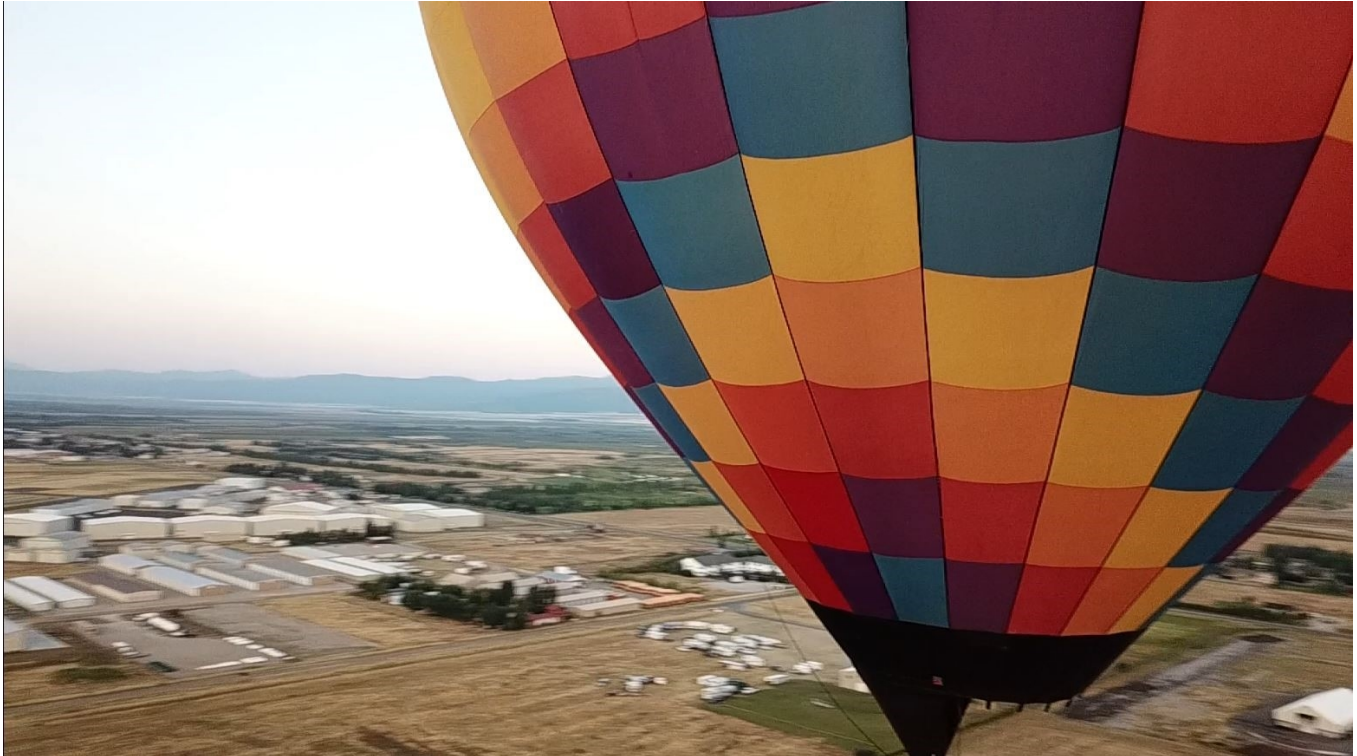
About one minute prior to the collision, the drone was at 225 feet agl, entered Active Track mode and followed the balloon, apparently tracking on the skirt and basket portions. Twenty-nine seconds prior to the collision, the video showed that the balloon was moving visibly closer to the drone, and the drone yawed left and climbed to 270 feet, then lost track and hovered. The balloon skirt and envelope filled approximately half of the drone's video frame.

Figure 2 - Video snapshot 29 seconds prior to collision

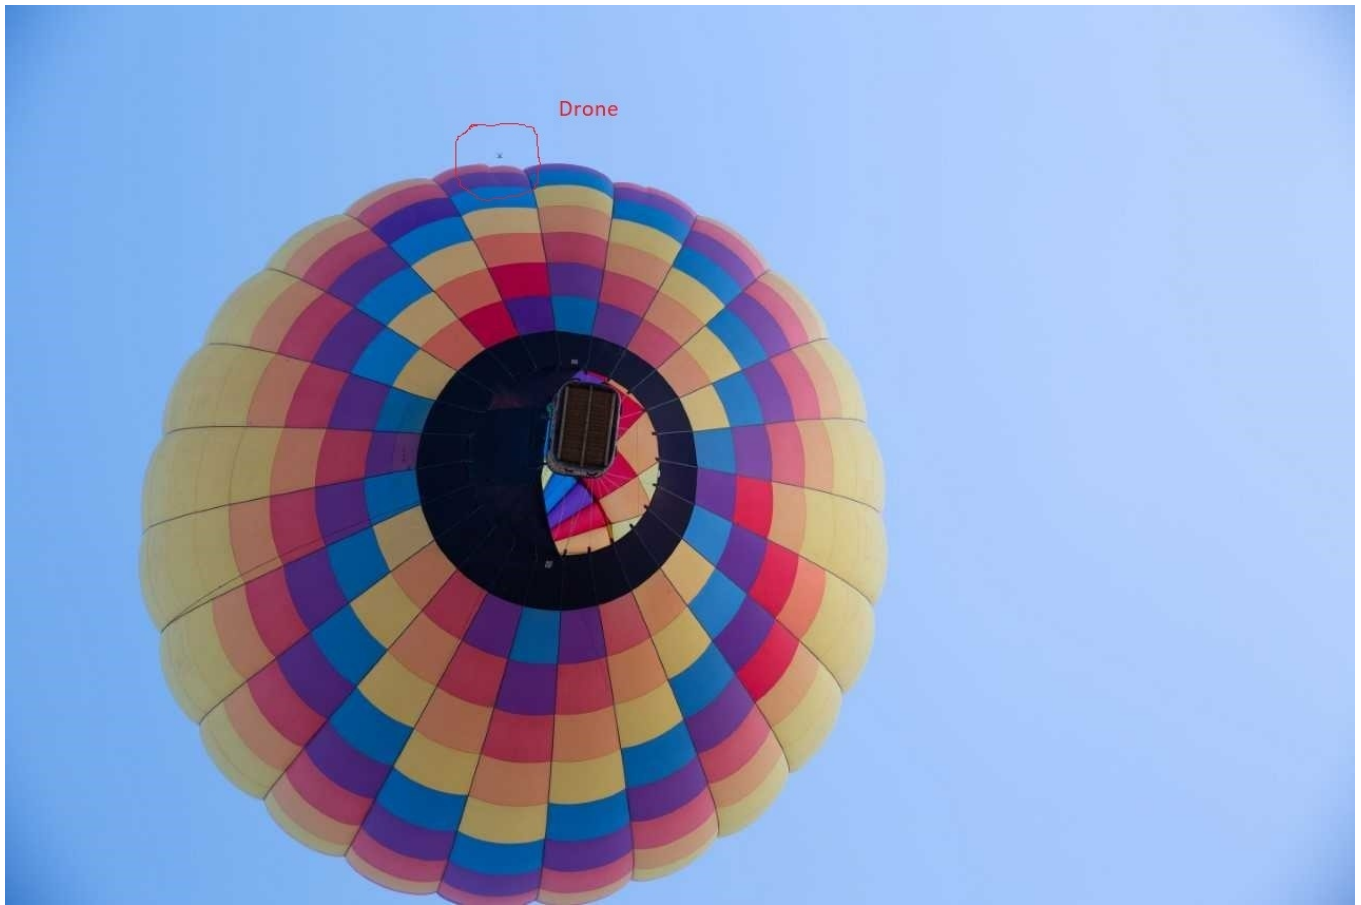
The data showed that the drone pilot manually re-entered Active Track mode, and the drone briefly followed the balloon, but, 5 seconds later, the drone's forward obstacle avoidance triggered, it lost track, briefly switched to GPS and back to Active Track. Data logs showed that the drone operator applied forward elevator and full throttle stick movements, which moved the drone toward the balloon and climbed it, and another obstacle avoidance braking maneuver activated, causing the drone to again switch out of Active Track.

Figure 3 - Ground photo showing drone in proximity to balloon

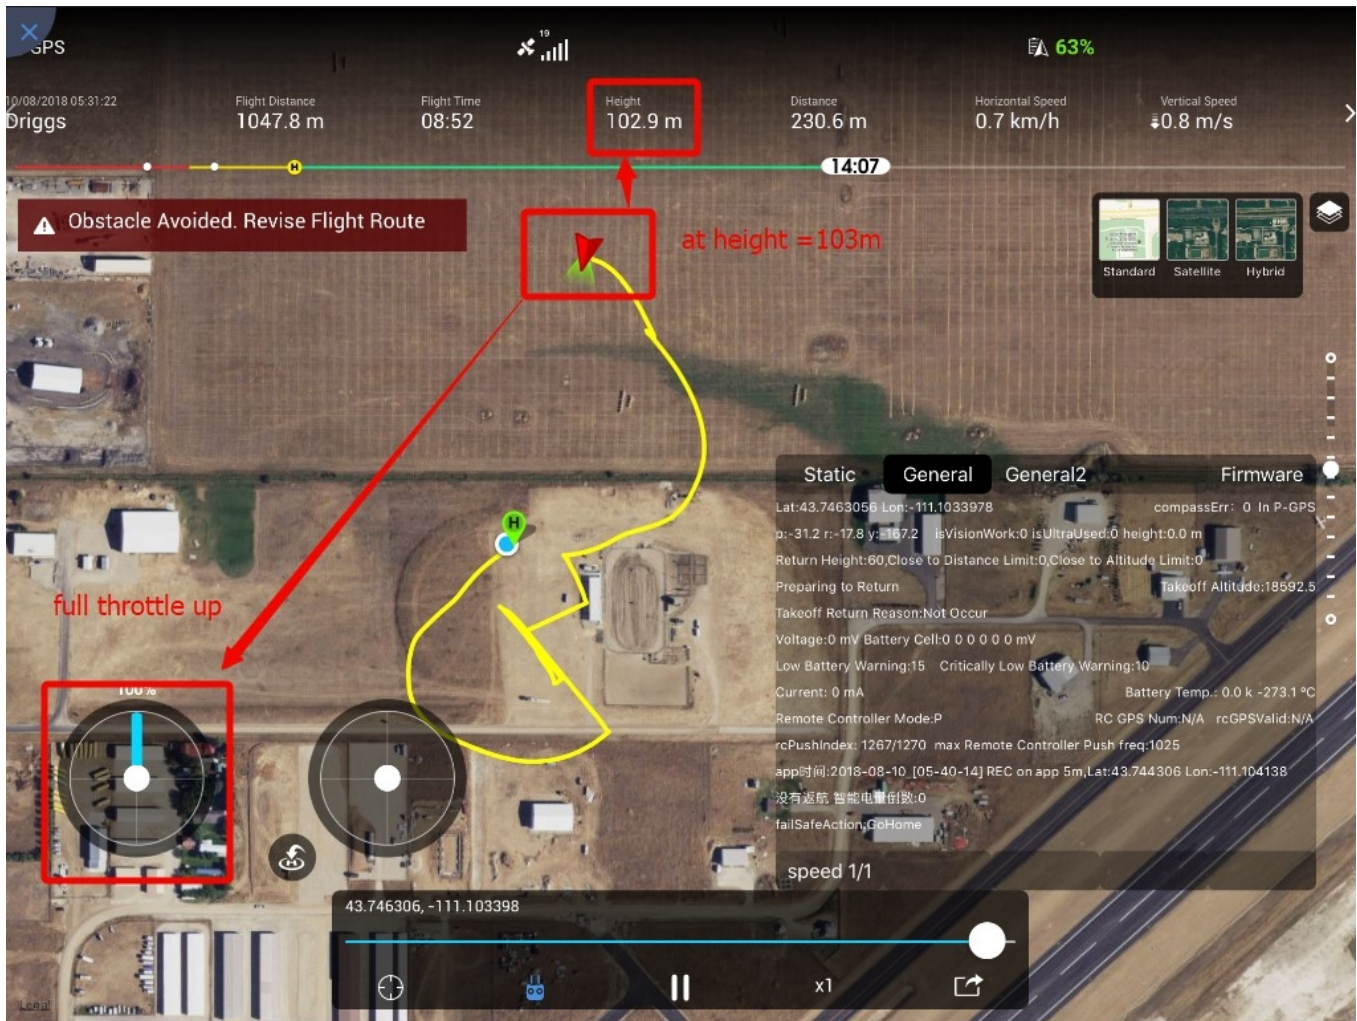
Twenty seconds prior to the collision, the balloon moved into the center of the video frame, and Active Track was reestablished briefly. The drone altitude was 310 feet agl. At four seconds prior to the collision, obstacle avoidance was again triggered and the drone's flight mode switched to GPS. The balloon envelope almost filled the entire video frame. The drone pilot reported that he had lost sight of the drone behind the balloon envelope and attempted to avoid the passengers with a full power climb command. The video and logs were consistent with the drone climbing into the outward tapering gore of the balloon envelope, colliding and tumbling, becoming briefly entangled in the balloon load lines. Data logs continued to record for 7 seconds after the collision and indicated the full throttle command remained, and the drone rotated in all axes and lost altitude. Data logs and video ended prior to ground impact.

Figure 4 - Snapshot of data log replay

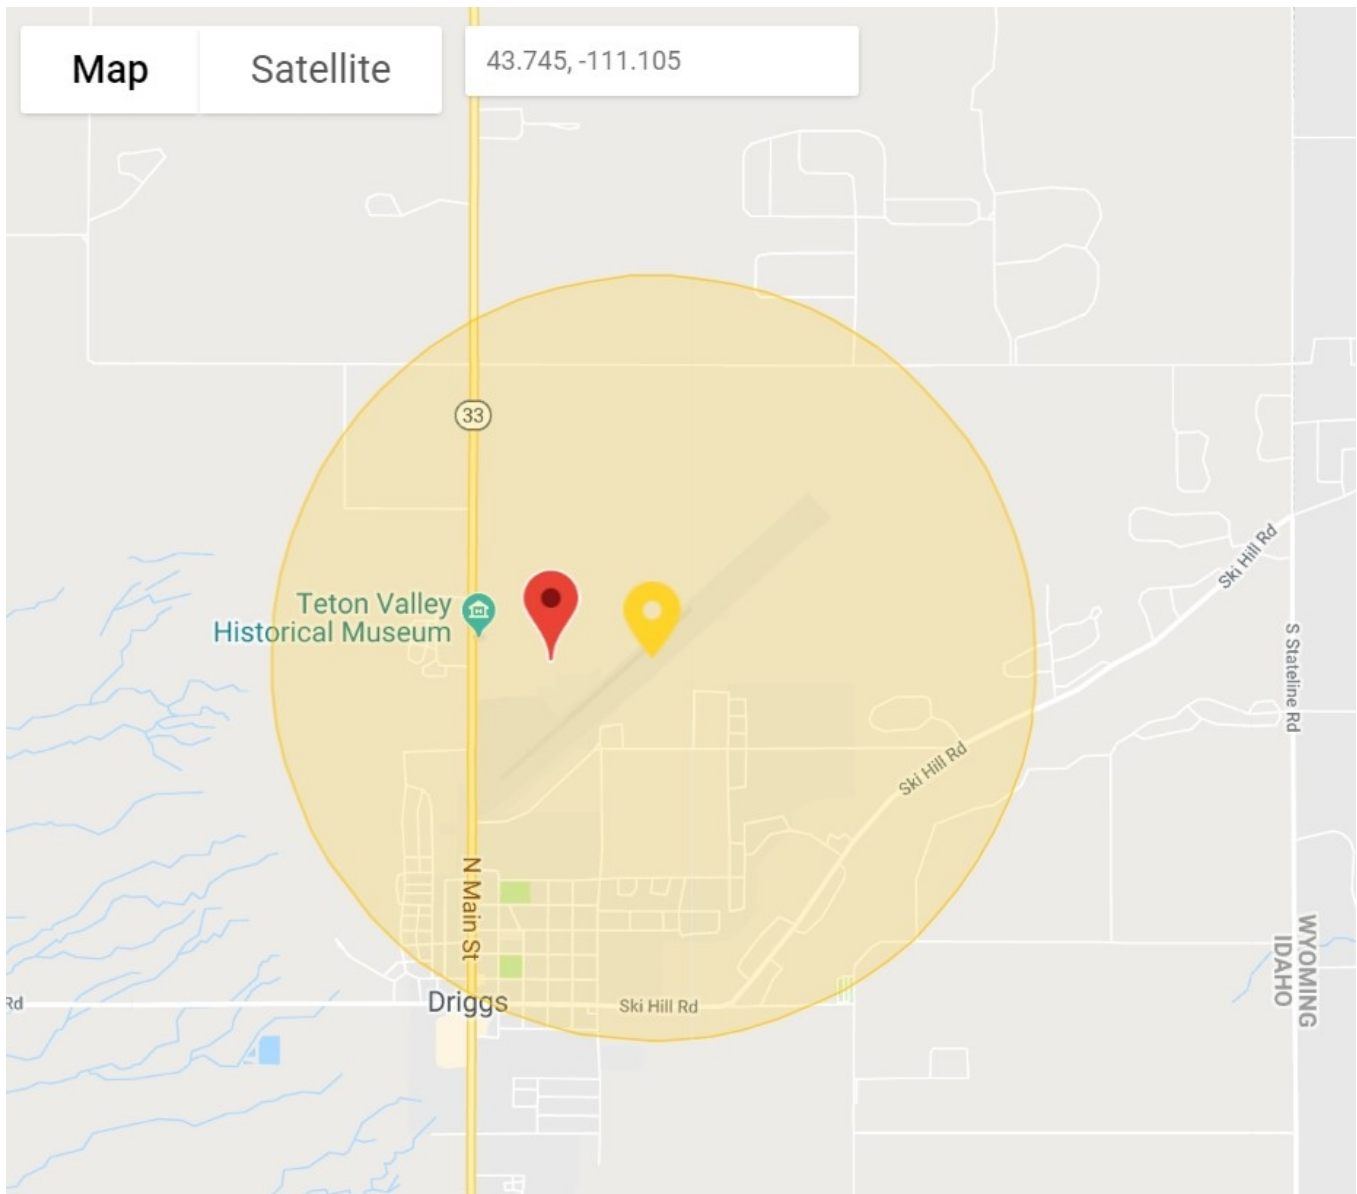
The drone pilot initiated his flight within 5 miles of an airport without notifying the airport authority, contrary to the provisions of 14 CFR 101.41.

Figure 1 - Map of DJI geofencing authorization zone for Driggs Airport. Red symbol is the location of the drone pilot

The balloon launch area was in an open field adjacent to a horse-riding ring, about 2,000 feet north of the KDIJ runway. Review of data logs and videos recovered from the drone, as well as pilot statements, revealed that the drone pilot launched the drone while the incident balloon was in the final stages of inflation then maneuvered it around the field taking video of the two balloons and scenery. The pilot reported that he intended to use a feature called "Active Track" in which the drone positions itself so that its camera can remain focused on a subject framed in the camera view. He reported that he easily maintained visual contact with the drone during his intended maneuver but lost sight of it in the moments prior to the collision when it was blocked by the balloon envelope. Data logs indicated that the drone reached a maximum of 200 yards away from the home point (near which the drone operator was located).

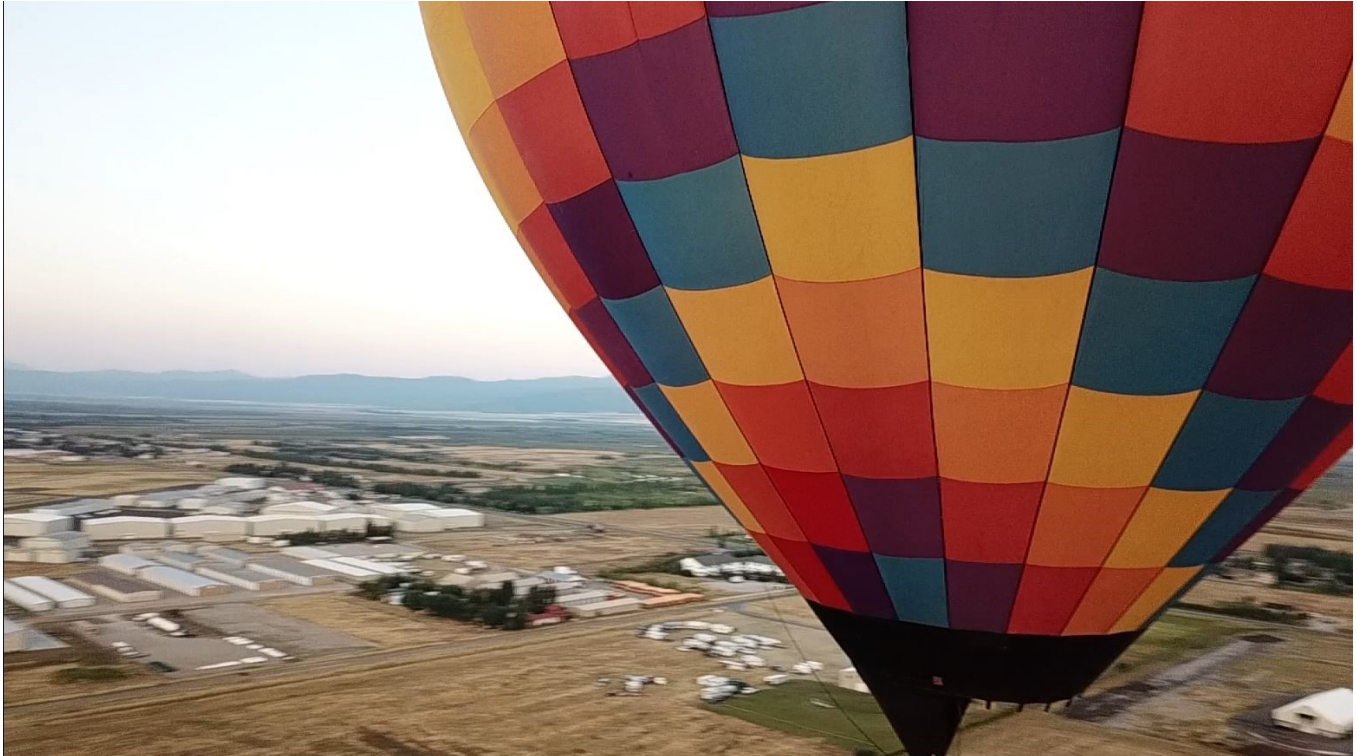
About one minute prior to the collision, the drone was at 225 feet agl, entered Active Track mode and followed the balloon, apparently tracking on the skirt and basket portions. Twenty-nine seconds prior to the collision, the video showed that the balloon was moving visibly closer to the drone, and the drone yawed left and climbed to 270 feet, then lost track and hovered. The balloon skirt and envelope filled approximately half of the drone's video frame.

Figure 2 - Video snapshot 29 seconds prior to collision

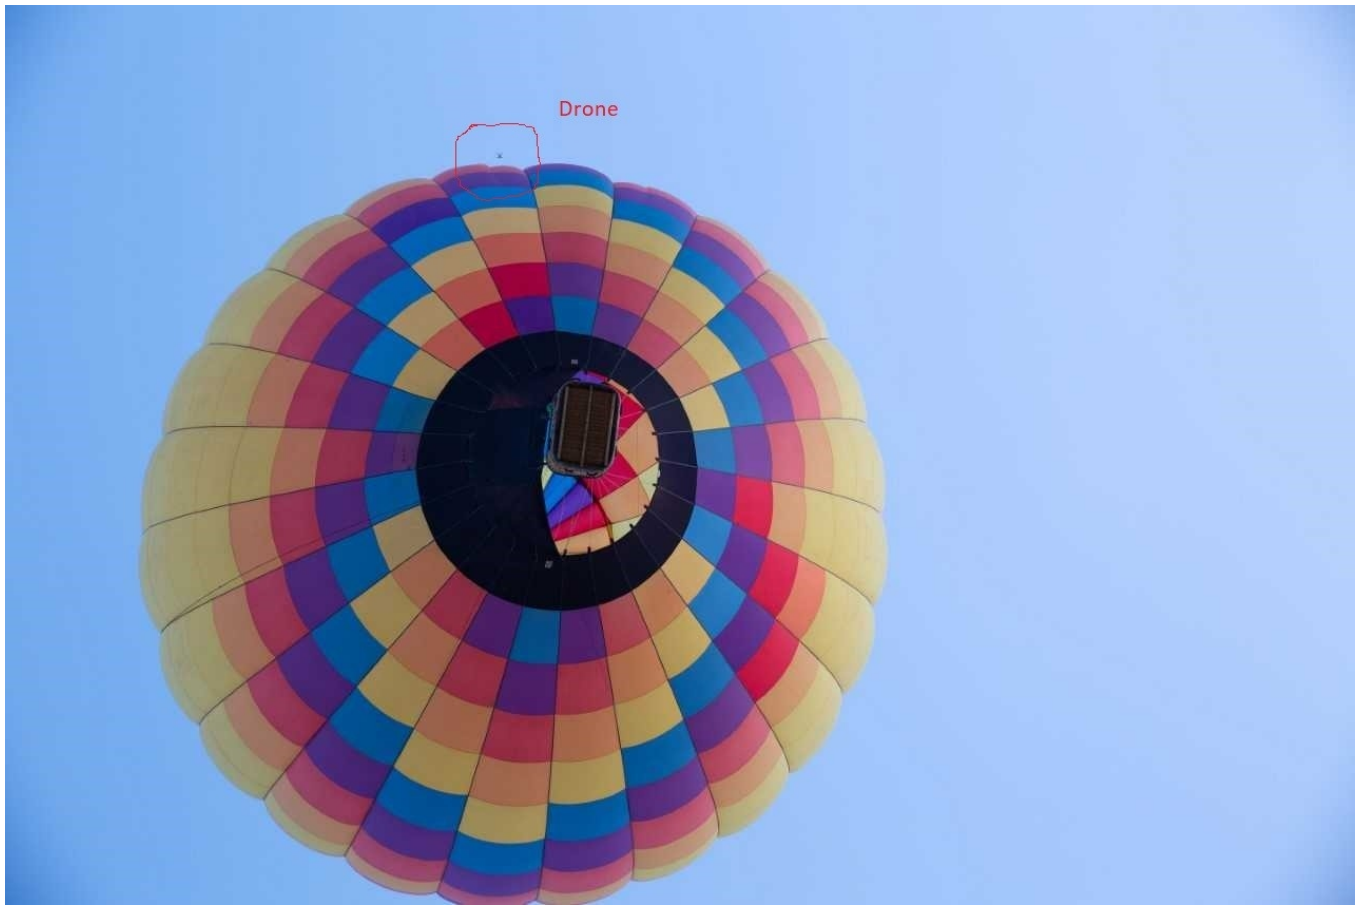
The data showed that the drone pilot manually re-entered Active Track mode, and the drone briefly followed the balloon, but, 5 seconds later, the drone's forward obstacle avoidance triggered, it lost track, briefly switched to GPS and back to Active Track. Data logs showed that the drone operator applied forward elevator and full throttle stick movements, which moved the drone toward the balloon and climbed it, and another obstacle avoidance braking maneuver activated, causing the drone to again switch out of Active Track.

Figure 3 - Ground photo showing drone in proximity to balloon

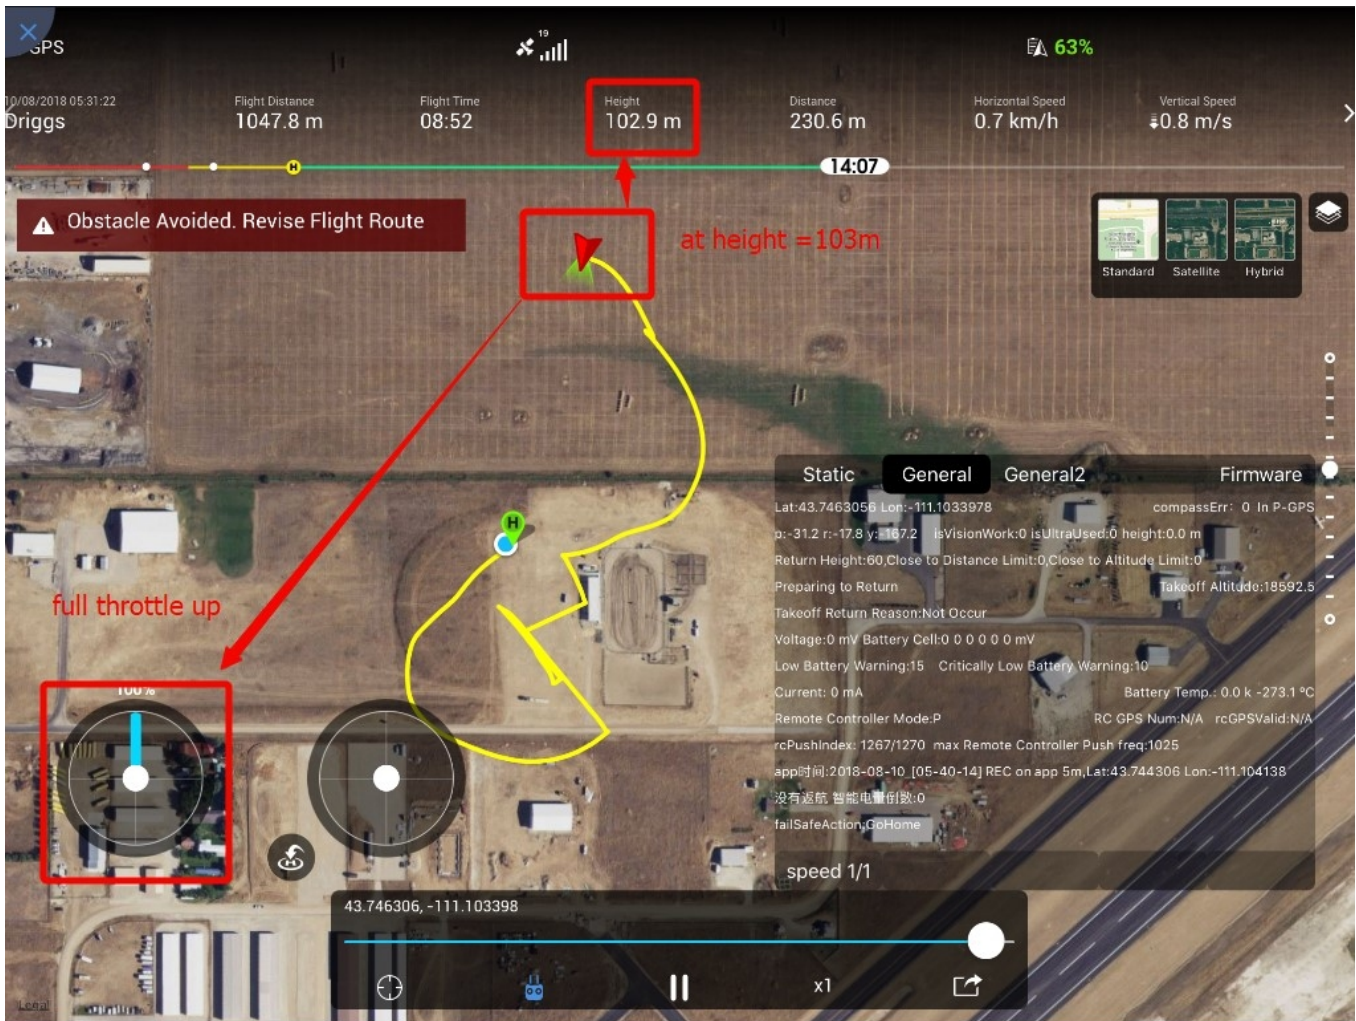
Twenty seconds prior to the collision, the balloon moved into the center of the video frame, and Active Track was reestablished briefly. The drone altitude was 310 feet agl. At four seconds prior to the collision, obstacle avoidance was again triggered and the drone's flight mode switched to GPS. The balloon envelope almost filled the entire video frame. The drone pilot reported that he had lost sight of the drone behind the balloon envelope and attempted to avoid the passengers with a full power climb command. The video and logs were consistent with the drone climbing into the outward tapering gore of the balloon envelope, colliding and tumbling, becoming briefly entangled in the balloon load lines. Data logs continued to record for 7 seconds after the collision and indicated the full throttle command remained, and the drone rotated in all axes and lost altitude. Data logs and video ended prior to ground impact.

Figure 4 - Snapshot of data log replay
