Aviation Investigation Final Report

Location:	Driggs, Idaho	Incident Number:	DCA181A264
Date & Time:	August 10, 2018, 06:40 Local	Registration:	N1410C
Aircraft:	Lindstrand 105A	Aircraft Damage:	None
Defining Event:	Midair collision	Injuries:	3 None
Flight Conducted Under:	Part 91: General aviation

Location:	Driggs, Idaho	Incident Number:	DCA181A264
Date & Time:	August 10, 2018, 06:40 Local	Registration:	UNREG
Aircraft:	DJI Mavic	Aircraft Damage:	Destroyed
Defining Event:	Midair collision	Injuries:	N/A
Flight Conducted Under:	Part 107: Small UAS

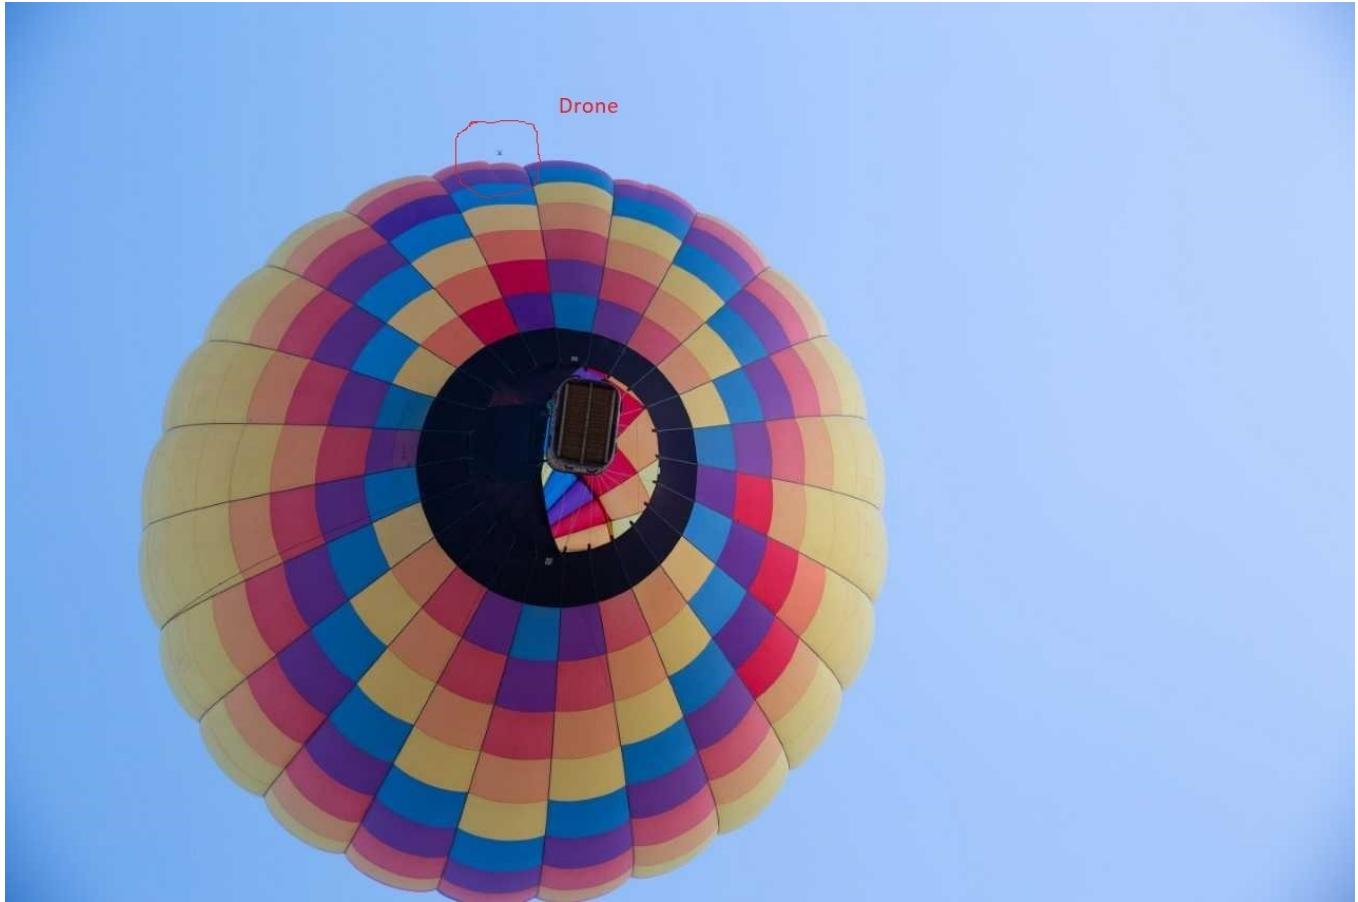
The data showed that the drone pilot manually re-entered Active Track mode, and the drone briefly followed the balloon, but, 5 seconds later, the drone's forward obstacle avoidance triggered, it lost track, briefly switched to GPS and back to Active Track. Data logs showed that the drone operator applied forward elevator and full throttle stick movements, which moved the drone toward the balloon and climbed it, and another obstacle avoidance braking maneuver activated, causing the drone to again switch out of Active Track.

Figure 3 - Ground photo showing drone in proximity to balloon

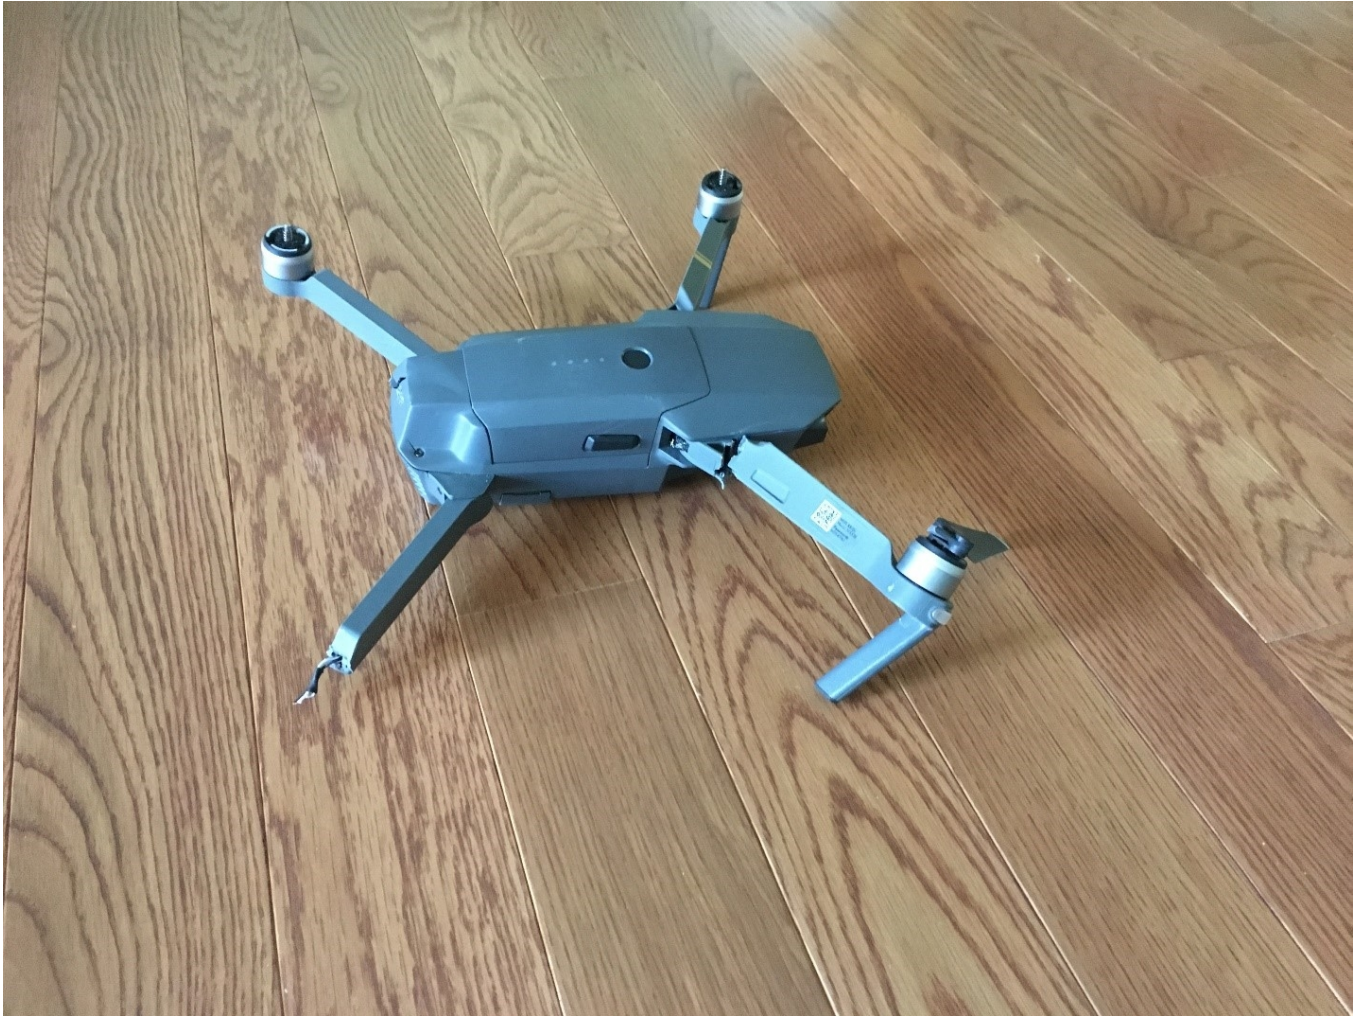
The Mavic Pro drone was substantially damaged.

Figure 5 - Damaged Mavic Pro drone

The Mavic Pro was recovered by the balloon ground crew. The propellers were mostly missing, the right side motor arms were broken, with the right rear arm appearing to have been pulled outwards, consistent with the video and passenger information indicating it became briefly entangled in one of the balloon lines.

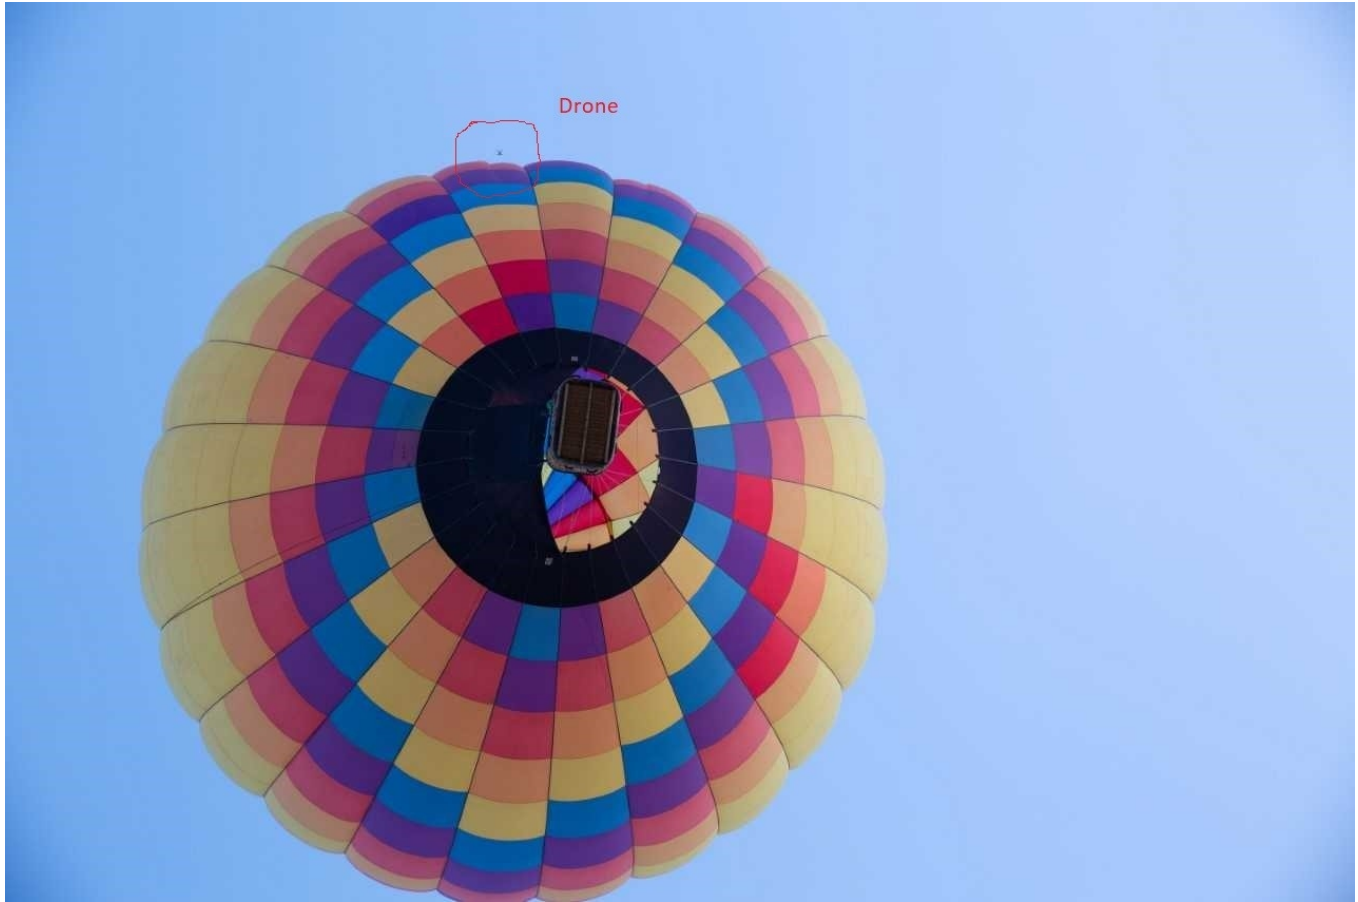
The data showed that the drone pilot manually re-entered Active Track mode, and the drone briefly followed the balloon, but, 5 seconds later, the drone's forward obstacle avoidance triggered, it lost track, briefly switched to GPS and back to Active Track. Data logs showed that the drone operator applied forward elevator and full throttle stick movements, which moved the drone toward the balloon and climbed it, and another obstacle avoidance braking maneuver activated, causing the drone to again switch out of Active Track.

Figure 3 - Ground photo showing drone in proximity to balloon

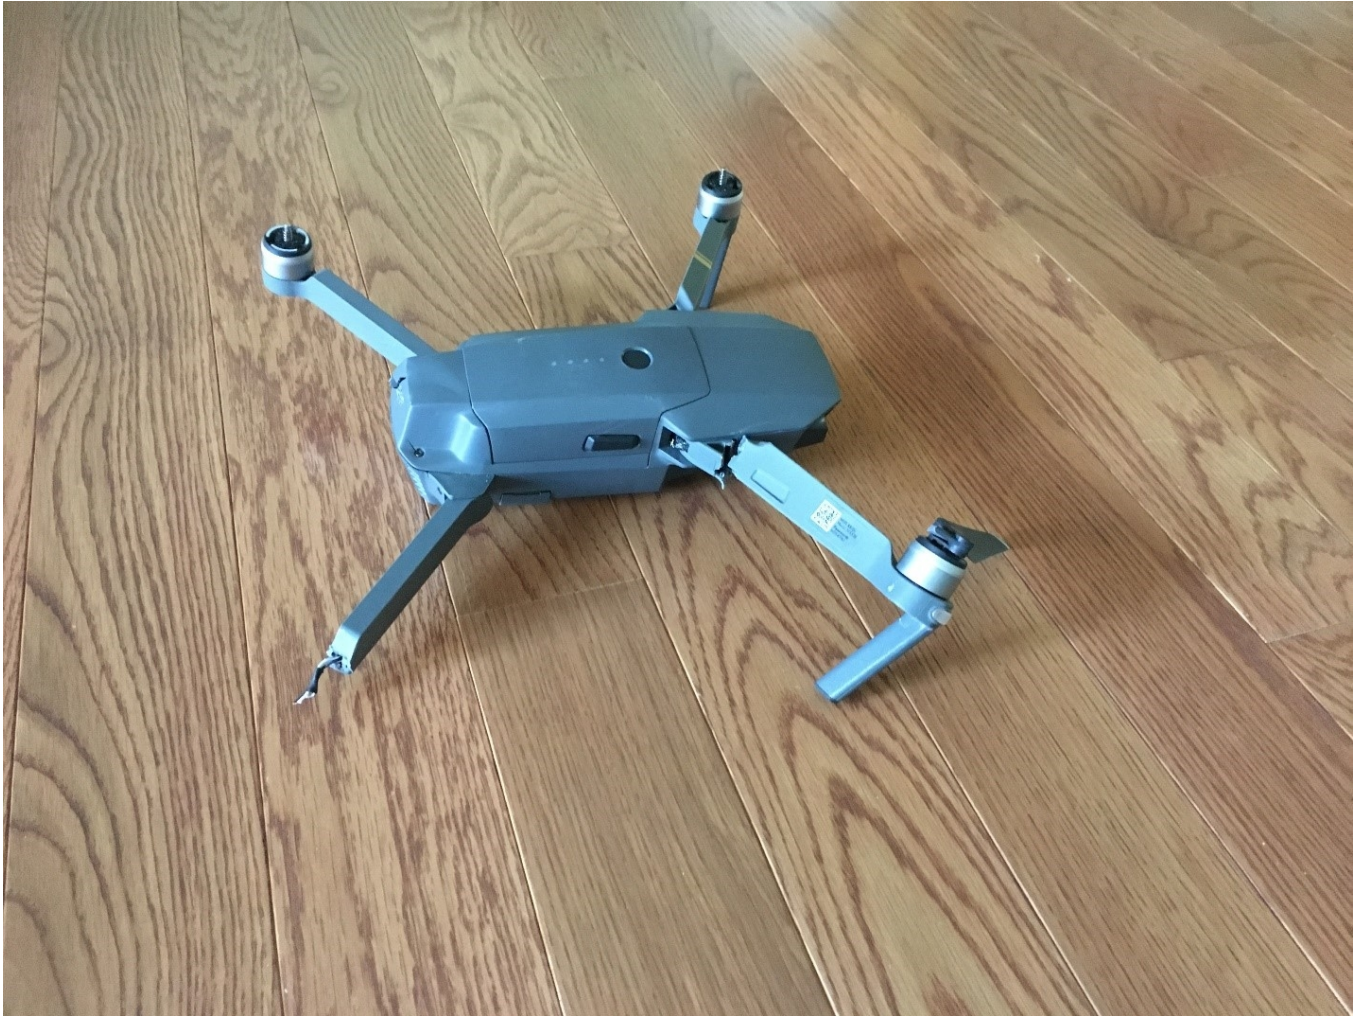
The Mavic Pro drone was substantially damaged.

Figure 5 - Damaged Mavic Pro drone

The Mavic Pro was recovered by the balloon ground crew. The propellers were mostly missing, the right side motor arms were broken, with the right rear arm appearing to have been pulled outwards, consistent with the video and passenger information indicating it became briefly entangled in one of the balloon lines.
