Aviation Investigation Final Report

Location:	Honolulu, Hawaii	Accident Number:	WPR18LA221
Date & Time:	August 8, 2018, 09:20 Local	Registration:	N369MH
Aircraft:	Hughes 369	Aircraft Damage:	Substantial
Defining Event:	Flight control sys malf/fail	Injuries:	4 None
Flight Conducted Under:	Part 135: Air taxi & commuter - Non-scheduled - Sightseeing

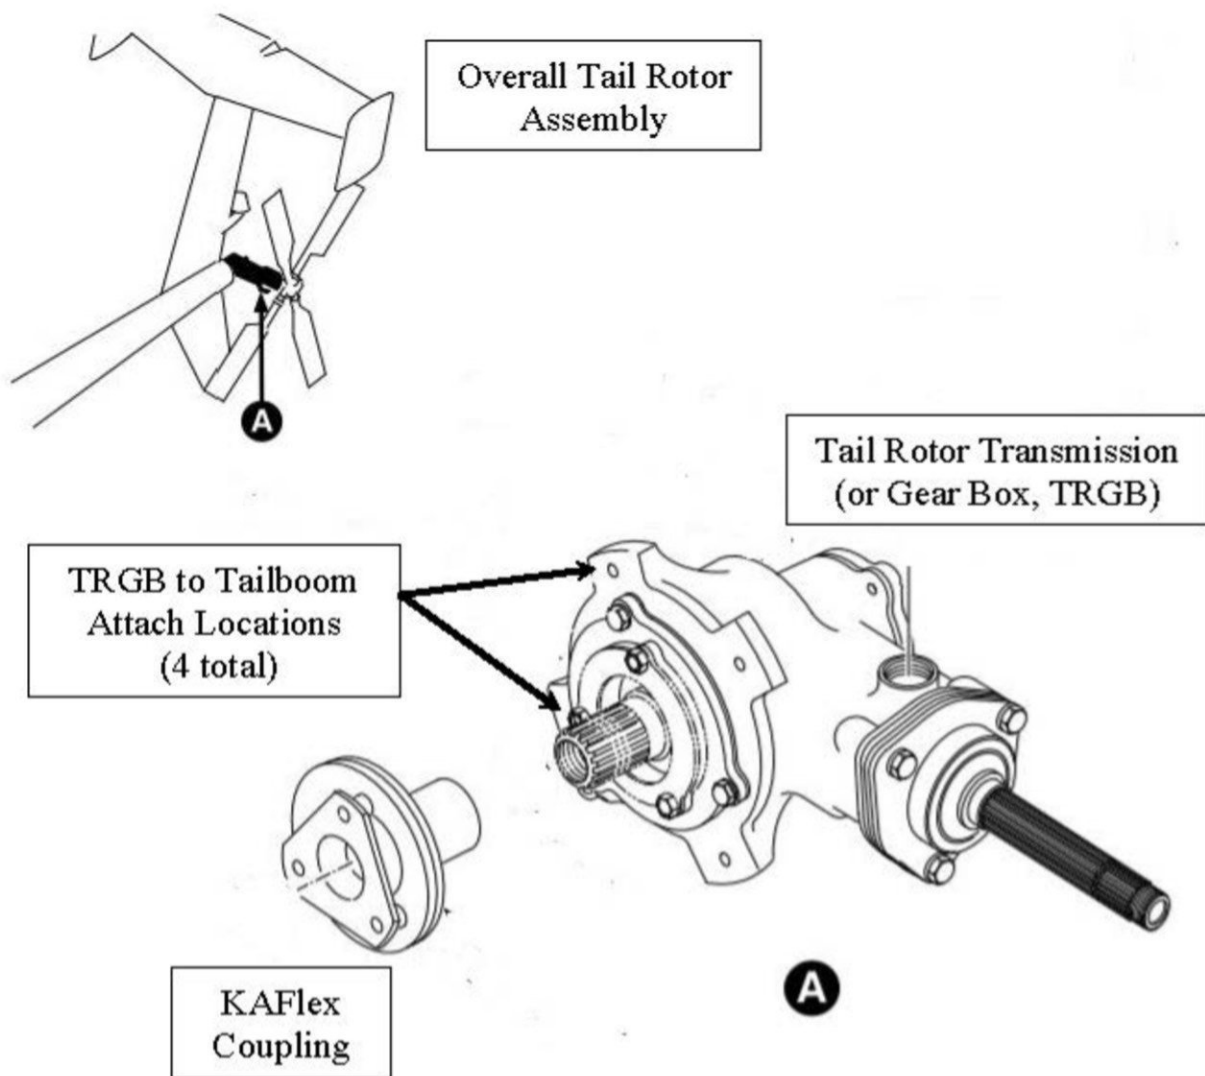
Figure 1. Overview of TR Assembly

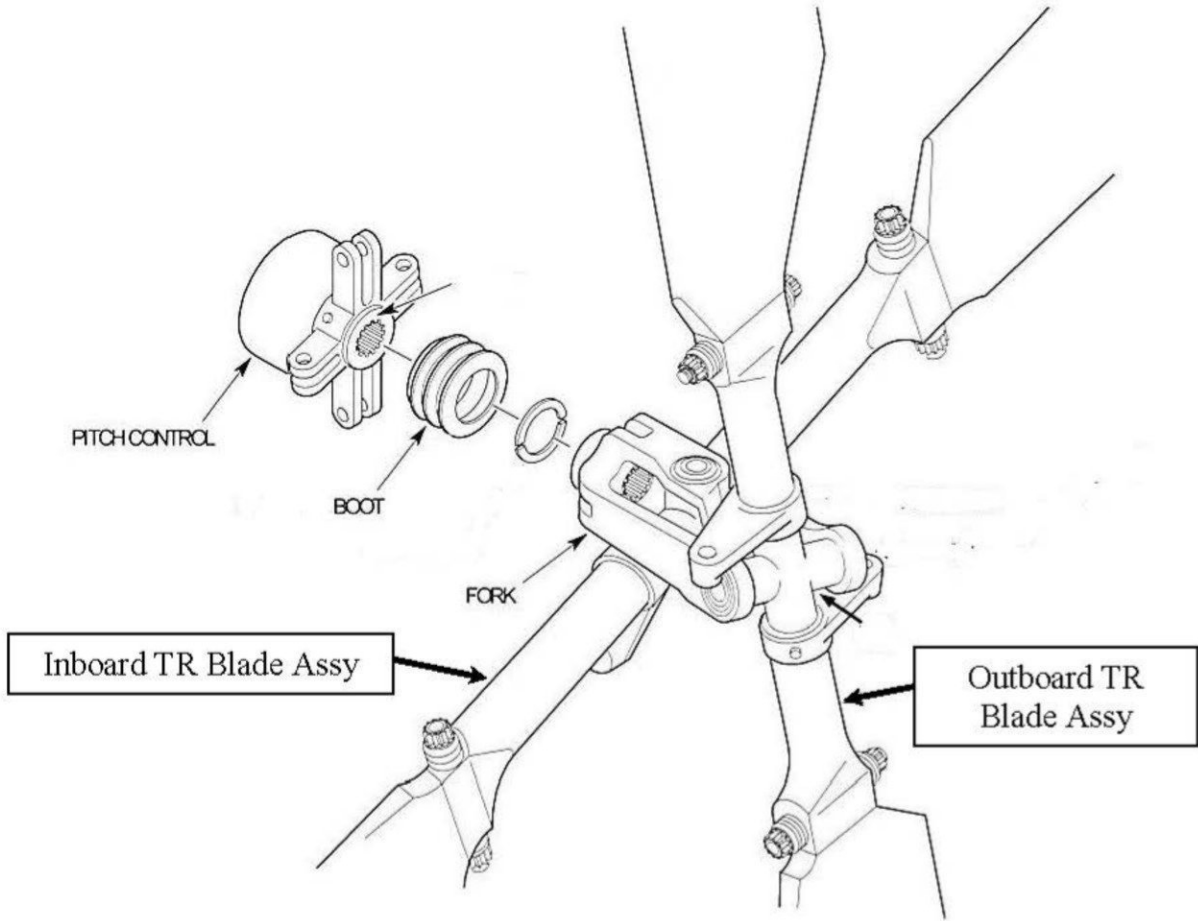
Figure 2. TR Forks and Blades

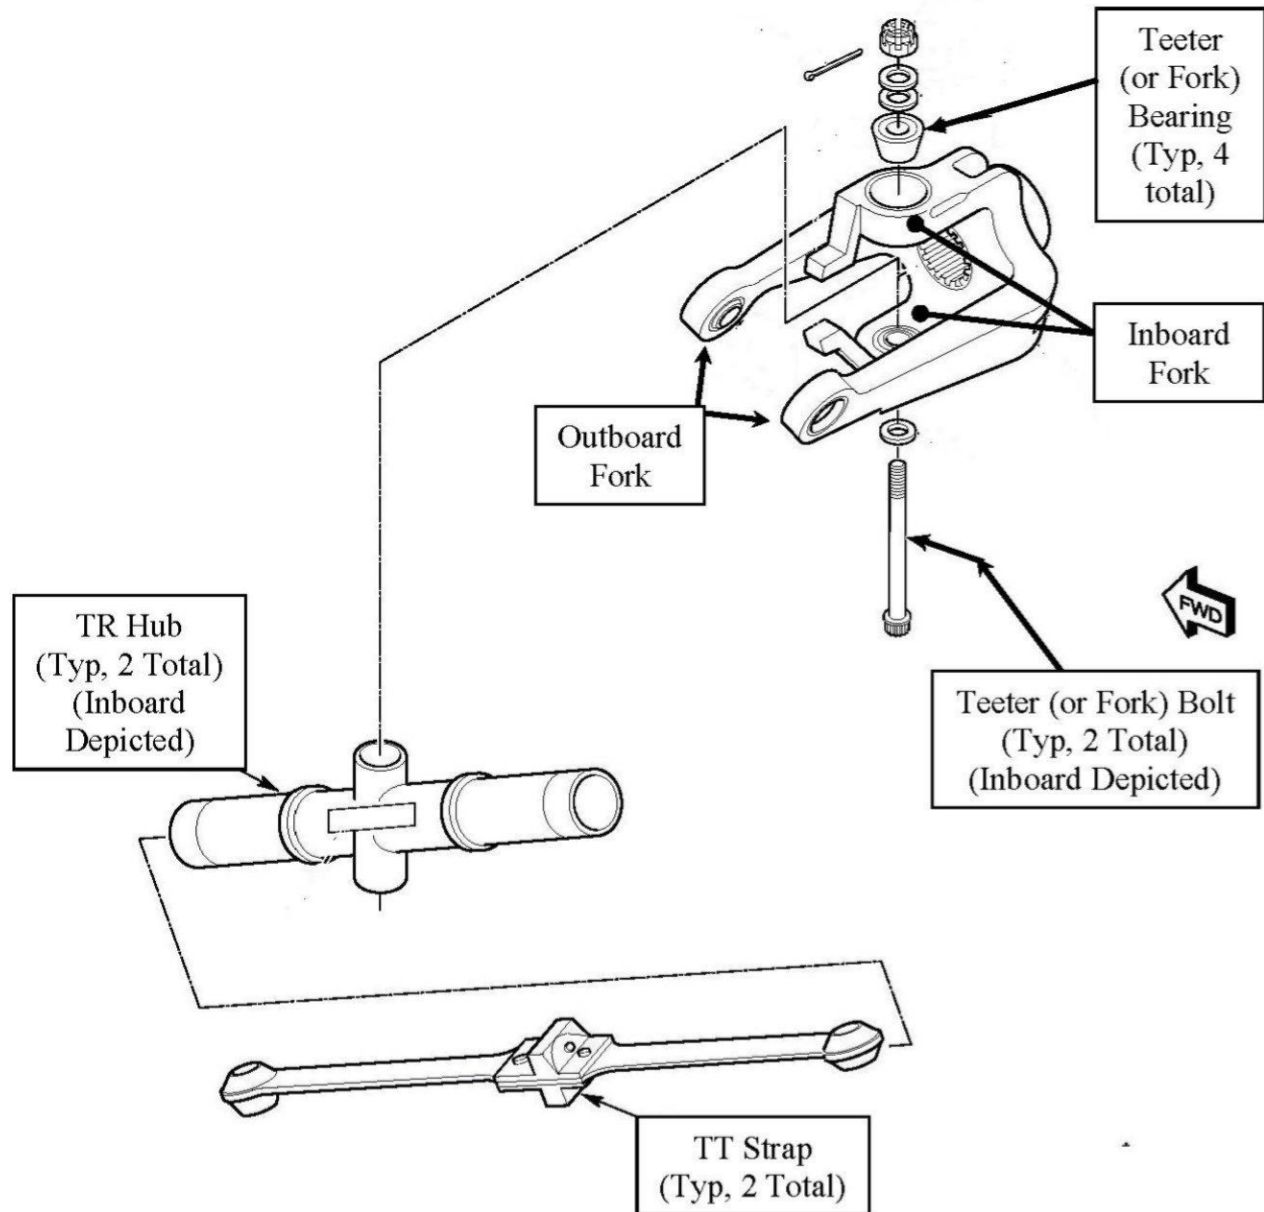
Figure 3. TR Hub and Forks
