Aviation Investigation Final Report

Location:	Blacksburg, Virginia	Incident Number:	DCA181A269
Date & Time:	August 14, 2018, 13:30 Local	Registration:	FA3HCWCR4X
Aircraft:	DJI Phantom	Aircraft Damage:	Minor
Defining Event:	Loss of control in flight	Injuries:	1 Minor, 1 None
Flight Conducted Under:	Part 107: Small UAS

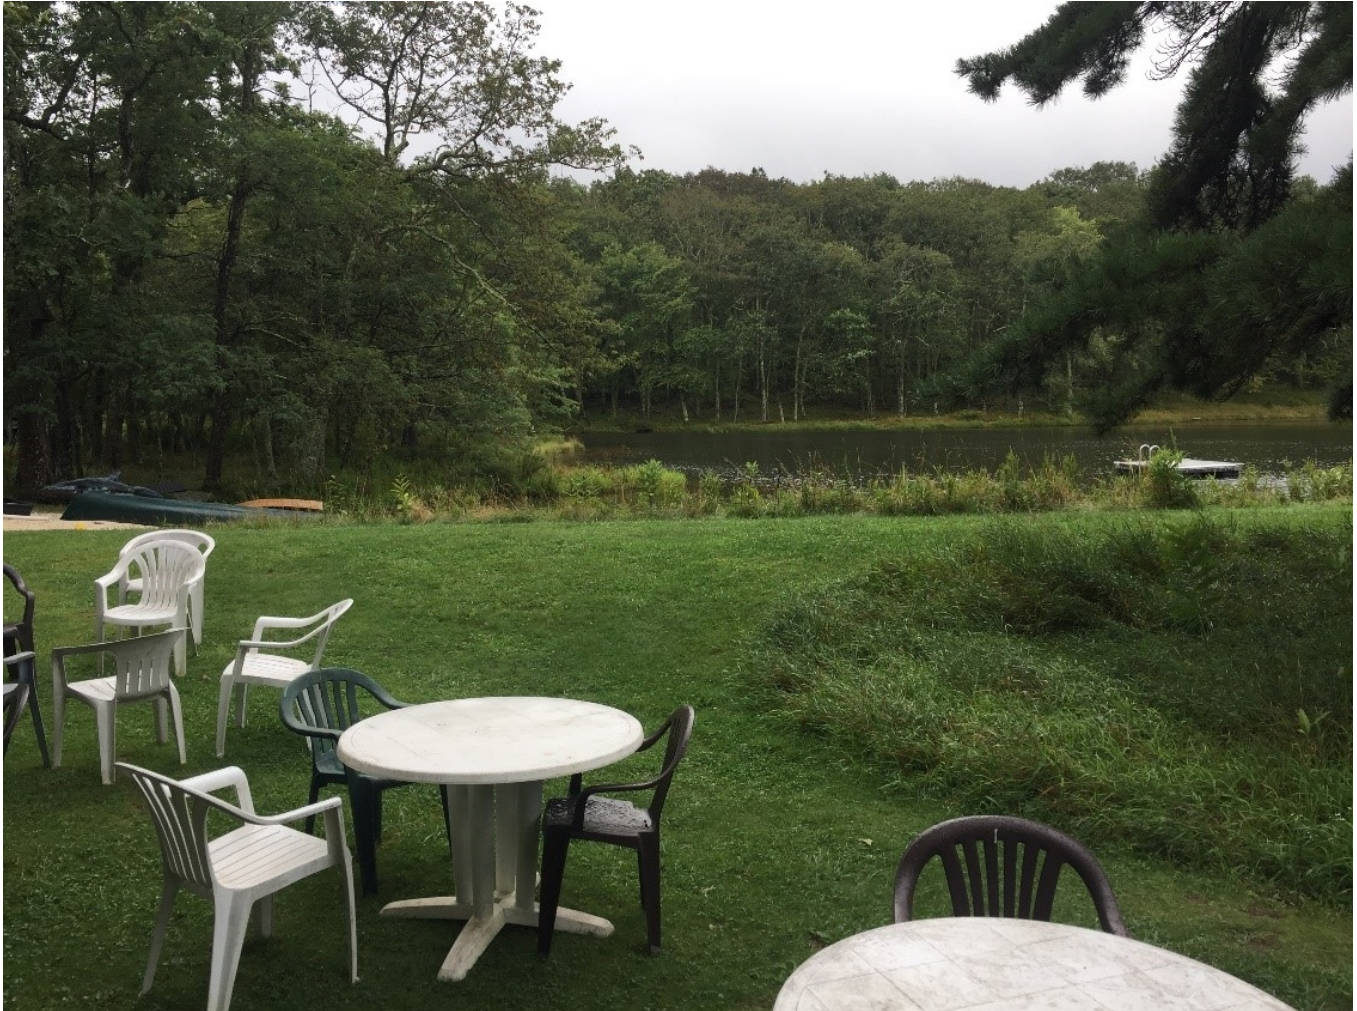
Figure 1 – Photo of Operating Area

The flight demonstration area was near a small beach and grassy area adjacent to the pond (figure 1). The area and the pond were surrounded by trees. Plastic lawn chairs and tables were in the area.

The six students who were observing the demo flight were located less than 10 feet from the pilot. There was no visual observer or other assistant to the pilot for this flight. He started the demo in manual flight mode, and took off from a plastic picnic table on the berm of the pond. He reported the flight was normal, although the wind picked up a little bit during the flight. He flew the drone back to the picnic table for landing but reported that it would not touch down onto the table. The pilot reported that he made numerous attempts to land and attempted "the shutdown procedure," but the drone flew off to the side. He then reported that he climbed the drone back up and attempted an automatic landing and a landing in the grass, again using the "shutdown procedure," but the drone did not respond as he expected. He reported that he did not feel comfortable having one of the students try to hand-catch the drone, so he decided to crash it. The drone flew laterally and struck one of the students resulting in the injury, then continued into bushes where it stopped.

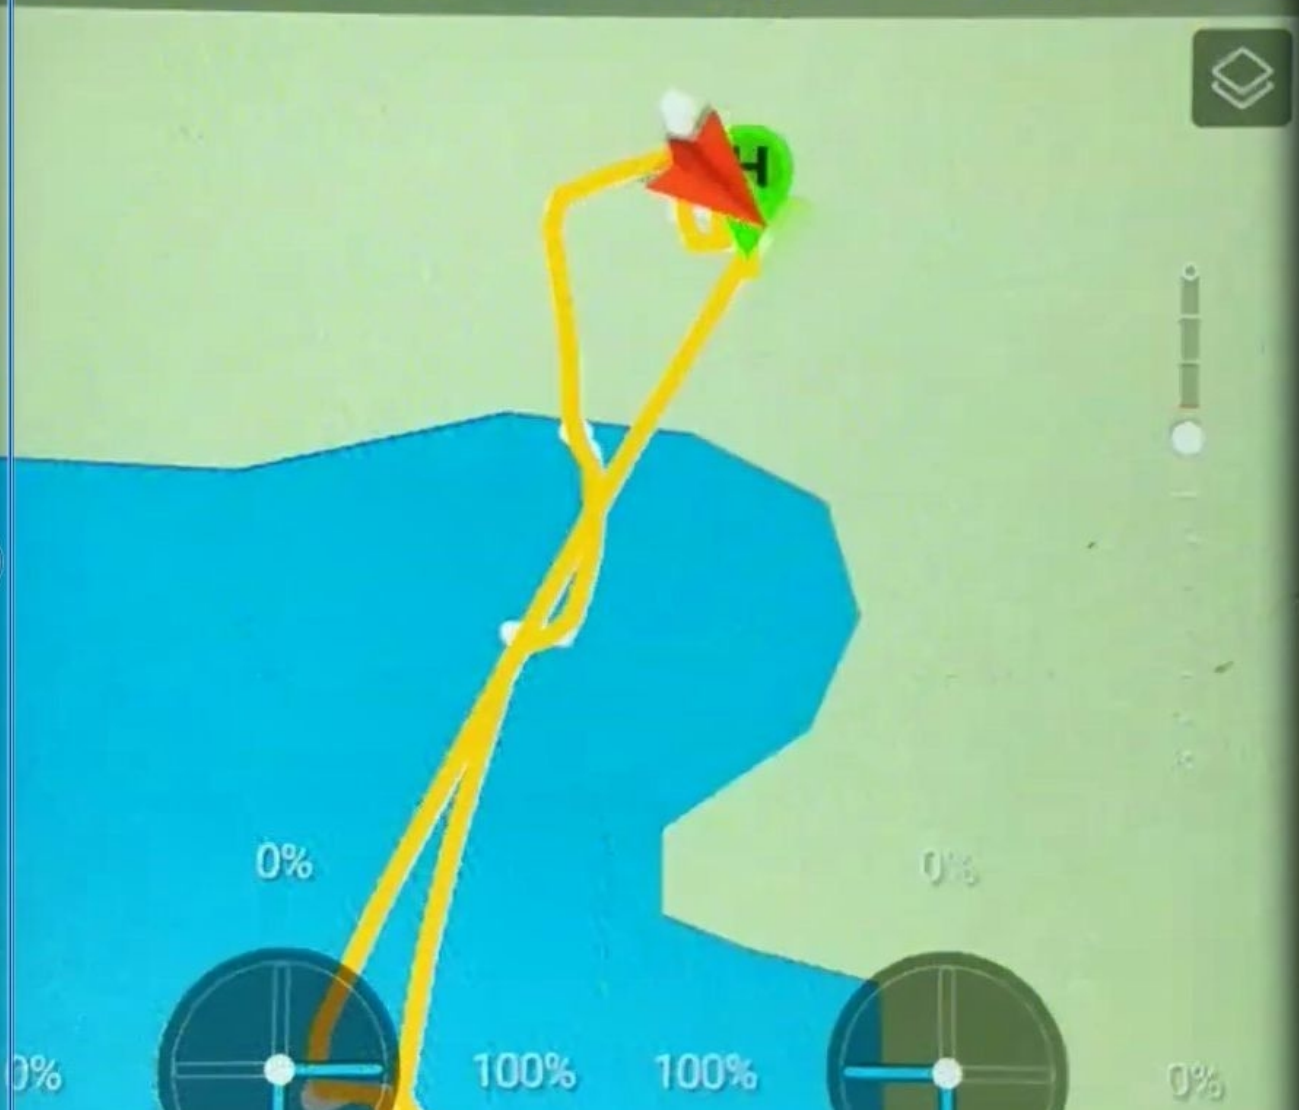
Figure 2 – First CSC command 1:10 prior to end

Examination of the logs revealed that, at 1 minute10 seconds before the end of data, the drone was being maneuvering at low altitude near the home point in GPS mode. Then the pilot partially decreased throttle followed by the "down and in" CSC.

The log data showed that, while the drone was still in the air, it responded to the pilot's "down and in" CSC input by pitching up, yawing right, and banking left. Logs indicated a "braking" message indicating the obstacle avoidance/visual positioning system (VPS) was activated.

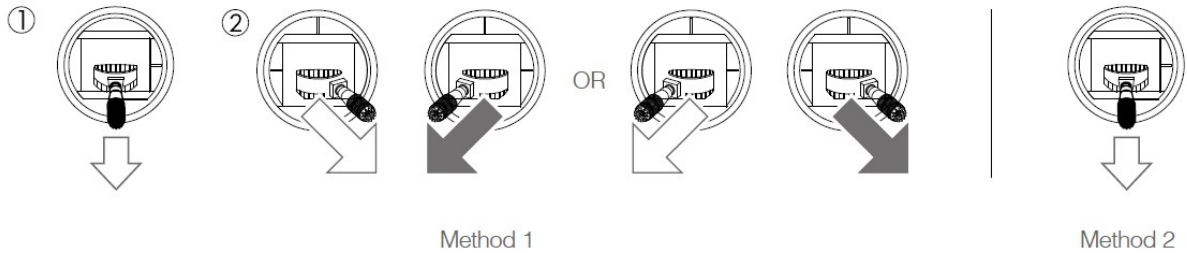
Figure 3 – Excerpt from Phantom 4 User Manual, Stopping the Motors

According to the DJI Phantom 4 User Manual, the "down and in" command shuts down the motors immediately when the drone is on the ground. Alternatively, a method to stop motors on the ground is to retard the throttle straight back and hold for 3 seconds (figure 3). The method for emergency stop of motors in flight or prior to the drone sensing that it has landed is to pull the throttle back and to the right while simultaneously pressing the Return to Home button (figure 4).
