Aviation Investigation Final Report

Location:	Blacksburg, Virginia	Incident Number:	DCA181A269
Date & Time:	August 14, 2018, 13:30 Local	Registration:	FA3HCWCR4X
Aircraft:	DJI Phantom	Aircraft Damage:	Minor
Defining Event:	Loss of control in flight	Injuries:	1 Minor, 1 None
Flight Conducted Under:	Part 107: Small UAS

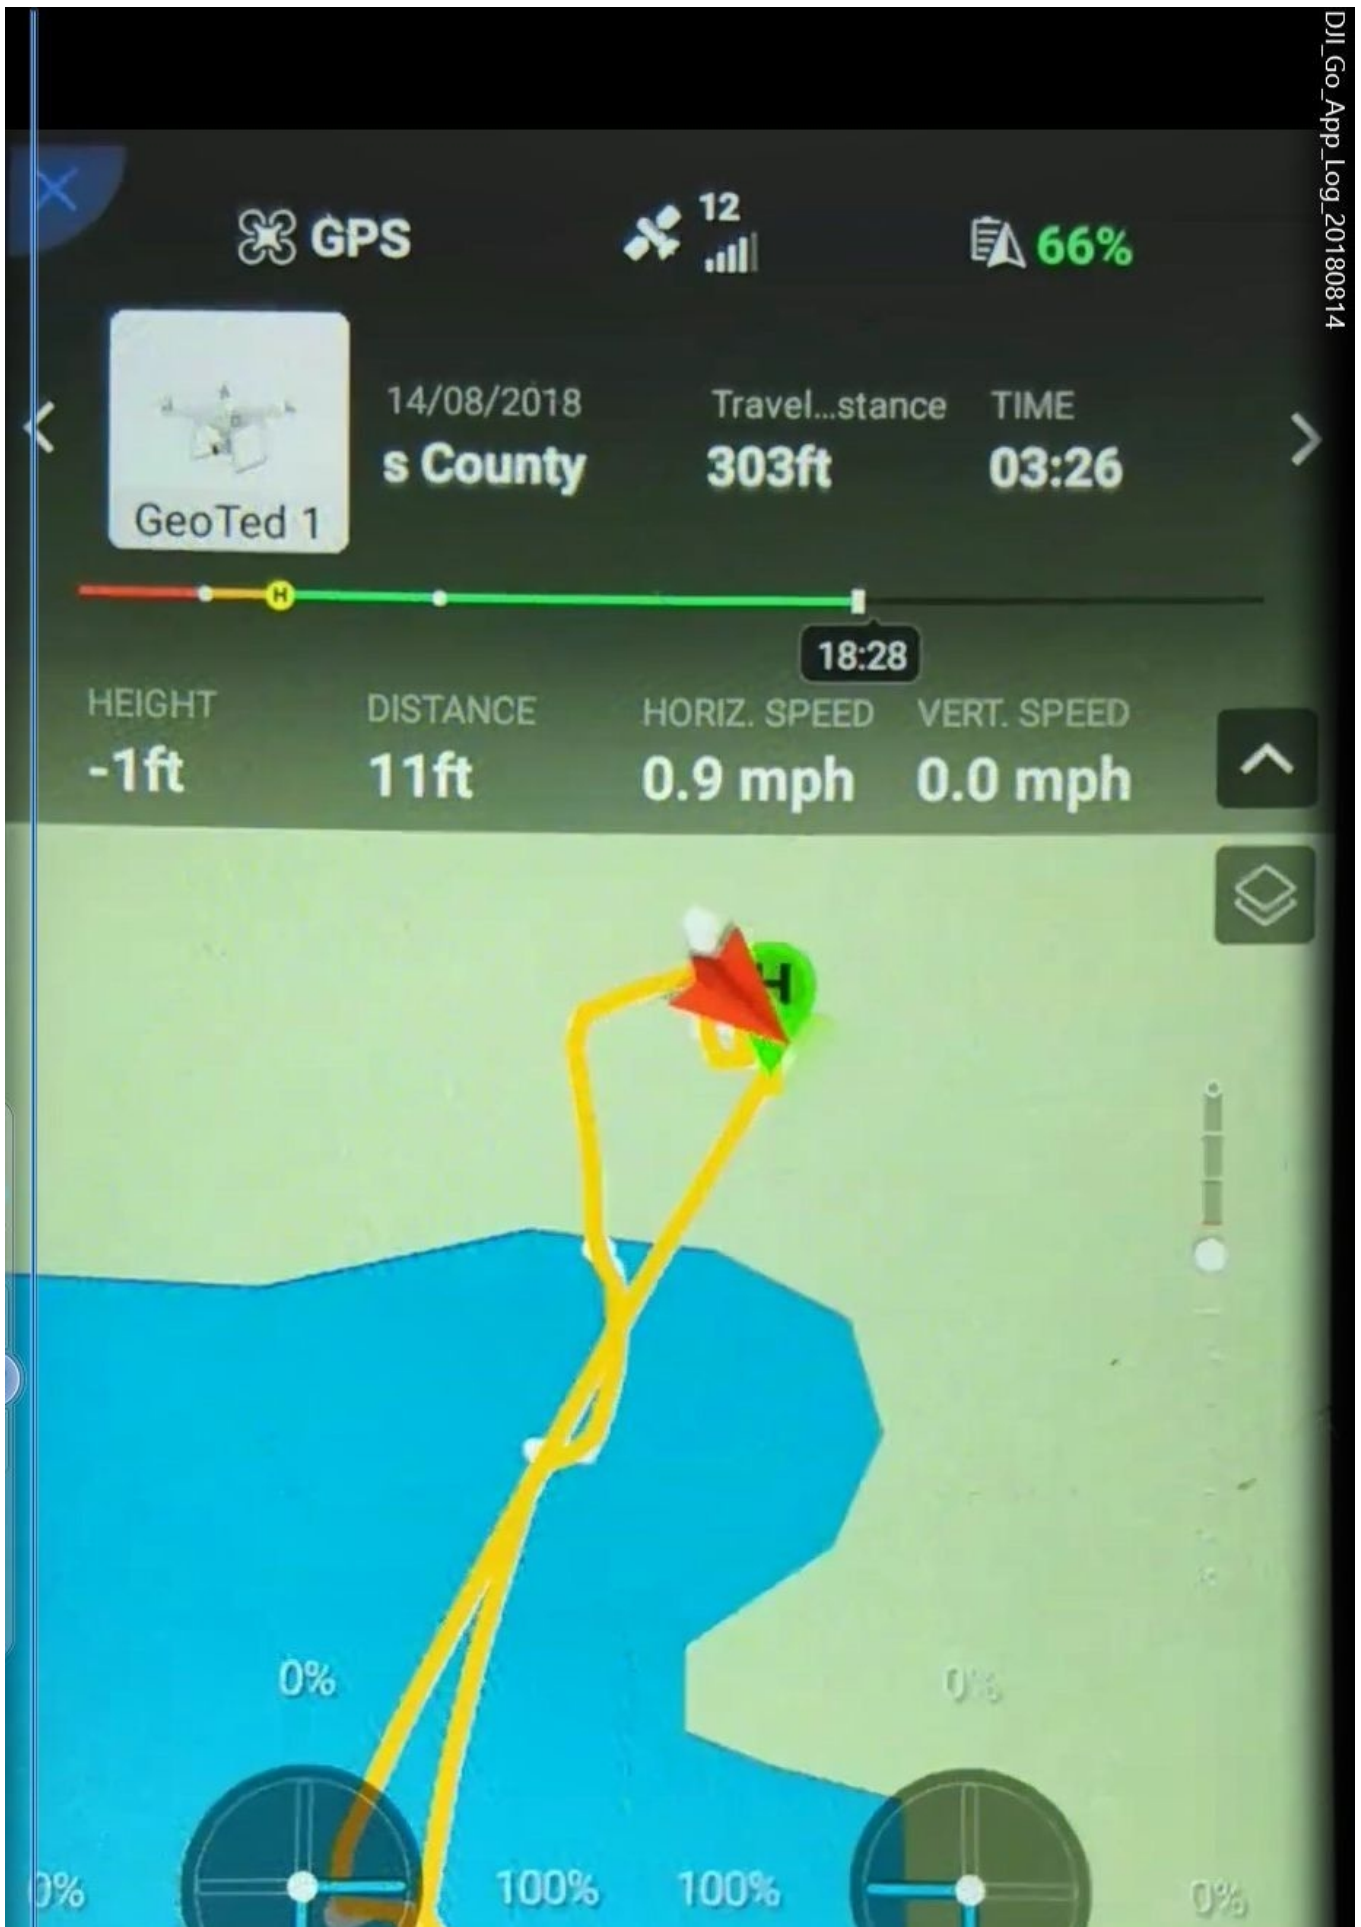
Figure 2 – First CSC command 1:10 prior to end

Examination of the logs revealed that, at 1 minute10 seconds before the end of data, the drone was being maneuvering at low altitude near the home point in GPS mode. Then the pilot partially decreased throttle followed by the "down and in" CSC.

The log data showed that, while the drone was still in the air, it responded to the pilot's "down and in" CSC input by pitching up, yawing right, and banking left. Logs indicated a "braking" message indicating the obstacle avoidance/visual positioning system (VPS) was activated.

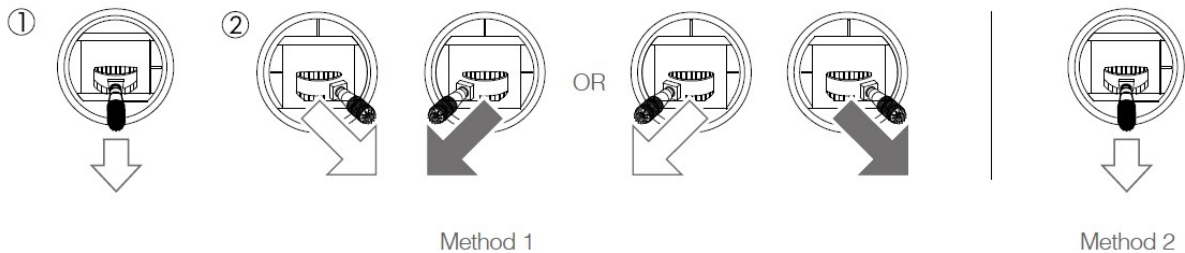
Figure 3 – Excerpt from Phantom 4 User Manual, Stopping the Motors

According to the DJI Phantom 4 User Manual, the "down and in" command shuts down the motors immediately when the drone is on the ground. Alternatively, a method to stop motors on the ground is to retard the throttle straight back and hold for 3 seconds (figure 3). The method for emergency stop of motors in flight or prior to the drone sensing that it has landed is to pull the throttle back and to the right while simultaneously pressing the Return to Home button (figure 4).
