Aviation Investigation Final Report

Location:	Prescott, Arizona	Accident Number:	WPR18FA245
Date & Time:	August 29, 2018, 20:35 Local	Registration:	N6500W
Aircraft:	Cessna P210	Aircraft Damage:	Destroyed
Defining Event:	Controlled flight into terr/obj (CFIT)	Injuries:	1 Fatal
Flight Conducted Under:	Part 91: General aviation - Personal

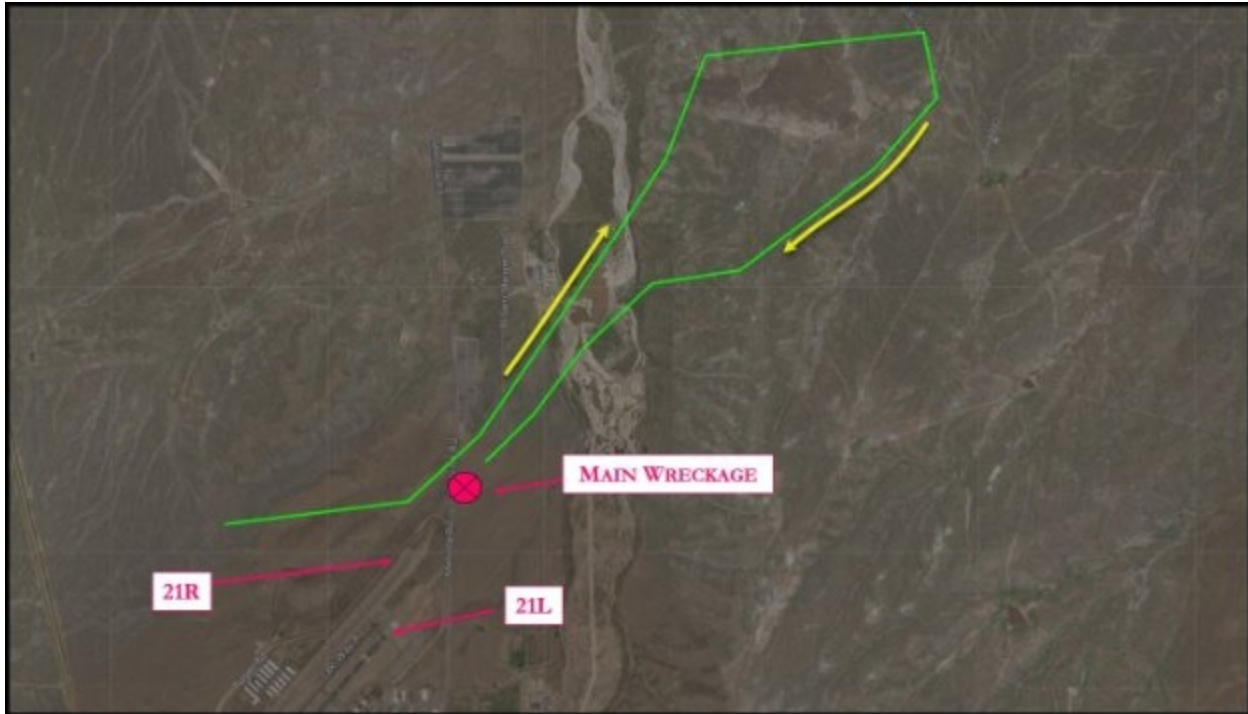
Figure 1: Radar Track

A review of the radar track data indicated that after departure, the airplane joined a right traffic pattern for runway 21R (see figure 1). On the downwind leg, the track was not parallel to the runway and neared the approach end. The track then progressed into a long teardrop-shaped 180° turn; about 2.8 nautical miles (nm) from the approach end of runway 21R, the airplane's heading turned right toward the runway. At 2032:59 the tower controller stated to the pilot, "just verifying you're lining up for runway 21R." Four seconds later the pilot replied, "roger that, 21R, 6500W." At 2033:19 the controller told the pilot to go around.

The last recorded data point was at 2034:17 and about 740 ft northeast of the accident site. At that time, the airplane was about 5,050 ft mean sea level (msl), which was about 145 ft above ground level (agl), at a ground speed of 99 kts. At 2034:24, the controller again told the pilot to go around, to which another pilot in the pattern responded that the airplane was on fire.

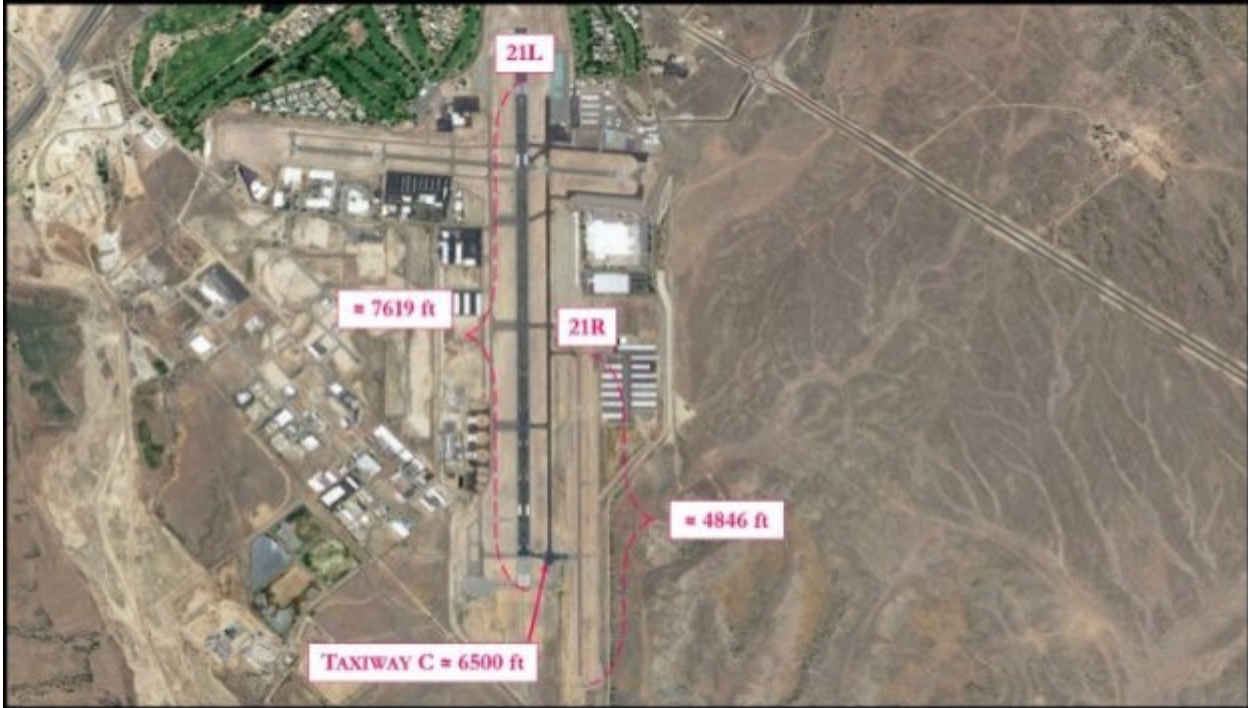
Figure 2: Airport

Runway 21R was 4,846 ft long by 60 ft wide, and runway 21L was 7,619 ft long by 150 ft wide. The threshold for runway 21L was 1,500 ft beyond the threshold for runway 21R (see figure 2). Further, a lighted taxiway was between the two runways.

Runway 21R was equipped with a 2-light precision approach path indicator (PAPI) system with an approach angle of 3.00° located to the left of the runway that provided a threshold crossing height of 48 ft. The runway was equipped with medium intensity edge lights. The runway 21R threshold was at an elevation of 4,938 ft and it sloped up at 0.8% to 4,975 ft at the runway end.

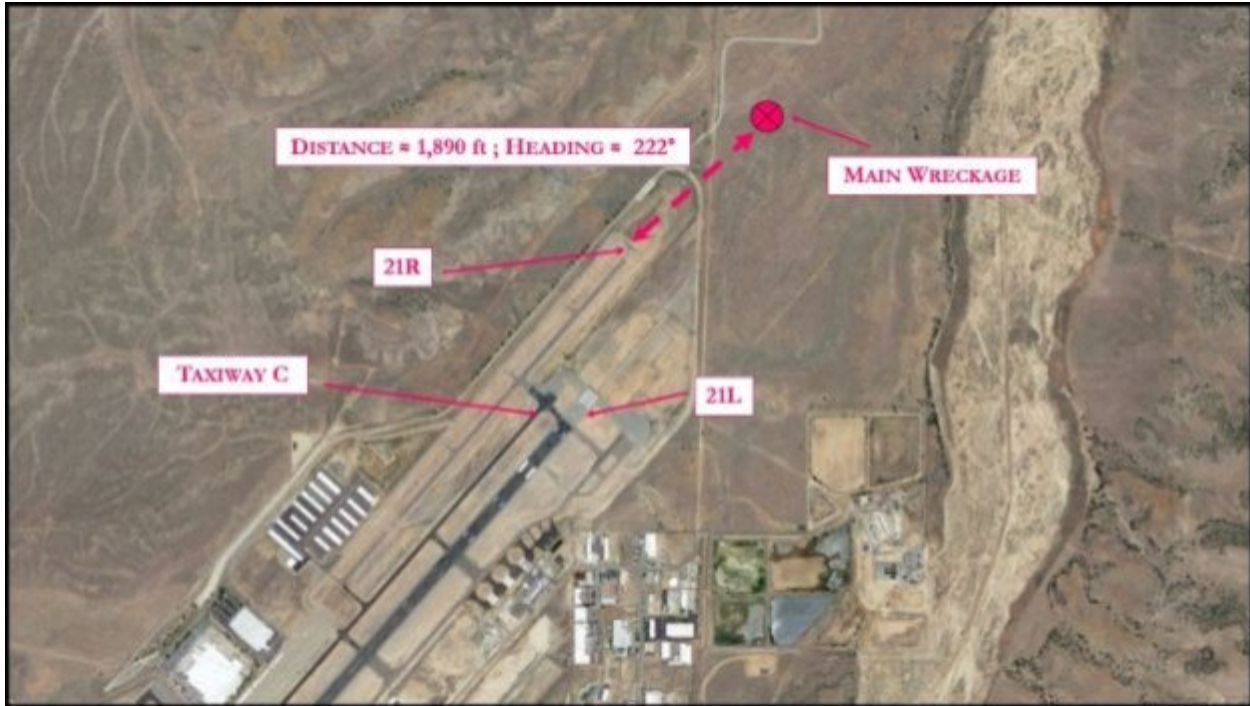
Figure 3: Accident Site in Reference to the Airport

The accident site was located in desert terrain about 1,890 ft from the runway 21R threshold (see figure 3). The wreckage was found distributed over a 240-ft distance on a median magnetic track of about 222°.
