# Aviation Investigation Final Report

<b>Location:</b>	Kennett, Missouri	<b>Accident Number:</b>	WPR18LA256
<b>Date &amp; Time:</b>	September 7, 2018, 15:00 Local	<b>Registration:</b>	N131TX
<b>Aircraft:</b>	Cirrus SR22	<b>Aircraft Damage:</b>	Substantial
<b>Defining Event:</b>	Fuel related	<b>Injuries:</b>	2 Minor
<b>Flight Conducted Under:</b>	Part 91: General aviation - Personal

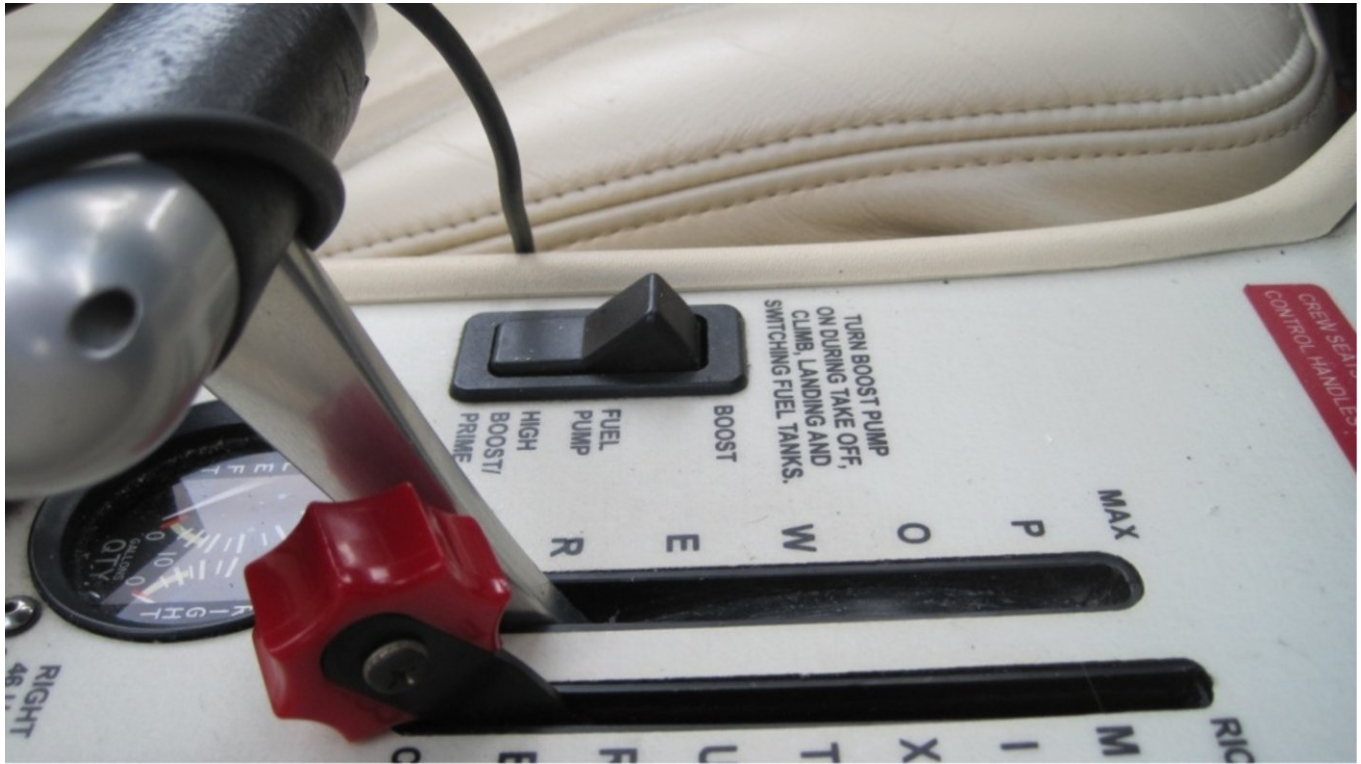
Figure 1. Fuel Boost Pump Switch

It is likely that, during his attempt to free the headset control module, the pilot inadvertently and unknowingly repositioned the unguarded three-position fuel pump control rocker switch, located on the center console, to the HIGH BOOST/PRIME position. This selection resulted in the loss of engine power.

The airplane was equipped with an electrically powered fuel boost pump. A three-position (boost, off, high boost/prime) rocker switch to control the fuel pump was located on the horizontal surface of the center console between the two forward seats, just left of the engine power lever. (see Figure 1.) The fuel pump is unpowered (off) when the switch is in its neutral position. Depressing the forward end of the switch face powers the pump in the BOOST mode, which is used for takeoff, climb, landing, and switching fuel tanks. Depressing the aft end of the switch face powers the pump in the HIGH BOOST/PRIME mode, which is used to prime the engine before engine start, and for suppressing vapor

formation in flight above 18,000 ft with hot fuel. The switch was not guarded or otherwise physically protected from inadvertent operation.

fuel pump switch was in the HIGH BOOST/PRIME position. No other non-impact damage or abnormalities were observed.

About 4 months before the accident, Cirrus began implementing software changes intended to prevent improper operation of the electric fuel boost pump. The approach consisted of a software-controlled lockout feature that was to be retroactively applied to all SR22T model Cirrus airplanes via service bulletins (SBs). The revised software locks out the high boost function of the pump (when HIGH BOOST/PRIME is selected) until the airplane reaches a pressure altitude of 10,000 feet; this prevents an engine power loss at low altitudes due to improper selection of HIGH BOOST/PRIME.
