Aviation Investigation Final Report

Location:	Kennett, Missouri	Accident Number:	WPR18LA256
Date & Time:	September 7, 2018, 15:00 Local	Registration:	N131TX
Aircraft:	Cirrus SR22	Aircraft Damage:	Substantial
Defining Event:	Fuel related	Injuries:	2 Minor
Flight Conducted Under:	Part 91: General aviation - Personal

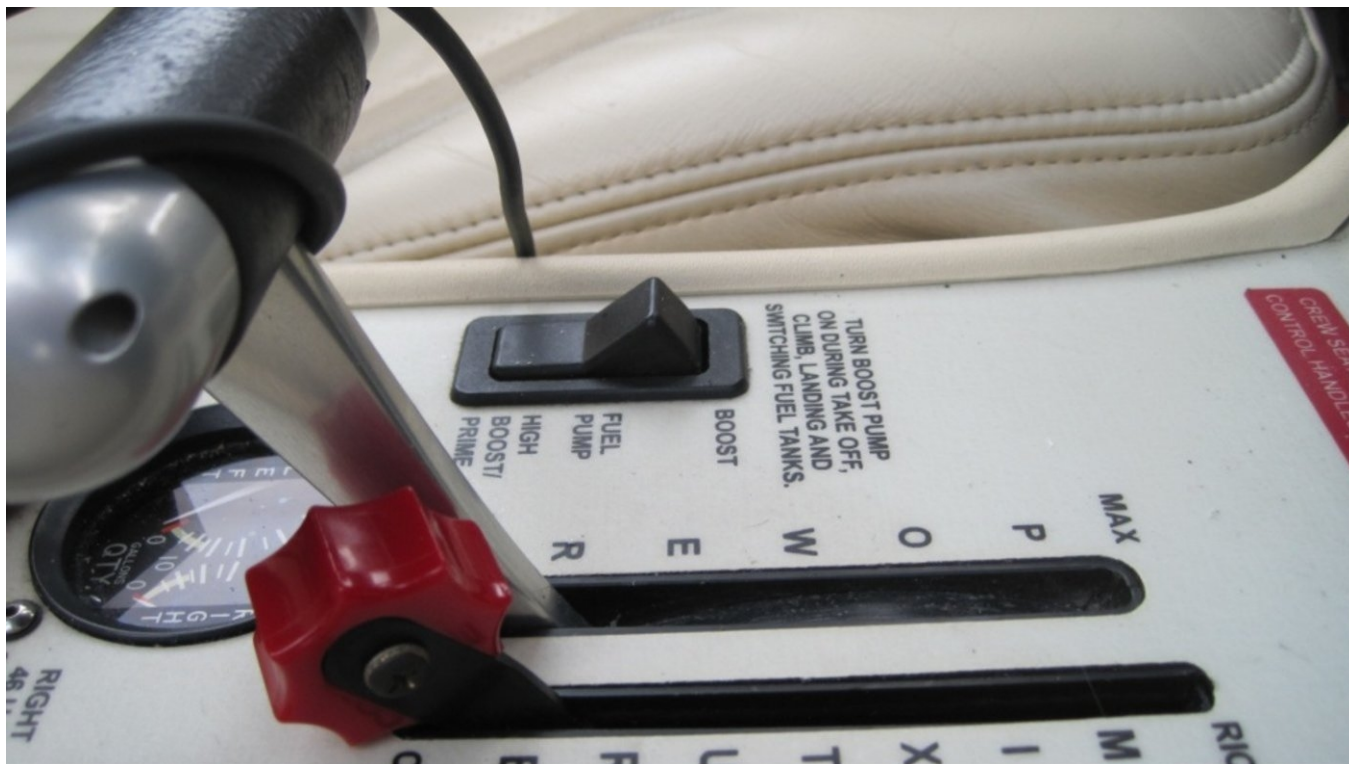
Figure 1. Fuel Boost Pump Switch

It is likely that, during his attempt to free the headset control module, the pilot inadvertently and unknowingly repositioned the unguarded three-position fuel pump control rocker switch, located on the center console, to the HIGH BOOST/PRIME position. This selection resulted in the loss of engine power.

The airplane was equipped with an electrically powered fuel boost pump. A three-position (boost, off, high boost/prime) rocker switch to control the fuel pump was located on the horizontal surface of the center console between the two forward seats, just left of the engine power lever. (see Figure 1.) The fuel pump is unpowered (off) when the switch is in its neutral position. Depressing the forward end of the switch face powers the pump in the BOOST mode, which is used for takeoff, climb, landing, and switching fuel tanks. Depressing the aft end of the switch face powers the pump in the HIGH BOOST/PRIME mode, which is used to prime the engine before engine start, and for suppressing vapor

formation in flight above 18,000 ft with hot fuel. The switch was not guarded or otherwise physically protected from inadvertent operation.

fuel pump switch was in the HIGH BOOST/PRIME position. No other non-impact damage or abnormalities were observed.

About 4 months before the accident, Cirrus began implementing software changes intended to prevent improper operation of the electric fuel boost pump. The approach consisted of a software-controlled lockout feature that was to be retroactively applied to all SR22T model Cirrus airplanes via service bulletins (SBs). The revised software locks out the high boost function of the pump (when HIGH BOOST/PRIME is selected) until the airplane reaches a pressure altitude of 10,000 feet; this prevents an engine power loss at low altitudes due to improper selection of HIGH BOOST/PRIME.
