Aviation Investigation Final Report

Location:	Cottonwood, Arizona	Accident Number:	WPR18FA266
Date & Time:	September 17, 2018, 09:45 Local	Registration:	N2031D
Aircraft:	Beech 33	Aircraft Damage:	Substantial
Defining Event:	Loss of engine power (total)	Injuries:	1 Fatal
Flight Conducted Under:	Part 91: General aviation - Personal

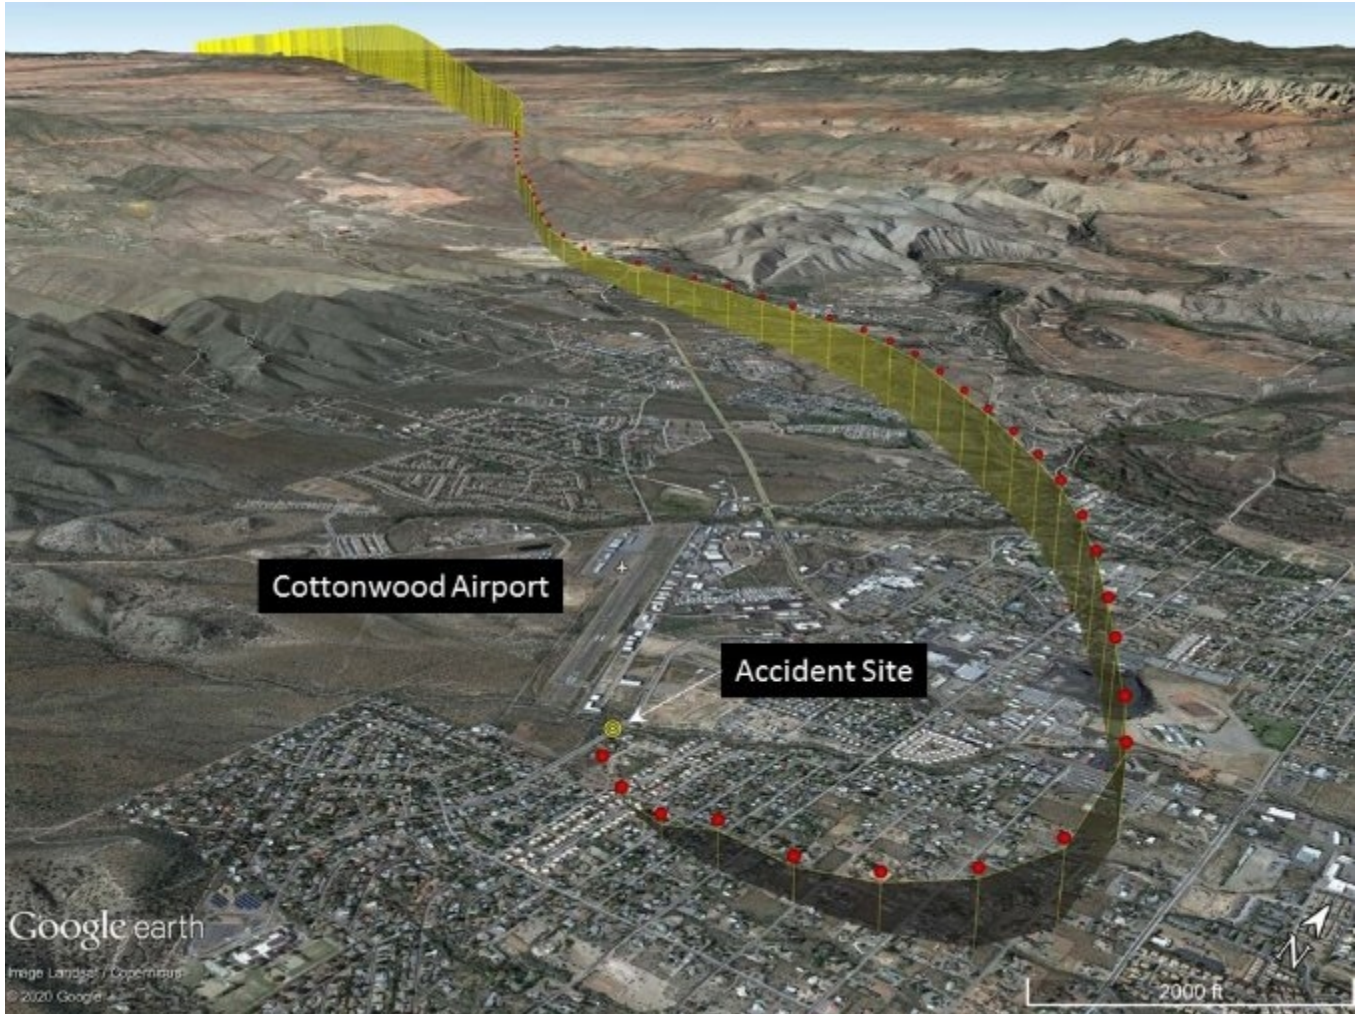
Radar data showed that, as the airplane approached P52, it entered a right downwind leg for runway 32. The airplane made a right turn for the base leg for runway 32 and began to descend, then continued its descent as it turned toward the runway; the last radar returns were low to the ground and near the accident site. (See Figure 1.) The airplane impacted a house and cartwheeled into the backyard.

Figure 1-Radar flight track data and the accident site location.
