Aviation Investigation Final Report

Location:	Heber, Utah	Accident Number:	WPR18LA272
Date & Time:	September 25, 2018, 11:00 Local	Registration:	N90339
Aircraft:	Smith Aerostar601	Aircraft Damage:	Substantial
Defining Event:	Landing gear collapse	Injuries:	1 None
Flight Conducted Under:	Part 91: General aviation - Personal

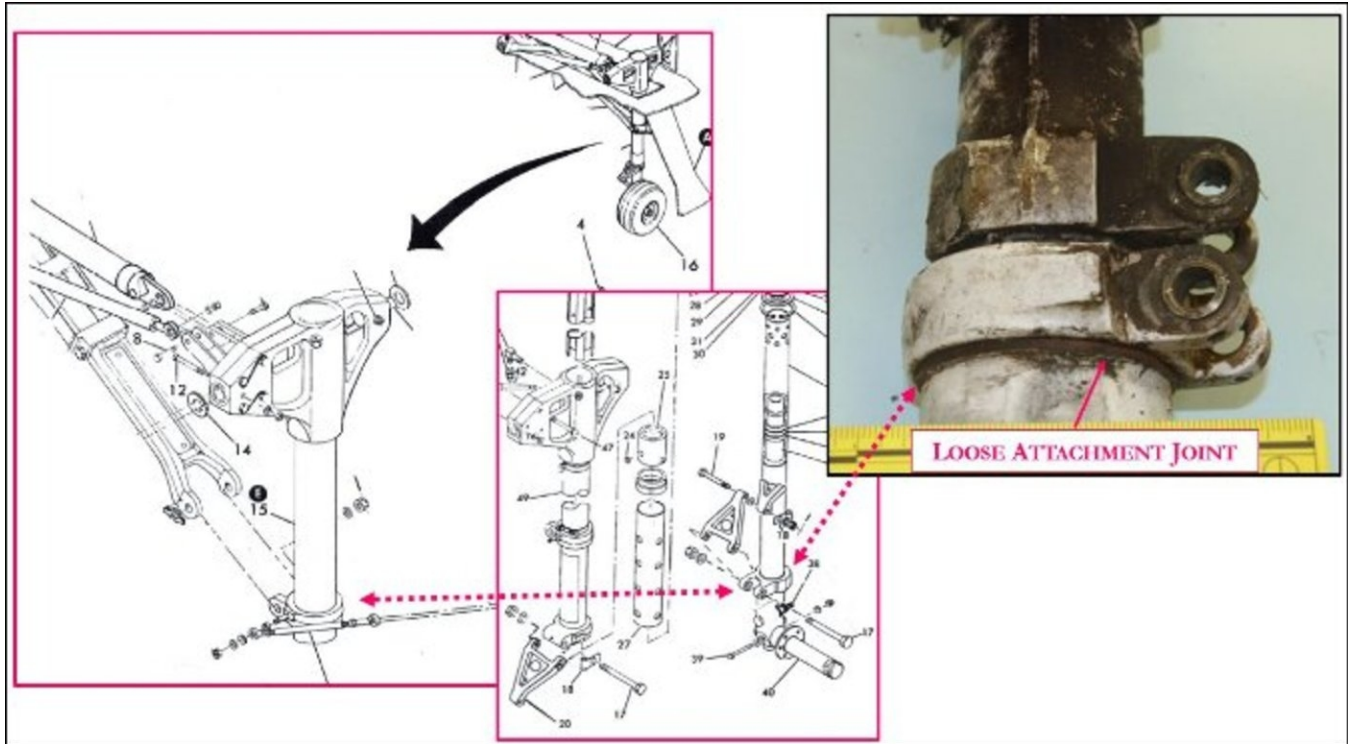
Figure: Diagram and forward aft view picture of the left main landing gear

Postaccident examination of the landing gear assembly revealed that the weld had failed on the joint attached to the main landing gear cylinder and upper scissor assembly. Most of the fracture surface of the failure surface had been obliterated by smearing and grinding, consistent with post-fracture damage. The degree of the fracture surface damage was consistent with the fracture and separation happening before the accident. Landing gear components are under cyclic loads at every landing and during landing actions (such as braking or taxiing). There was no evidence of fatigue, corrosion, or other progressive mechanisms would have led to the fracture of this joint from the strut cylinder.

It is likely that a recent hard landing fractured the joint from the cylinder, but it could not be determined whether this occurred during the accident landing or beforehand due to the damage incurred after the gear collapsed.

A recent hard landing resulted in a fracture of a joint from a cylinder to a main landing gear.

Postaccident examination of a portion of the left main landing gear assembly by the National Transportation Safety Board Materials Laboratory revealed that the weld had failed on the joint attached to the landing gear cylinder and upper scissor assembly. The inboard fitting of the joint remained affixed to the scissor assembly by an attachment bolt. The joint was loose where it attached to the cylinder, and it could be rotated against the cylinder exterior. The adjacent hexagonal cap below the loose joint was still tight against the cylinder assembly (see figure).

The attachment joint had fractured and separated about the entire circumference of the cylinder exterior. This separation allowed the joint (and linkage) to rotate approximately 30° about the cylinder. The fracture surface of the attachment joint faced upward on the strut cylinder where the joint had been welded to the cylinder. Examination of the joint portions of the fracture surface, particularly along the fractured weld protrusions, did not reveal any fracture features. Portions of the external weld on the joint exhibited features of localized deformation, all of which were consistent with overstress fracture. Most of the fracture surface features had been obliterated by smearing and grinding, consistent with post fracture damage. The degree of the fracture surface damage was consistent with the fracture and separation existing prior to the accident. Landing gear components are under cyclic loads at every landing and during landing actions (such as braking or taxiing).

According to a representative of Aerostar, the airframe manufacturer, the attachment joint failure looked like the same type of failure that a few Aerostar airplanes had in the early 1970s because of an inadequate braze joint, which allowed the landing gear to rotate. Following those failures, the manufacturer enhanced the brazing methods and performed an x-ray inspection after furnace brazing to verify that the surface braze was complete. The manufacturer was not aware of any recent failures occurring in this area and there is not a specific inspection for this braze and further stated that, with multiple hard landings or an opposing gear collapsing, the gear could fail at the braze joint from overstress. A failure of the weld makes the airplane uncontrollable on the ground.
