# Aviation Investigation Final Report

<b>Location:</b>	Marion, Indiana	<b>Accident Number:</b>	CEN19FA035
<b>Date &amp; Time:</b>	November 29, 2018, 14:21 Local	<b>Registration:</b>	N7751Y
<b>Aircraft:</b>	Piper PA 30	<b>Aircraft Damage:</b>	Destroyed
<b>Defining Event:</b>	Aerodynamic stall/spin	<b>Injuries:</b>	1 Fatal
<b>Flight Conducted Under:</b>	Part 91: General aviation - Personal

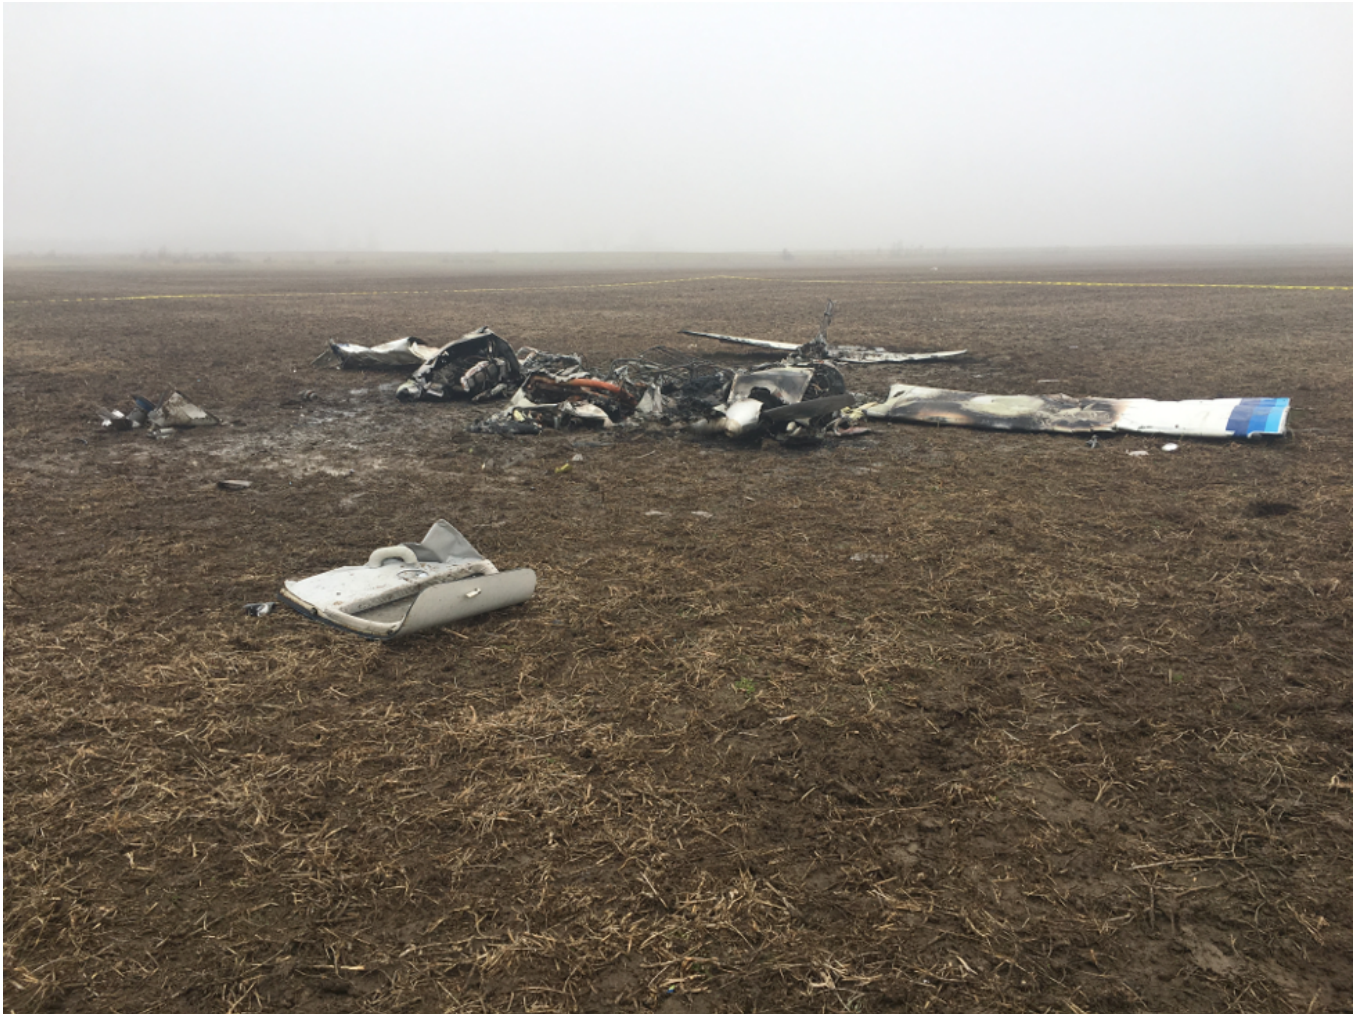
Figure. Accident Site

The airplane came to rest upright in a soft, wet field about 1/4 mile south of the departure runway. The accident site and the airplane wreckage are shown in the figure. Postaccident examination of the airplane showed that the fuselage, empennage, and inboard sections of both wings were consumed by post-impact fire. The instrument panel, instruments, and engine controls were destroyed by fire and impact. The front left seat remained attached to the cabin floor. (The right front seat was not installed and was found in the pilot's hangar.) The main cabin door was separated and came to rest about 15 ft forward of the main wreckage. The upper latch and side pin were found engaged, consistent with a closed or locked door position.

The left and right wings remained partially attached to the fuselage and displayed thermal, buckling, and leading edge damage. The left and right ailerons remained attached to the wing attach brackets and control pushrod. The left and right flaps remained attached to the wing structure and displayed thermal damage. The right outboard wing and wing tip were deformed aft. A ground scar, consistent with the right wing, was noted about 3 ft in front of the damaged right wing. The right flap control mechanism displayed thermal damage and the control arm was found between the flaps 0° and slightly extended position. The landing gear retraction push-pull rod was found in the landing gear extended position.

The left engine and propeller assembly remained partially attached to the airframe. One propeller blade showed no damage, and one propeller blade was not twisted and bent aft. The right engine remained partially attached to the airframe, and the right propeller assembly was separated from the engine, aft of the crankshaft flange. The crankshaft fracture surface exhibited 45° shear lips. One propeller blade was twisted and bent forward, and one propeller blade was twisted and bent aft. Both the left and right propeller blades appeared to be in a low-pitch position.
