# Aviation Investigation Final Report

<b>Location:</b>	Uvalde, Texas	<b>Accident Number:</b>	CEN19LA054
<b>Date &amp; Time:</b>	January 12, 2019, 11:30 Local	<b>Registration:</b>	N813WT
<b>Aircraft:</b>	Canadair CL 600 2A12	<b>Aircraft Damage:</b>	Substantial
<b>Defining Event:</b>	Hard landing	<b>Injuries:</b>	9 None
<b>Flight Conducted Under:</b>	Part 91: General aviation

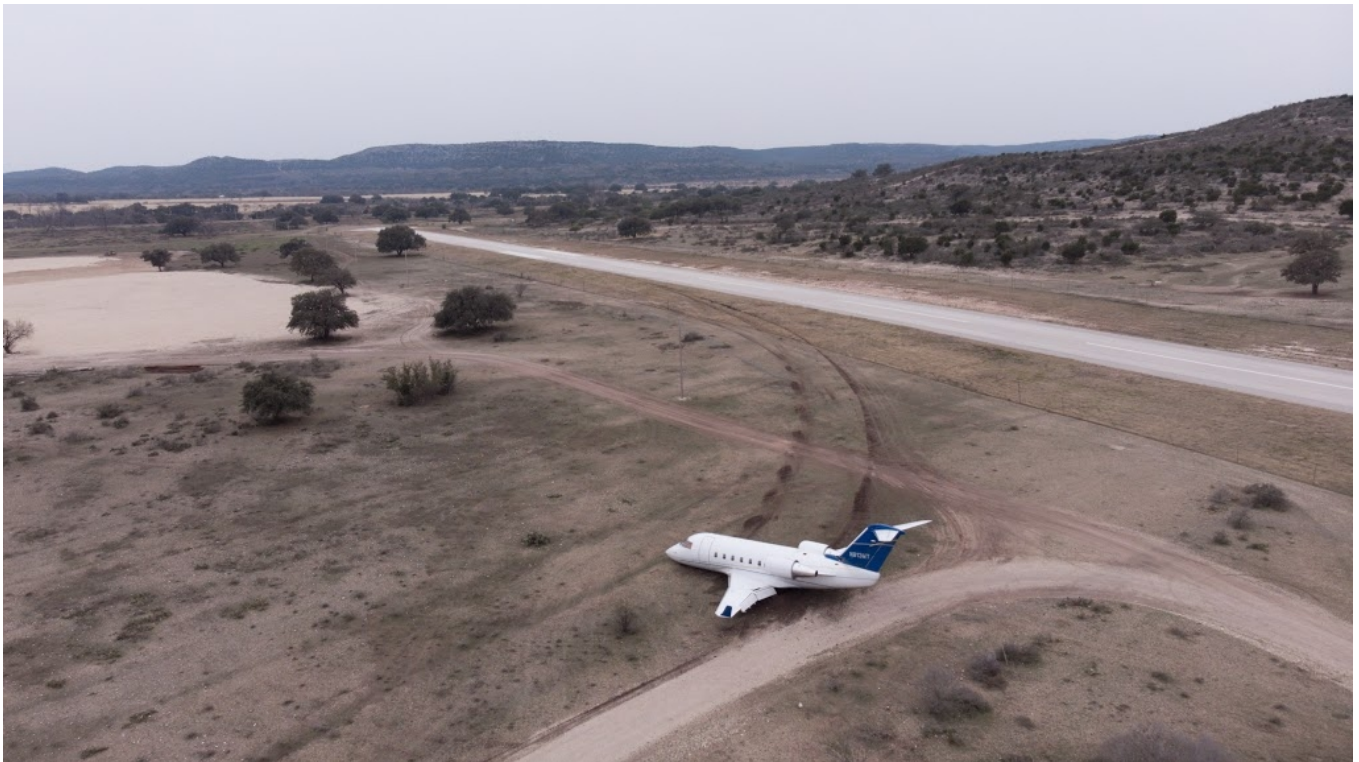
A representative for the airport reported that the airplane on landing hit hard. About two-thirds of the way down runway 35, the airplane slid off the right side of the runway. The airplane proceeded through a ditch and struck a perimeter fence before coming to a stop.

Figure 1: Accident Scene

The airplane wreckage was in a field near a dirt service road on airport property, about 2,100 ft. east of runway 35. The airplane was upright and oriented on a 170° heading. Preceding the airplane were two sets of parallel skid marks in the dirt that began about 1,600 ft from the runway threshold and curved along the ground ending at the airplane. Also preceding the airplane was a three inch wide, 2 inch deep, and 1,500 ft long gouge in the runway asphalt that began 53 ft from the runway threshold and ran parallel to the right side of the runway to where it ended, the point where the airplane departed the right side of the runway.

The airplane was intact and rested on the right wing, left main landing gear, and the nose section beneath the flight deck. A portion of the airport perimeter fence was found embedded in the vertical fin leading to the vertical stabilizer. The right main landing gear was broken aft and collapsed under the right wing. It remained attached to the airplane at the main gear side strut retraction actuator. The right winglet and leading edge of the right wing showed impact damage along their spans. The trailing edge of the right wing and spar structure at the right main landing gear wheel well were bent and broken upward. The inboard portion of the right inboard flap was broken upward at the wing root. A black rubber mark corresponding to the tread of the right main landing gear outboard tire was found smeared on the underside of the broken inboard piece of the right inboard flap.
