# Aviation Investigation Final Report

<b>Location:</b>	Uvalde, Texas	<b>Accident Number:</b>	CEN19LA054
<b>Date &amp; Time:</b>	January 12, 2019, 11:30 Local	<b>Registration:</b>	N813WT
<b>Aircraft:</b>	Canadair CL 600 2A12	<b>Aircraft Damage:</b>	Substantial
<b>Defining Event:</b>	Hard landing	<b>Injuries:</b>	9 None
<b>Flight Conducted Under:</b>	Part 91: General aviation

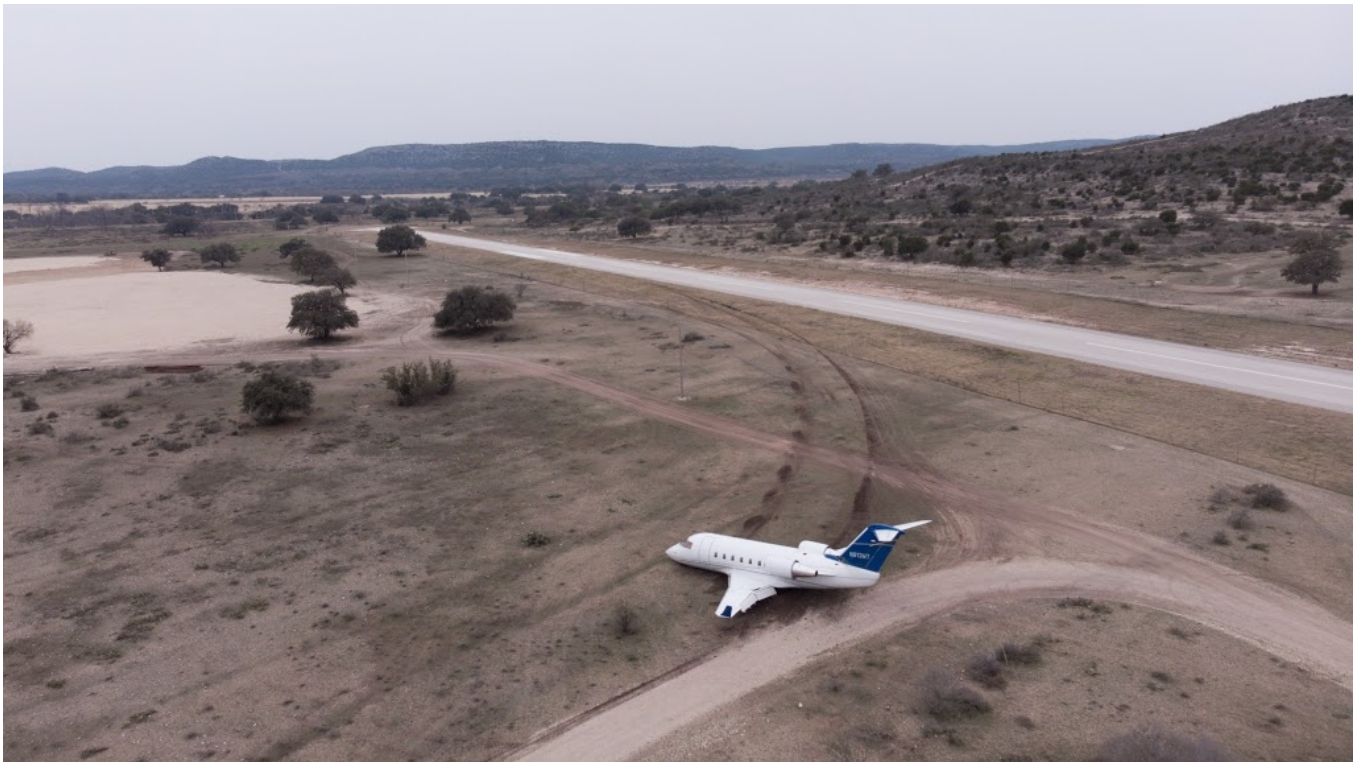
Figure 1: Accident Scene

A representative for the airport reported that the airplane on landing hit hard. About two-thirds of the way down runway 35, the airplane slid off the right side of the runway. The airplane proceeded through a ditch and struck a perimeter fence before coming to a stop.

The airplane wreckage was in a field near a dirt service road on airport property, about 2,100 ft. east of runway 35. The airplane was upright and oriented on a 170° heading. Preceding the airplane were two sets of parallel skid marks in the dirt that began about 1,600 ft from the runway threshold and curved along the ground ending at the airplane. Also preceding the airplane was a three inch wide, 2 inch deep, and 1,500 ft long gouge in the runway asphalt that began 53 ft from the runway threshold and ran parallel to the right side of the runway to where it ended, the point where the airplane departed the right side of the runway.

The airplane was intact and rested on the right wing, left main landing gear, and the nose section beneath the flight deck. A portion of the airport perimeter fence was found embedded in the vertical fin leading to the vertical stabilizer. The right main landing gear was broken aft and collapsed under the right wing. It remained attached to the airplane at the main gear side strut retraction actuator. The right winglet and leading edge of the right wing showed impact damage along their spans. The trailing edge of the right wing and spar structure at the right main landing gear wheel well were bent and broken upward. The inboard portion of the right inboard flap was broken upward at the wing root. A black rubber mark corresponding to the tread of the right main landing gear outboard tire was found smeared on the underside of the broken inboard piece of the right inboard flap.

The nose landing gear was twisted sideways 90°, collapsed aft and upward, and pressed into the underside of the nose landing gear wheel well, right nose wheel well door, and the underside of the fuselage, left of the nose gear wheel well.

The pilot's number one windshield outer pane was shattered due to impact damage. There were numerous scratches in the forward fuselage of the airplane that began at the nose and ran horizontally along the right side and top of the fuselage. The fin forward of the vertical stabilizer was broken aft. The leading edge of the vertical stabilizer was bent and broken aft at the fuselage. A length of metal mesh fencing was embedded at the base of the vertical fin and trailed toward the right side of the airplane.
