Aviation Investigation Final Report

Location:	Uvalde, Texas	Accident Number:	CEN19LA054
Date & Time:	January 12, 2019, 11:30 Local	Registration:	N813WT
Aircraft:	Canadair CL 600 2A12	Aircraft Damage:	Substantial
Defining Event:	Hard landing	Injuries:	9 None
Flight Conducted Under:	Part 91: General aviation

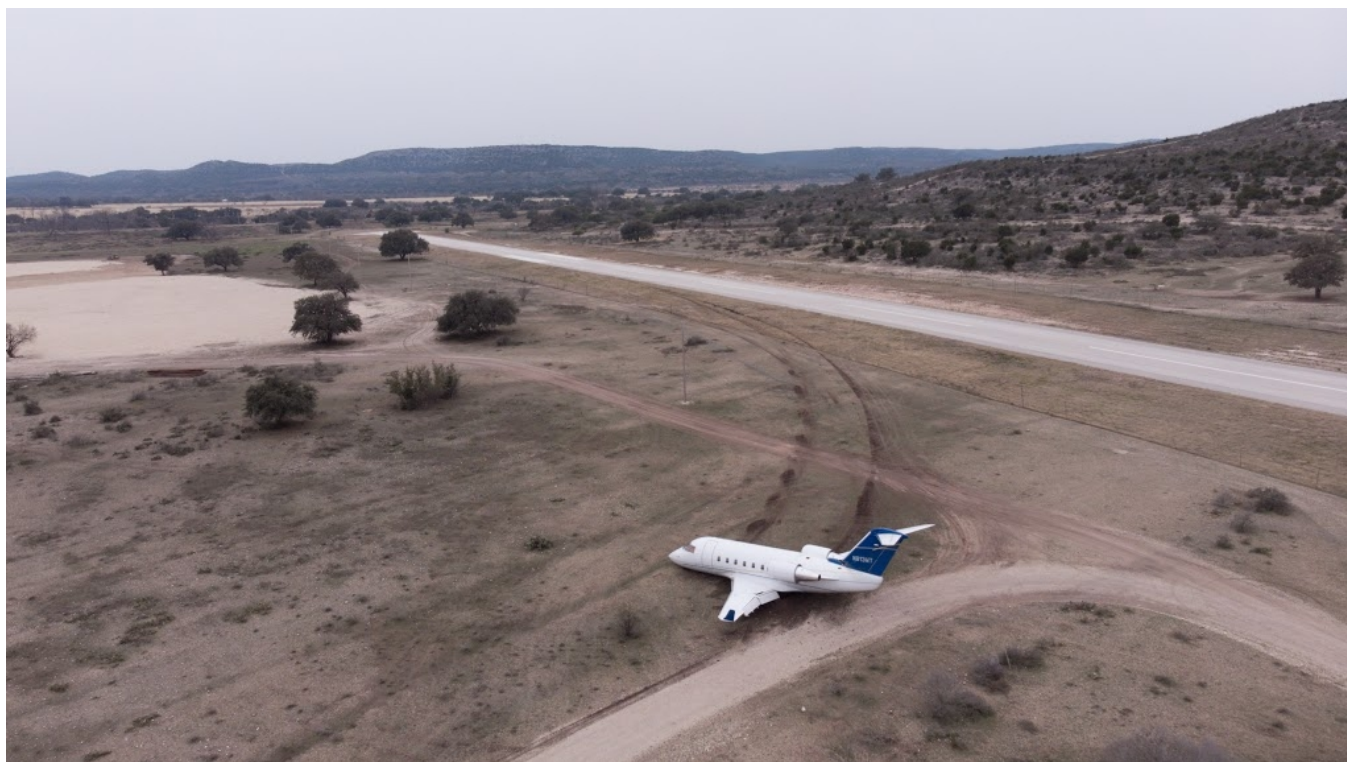
Figure 1: Accident Scene

A representative for the airport reported that the airplane on landing hit hard. About two-thirds of the way down runway 35, the airplane slid off the right side of the runway. The airplane proceeded through a ditch and struck a perimeter fence before coming to a stop.

The airplane wreckage was in a field near a dirt service road on airport property, about 2,100 ft. east of runway 35. The airplane was upright and oriented on a 170° heading. Preceding the airplane were two sets of parallel skid marks in the dirt that began about 1,600 ft from the runway threshold and curved along the ground ending at the airplane. Also preceding the airplane was a three inch wide, 2 inch deep, and 1,500 ft long gouge in the runway asphalt that began 53 ft from the runway threshold and ran parallel to the right side of the runway to where it ended, the point where the airplane departed the right side of the runway.

The airplane was intact and rested on the right wing, left main landing gear, and the nose section beneath the flight deck. A portion of the airport perimeter fence was found embedded in the vertical fin leading to the vertical stabilizer. The right main landing gear was broken aft and collapsed under the right wing. It remained attached to the airplane at the main gear side strut retraction actuator. The right winglet and leading edge of the right wing showed impact damage along their spans. The trailing edge of the right wing and spar structure at the right main landing gear wheel well were bent and broken upward. The inboard portion of the right inboard flap was broken upward at the wing root. A black rubber mark corresponding to the tread of the right main landing gear outboard tire was found smeared on the underside of the broken inboard piece of the right inboard flap.
