Aviation Investigation Final Report

Location:	Kidron, Ohio	Accident Number:	CEN19LA056
Date & Time:	January 21, 2019, 09:12 Local	Registration:	N467KS
Aircraft:	Douglas DC3C	Aircraft Damage:	Substantial
Defining Event:	Loss of control in flight	Injuries:	2 Fatal
Flight Conducted Under:	Part 91: General aviation - Positioning

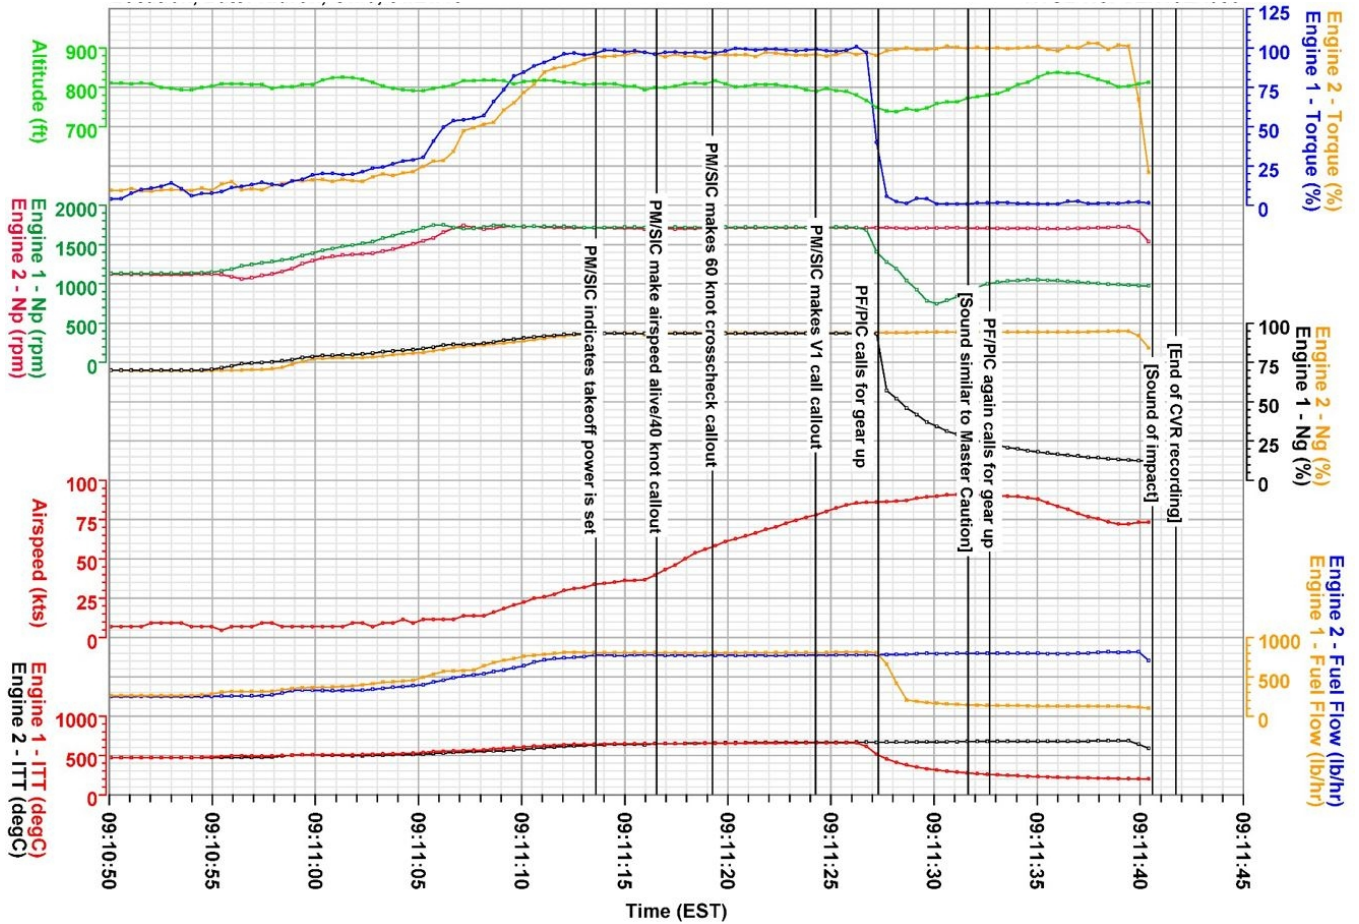
Figure 1 - Correlated ADAS Data and CVR Events

Downloaded automated data acquisition system (ADAS) data indicated left engine torque, fuel flow, gas generator speed (Ng), propeller rpm (Np) rapidly decreased at 0911:26.5. At 0911:27.2, left engine torque dropped to nearly zero and Ng decreased until the end of the recorded data.

Left engine Np dropped to 746 rpm at 0911:30, then increased to 1050 rpm about 4 seconds later. Airspeed reached a maximum of 91 knots at 0911:31. By the end of recorded data at 0911:41, Np and airspeed had decreased to 971 rpm and 73 knots, respectively.

Correlated ADAS data and CVR events are shown in Figure 1.
