Aviation Investigation Final Report

Location:	Kidron, Ohio	Accident Number:	CEN19LA056
Date & Time:	January 21, 2019, 09:12 Local	Registration:	N467KS
Aircraft:	Douglas DC3C	Aircraft Damage:	Substantial
Defining Event:	Loss of control in flight	Injuries:	2 Fatal
Flight Conducted Under:	Part 91: General aviation - Positioning

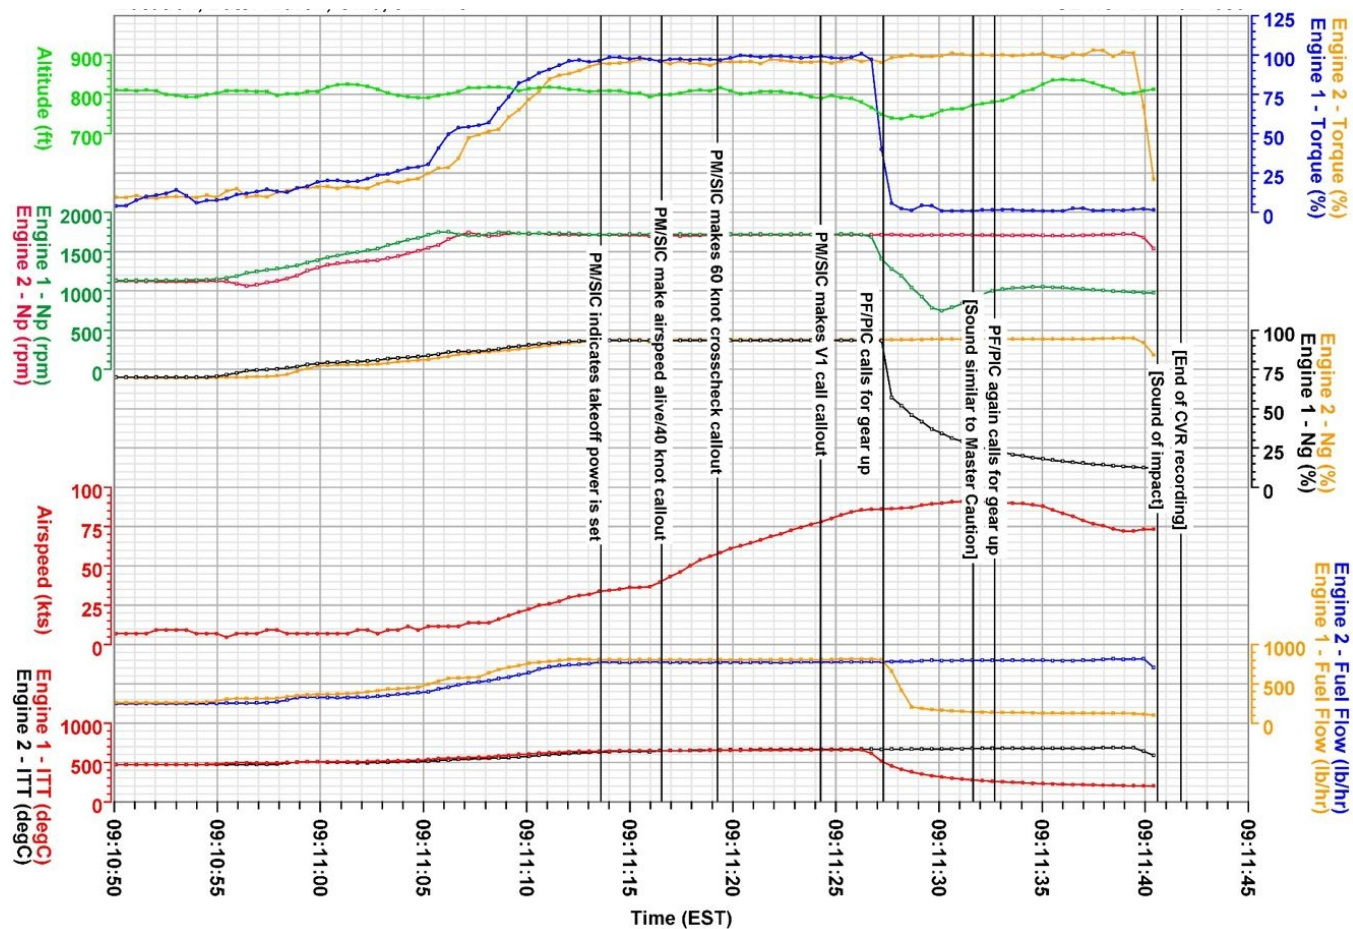
Figure 1 - Correlated ADAS Data and CVR Events

Downloaded automated data acquisition system (ADAS) data indicated left engine torque, fuel flow, gas generator speed (Ng), propeller rpm (Np) rapidly decreased at 0911:26.5. At 0911:27.2, left engine torque dropped to nearly zero and Ng decreased until the end of the recorded data.

Left engine Np dropped to 746 rpm at 0911:30, then increased to 1050 rpm about 4 seconds later. Airspeed reached a maximum of 91 knots at 09:11:31. By the end of recorded data at 0911:41, Np and airspeed had decreased to 971 rpm and 73 knots, respectively.

Correlated ADAS data and CVR events are shown in Figure 1.
