# Aviation Investigation Final Report

<b>Location:</b>	Kidron, Ohio	<b>Accident Number:</b>	CEN19LA056
<b>Date &amp; Time:</b>	January 21, 2019, 09:12 Local	<b>Registration:</b>	N467KS
<b>Aircraft:</b>	Douglas DC3C	<b>Aircraft Damage:</b>	Substantial
<b>Defining Event:</b>	Loss of control in flight	<b>Injuries:</b>	2 Fatal
<b>Flight Conducted Under:</b>	Part 91: General aviation - Positioning

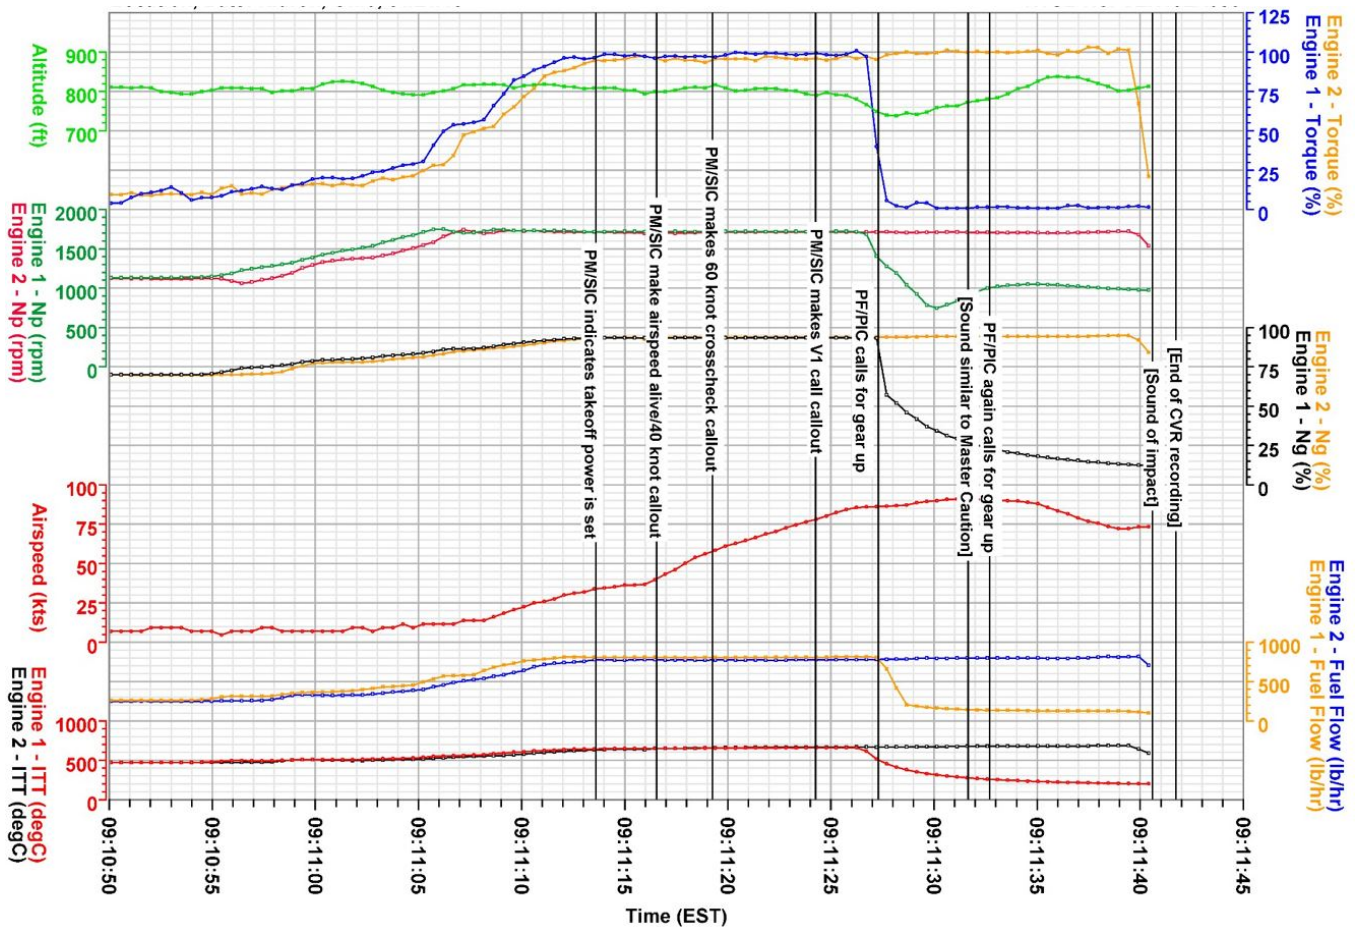
Figure 1 - Correlated ADAS Data and CVR Events

Downloaded automated data acquisition system (ADAS) data indicated left engine torque, fuel flow, gas generator speed (Ng), propeller rpm (Np) rapidly decreased at 0911:26.5. At 0911:27.2, left engine torque dropped to nearly zero and Ng decreased until the end of the recorded data.

Left engine Np dropped to 746 rpm at 0911:30, then increased to 1050 rpm about 4 seconds later. Airspeed reached a maximum of 91 knots at 09:11:31. By the end of recorded data at 0911:41, Np and airspeed had decreased to 971 rpm and 73 knots, respectively.

Correlated ADAS data and CVR events are shown in Figure 1.
