Aviation Investigation Final Report

Location:	Atlantic Ocean, Atlantic Ocean	Accident Number:	ERA19LA093
Date & Time:	February 1, 2019, 13:15 Local	Registration:	N3016L
Aircraft:	Piper PA32RT	Aircraft Damage:	Destroyed
Defining Event:	Inflight upset	Injuries:	2 Fatal
Flight Conducted Under:	Part 91: General aviation - Personal

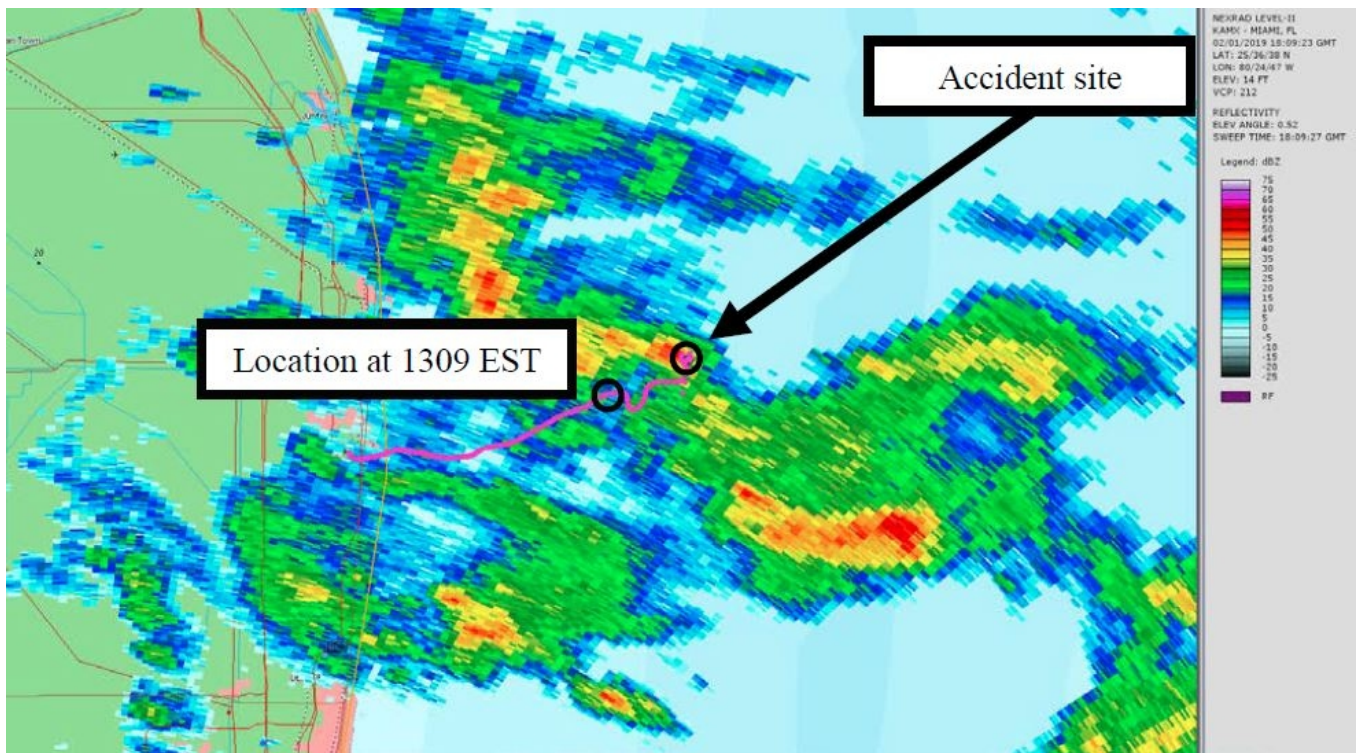
Radar data indicated that the airplane first entered precipitation between 1303 and 1309; reflectivity values between 30 and 50 dBZ, or moderate to heavy rain intensity echoes, were located above the accident site at the accident time (See figure 1). The reflectivity bands were moving from south to north.

Figure 1. KAMX WSR-88D 0.5° elevation scan initiated at 1309:27 with the accident site marked with a black circle, the accident flight track in pink
