Aviation Investigation Final Report

Location:	Canadian, Texas	Accident Number:	CEN19FA082
Date & Time:	February 15, 2019, 10:00 Local	Registration:	N421NS
Aircraft:	Cessna 421	Aircraft Damage:	Destroyed
Defining Event:	Loss of control in flight	Injuries:	2 Fatal
Flight Conducted Under:	Part 91: General aviation - Personal

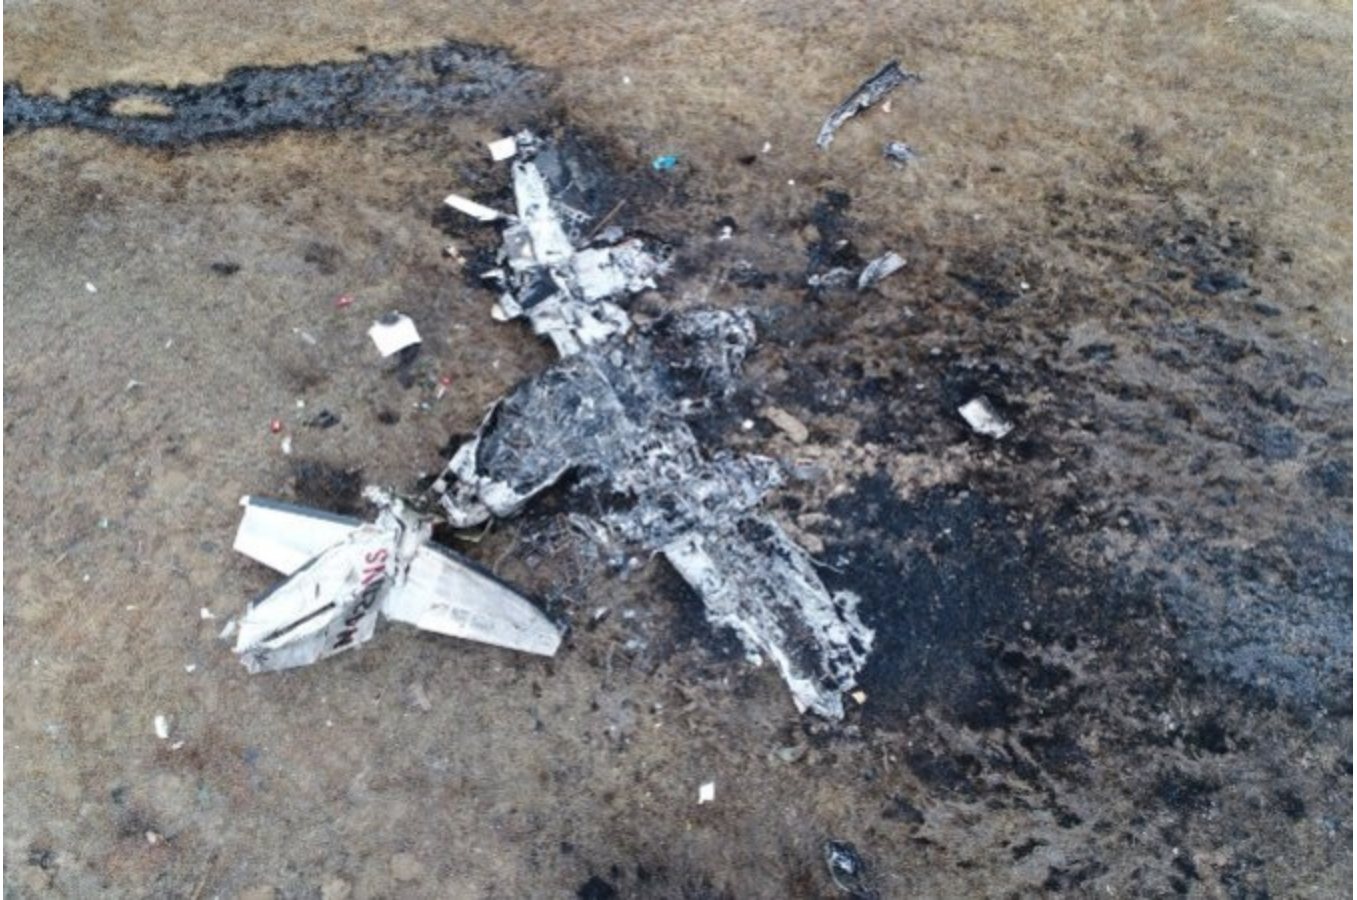
The airplane impacted terrain in a slightly nose-low and wings-level attitude with no evidence of forward movement, and a postimpact fire destroyed a majority of the wreckage. The damage to the airplane was consistent with a relatively flat spin to the left at the time of impact. A postaccident examination did not reveal any preimpact mechanical malfunctions or anomalies that would have precluded normal operation. A detailed examination of the cockpit instruments and other portions of the wreckage was not possible due to the fire damage.

The airplane impacted remote terrain and a post impact fire consumed a majority of the wreckage (see figure 1).

Figure 1 – Aerial image of the accident site. A majority of the airplane was consumed by fire.

A postaccident examination indicated the airplane impacted the ground in a slight nose-low and wings-level attitude and there was no evidence of forward momentum. All major airplane components were observed at the accident site. The empennage was displaced to the right. The flap setting was 15° extended. The cockpit and instrumentation were destroyed by fire and none of the components could be examined. The engines were found embedded in the mud and all propeller blades were accounted for. The engines and propellers exhibited signatures consistent with rotation at the time of impact. The examination did not reveal any preimpact mechanical malfunctions or anomalies that would have precluded normal operation.
