Aviation Investigation Final Report

Location:	Orlando, Florida	Incident Number:	ENG191A013
Date & Time:	February 21, 2019, 07:27 Local	Registration:	N30401
Aircraft:	Boeing 737	Aircraft Damage:	None
Defining Event:	Powerplant sys/comp malf/fail	Injuries:	181 None
Flight Conducted Under:	Part 121: Air carrier - Scheduled

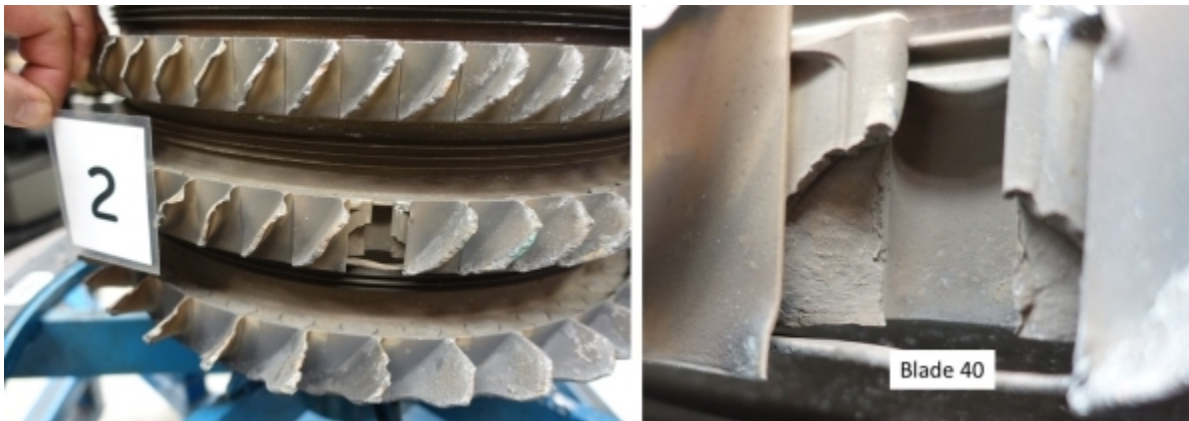
The No. 2 engine high pressure compressor (HPC) failure was caused by a stage 2 blade separation. A HPC stage 1 variable stator vane (VSV) trunnion stem, identified as VSV #33, was missing a washer and retaining nut that allowed VSV #33 to rotate independent of the other vanes in the stage. The out-of-schedule VSV created a 1 per revolution pulse on the HPC stage 2 rotor that eventually created fatigue cracks on the HPC stage 2 blade posts that secure the rotor blades in the disk spool. When one of the fatigue cracks transitioned to overload, a section of a blade post separated and allowed a blade to enter the gas path. Titanium fragments created by secondary impact damage as a result of the separated blade were caught between the rotating blade tips of the stage 1 blades and the steel HPC cases. The contact created a brief but intense titanium fire that melted the HPC case material around the HPC stage 1 rotor plane of rotation. The damage observed both immediately upstream of the separated HPC stage 2 blade and through all remaining stages aft was secondary impact damage.

During engine disassembly, eight HPC stage 2 rotor blades, including the blade dovetails, were found separated and missing. The HPC stage 2 disk blade slots for each of the eight missing blades had one or more separated disk post corners (**Photo 1**). There was secondary impact damage observed throughout the gas path aft of HPC inlet guide vanes. The HPT stage 1 blades and the LPT stage 1 nozzle vanes exhibited thermal damage. Metal flakes and debris were collected in the aft sump, adjacent to the No. 4 bearing.

Photo 1- HPC Stage 2 Separated Rotor Blade

The HPC stage 2 disk posts fracture morphology was consistent with a lower alternating stress, high cycle fatigue (HCF) and/or mixed-mode low cycle fatigue (LCF)/HCF mechanisms. The primary initiation occurred adjacent to the forward right corner of the disk posts. A metallographic examination through a crack origin on one of the HPC stage 2 disk posts did not identify any material anomalies or stress risers. The material microstructure was consistent with properly processed beta forged Ti-17 material as specified in the engineering drawing.

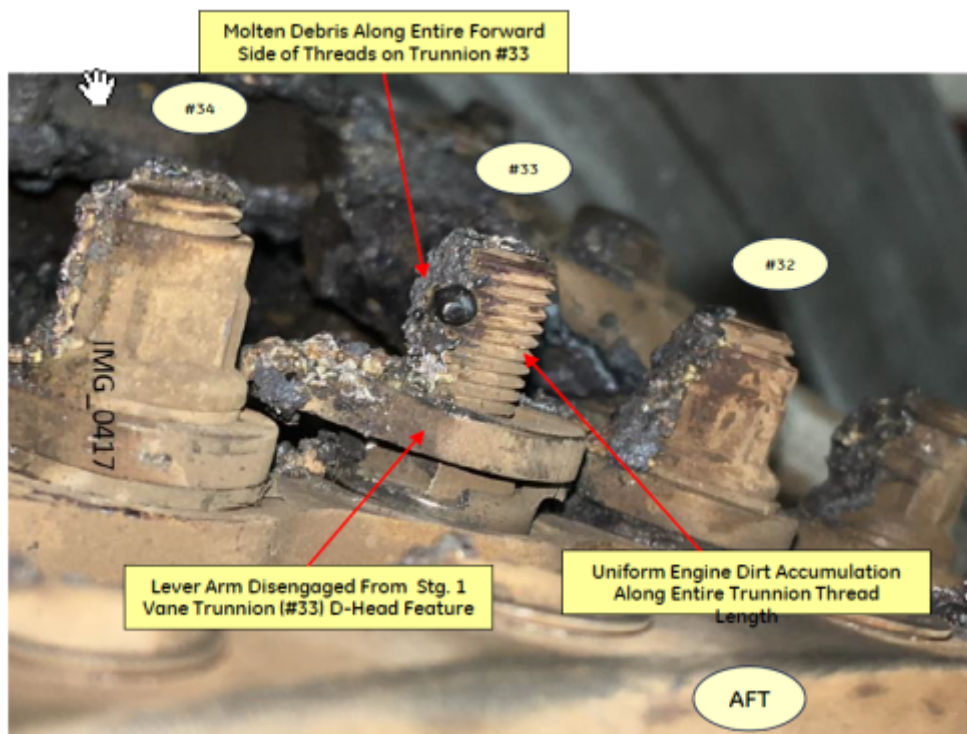
The GE Aviation Materials Laboratory performed a binocular analysis on the HPC VSV #33 trunnion stem and D-head and found wear patterns and witness marks that confirmed that a washer and retaining nut were present at some point. According to engine maintenance records, the last time the HPC VSVs were removed was during an engine overhaul at the GE Aviation- Celma maintenance, repair, and overhaul (MRO) facility, Petrópolis, Brazil in July 2014. When the HPC was assembled during the engine overhaul, the VSV #33 washer and retaining nut were likely either omitted or improperly torqued, which may have allowed the retention nut to back off during engine operation.

A visual examination of the HPC stator cases was performed after removal of the external engine components, and in addition to the case burn through, one HPC stage 1 variable stator vane (VSV) trunnion stem was missing a washer and retaining nut at the 1:30 position. The VSV alignment mark, located on the top of the trunnion stem was positioned (clocked) at a different angle relative to the rest of the vanes in the stage.

A visual and binocular examination of the HPC stage 1 VSV (identified as VSV #33) trunnion stem confirmed that the missing washer and retaining nut identified during the engine teardown resulted in disengagement of the lever arm from the trunnion D-head allowing the vane to go off-schedule approximately 31 degrees relative to the other HPC stage 1 VSVs. The HPC VSV #33 trunnion stem had a uniform coating of dirt/debris along the full length of the stem consistent with engine operation over an extended period of time without the washer and retaining nut. The laboratory analysis also identified witness marks on HPC VSV #33 indicating that a washer and retaining nut were present at some point, but it could not be determined when the parts were removed or separated (**Photo 2**).

Photo 2- HPC Stage 1 Variable Stator Vane Trunnion #33 (Photo Courtesy of GE Aviation)

Following the incident event, the GE Aviation-Celma CFM56 maintenance, repair and overhaul (MRO) facility incorporated additional control measures to avoid improper VSV lever arm installation. The revised installation procedure requires a trunnion nut torque verification check by a second technician using a torque wrench. The primary mechanic is then instructed to complete a trunnion nut seating check using a 0.001 inch feeler gauge to prevent false torque indications. The feeler gauge check ensures there is no gap between the nut and the lever arm surface.

The GE Aviation-Strother, Kansas CFM56 MRO facility also revised their VSV lever arm installation instructions to add a mechanic stamp requirement during engine build to confirm proper thread protrusion on each VSV trunnion.
