Aviation Investigation Final Report

Location:	Laramie, Wyoming	Accident Number:	WPR19LA088
Date & Time:	February 10, 2019, 16:00 Local	Registration:	N549CJ
Aircraft:	Lancair IV	Aircraft Damage:	Substantial
Defining Event:	Aircraft structural failure	Injuries:	2 None
Flight Conducted Under:	Part 91: General aviation - Personal

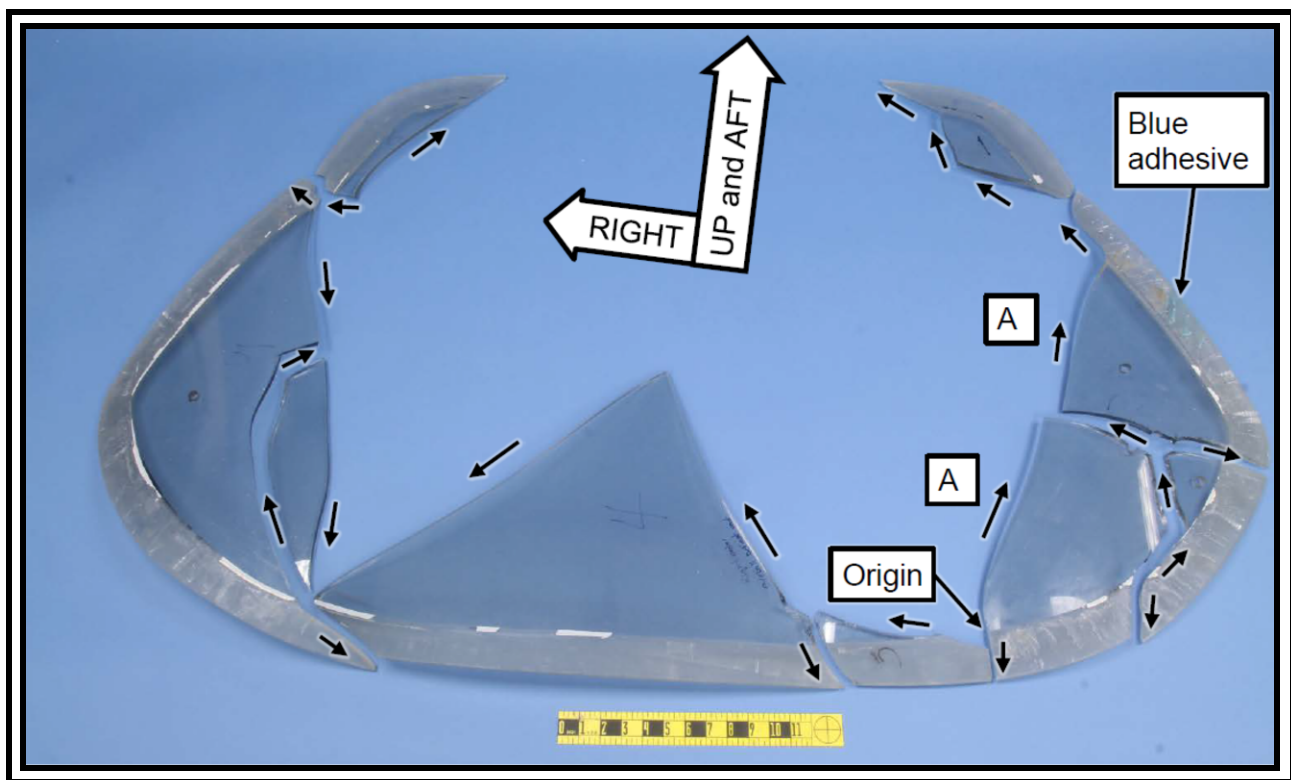
Figure 1: Overall view of the submitted windshield pieces. Unlabeled arrows indicate fracture propagation directions.

Most of the windshield fractures exhibited fracture planes that varied across the thickness with curving hackles turning toward the interior or exterior surface, features consistent with fracture under a combination of tension and bending loads. One fracture (shown as “A”) displayed smooth, mirror-like fracture features along most of the fracture surface in a flat plane perpendicular to the interior and exterior surfaces consistent with fracture under primarily tension loads. A portion of that fracture surface had curving rib marks and with a somewhat hazy surface, consistent with preexisting progressive crack growth. The features were consistent with the crack’s origin positioned at the forward left side of the windshield above the edge of the frame. The surface adjacent to the fracture appeared disturbed consistent with a surface scratch.

The origin area fracture displayed features consistent with a preexisting crack that developed due to environmental stress cracking (ESC). ESC is a fracture mechanism in polymer materials that occurs when a susceptible polymer material is exposed to a combination of tensile stress and exposure to a substance that degrades the integrity of the material. At high magnification, the crack surface had fracture features that were significantly different than features observed in laboratory-created impact fracture surfaces.

The examination further revealed liquid oozing from secondary cracks. The liquid was identified as a plasticizer, a chemical that could cause ESC in acrylic. The source of the plasticizer was unknown, but potential sources include flexible polymers such as vinyl tape potentially used in the construction of the windshield or possible contact with a vinyl material if that material had been used in the airplane
