Aviation Investigation Final Report

Location:	Laramie, Wyoming	Accident Number:	WPR19LA088
Date & Time:	February 10, 2019, 16:00 Local	Registration:	N549CJ
Aircraft:	Lancair IV	Aircraft Damage:	Substantial
Defining Event:	Aircraft structural failure	Injuries:	2 None
Flight Conducted Under:	Part 91: General aviation - Personal

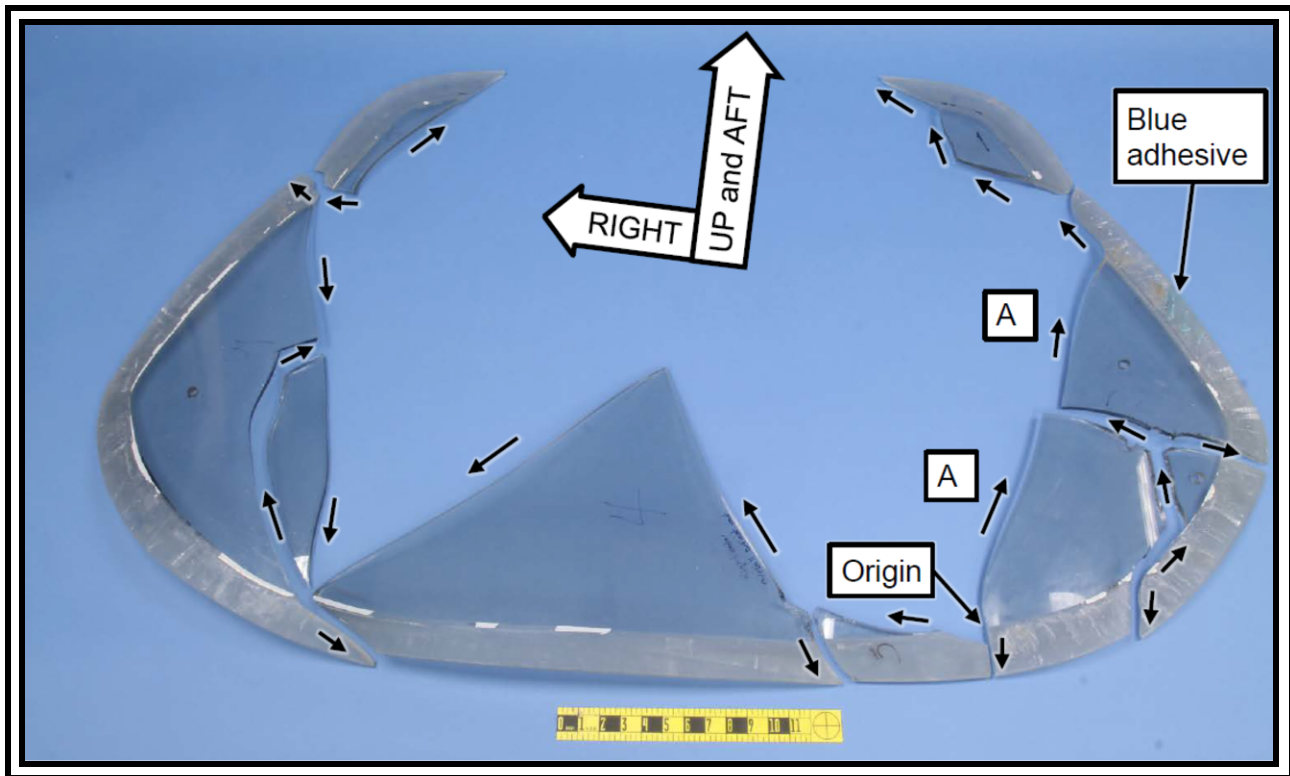
Recovered portions of the windshield pieces were sent to the National Transportation Safety Board (NTSB) for examination. (see Figure 1.) The outer edge of the windshield displayed a white appearance consistent with a roughening process used during the windshield installation process before bonding to the windshield frame.

Figure 1: Overall view of the submitted windshield pieces. Unlabeled arrows indicate fracture propagation directions.

Most of the windshield fractures exhibited fracture planes that varied across the thickness with curving hackles turning toward the interior or exterior surface, features consistent with fracture under a combination of tension and bending loads. One fracture (shown as “A”) displayed smooth, mirror-like fracture features along most of the fracture surface in a flat plane perpendicular to the interior and exterior surfaces consistent with fracture under primarily tension loads. A portion of that fracture surface had curving rib marks and with a somewhat hazy surface, consistent with preexisting progressive crack growth. The features were consistent with the crack’s origin positioned at the forward left side of the windshield above the edge of the frame. The surface adjacent to the fracture appeared disturbed consistent with a surface scratch.

The origin area fracture displayed features consistent with a preexisting crack that developed due to environmental stress cracking (ESC). ESC is a fracture mechanism in polymer materials that occurs when a susceptible polymer material is exposed to a combination of tensile stress and exposure to a substance that degrades the integrity of the material. At high magnification, the crack surface had fracture features that were significantly different than features observed in laboratory-created impact fracture surfaces.

The examination further revealed liquid oozing from secondary cracks. The liquid was identified as a plasticizer, a chemical that could cause ESC in acrylic. The source of the plasticizer was unknown, but potential sources include flexible polymers such as vinyl tape potentially used in the construction of the windshield or possible contact with a vinyl material if that material had been used in the airplane
