Aviation Investigation Final Report

Location:	Presque Isle, Maine	Accident Number:	DCA19FA089
Date & Time:	March 4, 2019, 11:29 Local	Registration:	N14171
Aircraft:	Embraer EMB145	Aircraft Damage:	Substantial
Defining Event:	Wrong surface or wrong airport	Injuries:	3 Minor, 28 None
Flight Conducted Under:	Part 121: Air carrier - Scheduled

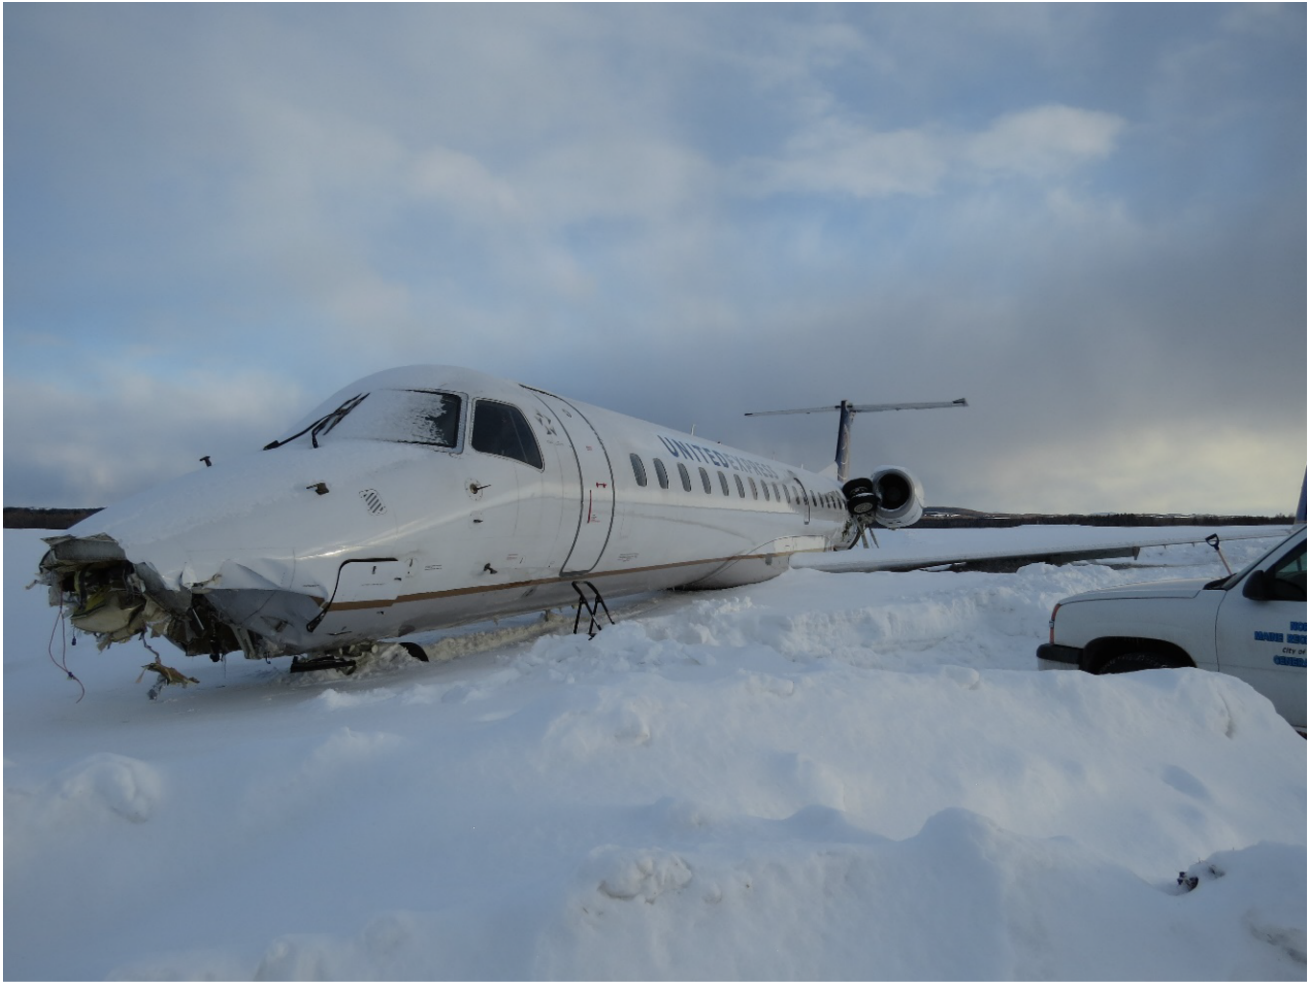
Emergency personnel took the first officer off the airplane, and the flight attendant then directed the passengers to exit the airplane via a ladder that firefighters had brought to the airplane. After the passengers had exited, the flight attendant checked to make sure that no one was left behind, and the captain and the flight attendant then exited the airplane. A bus transported the captain, flight attendant, and passengers to the terminal.

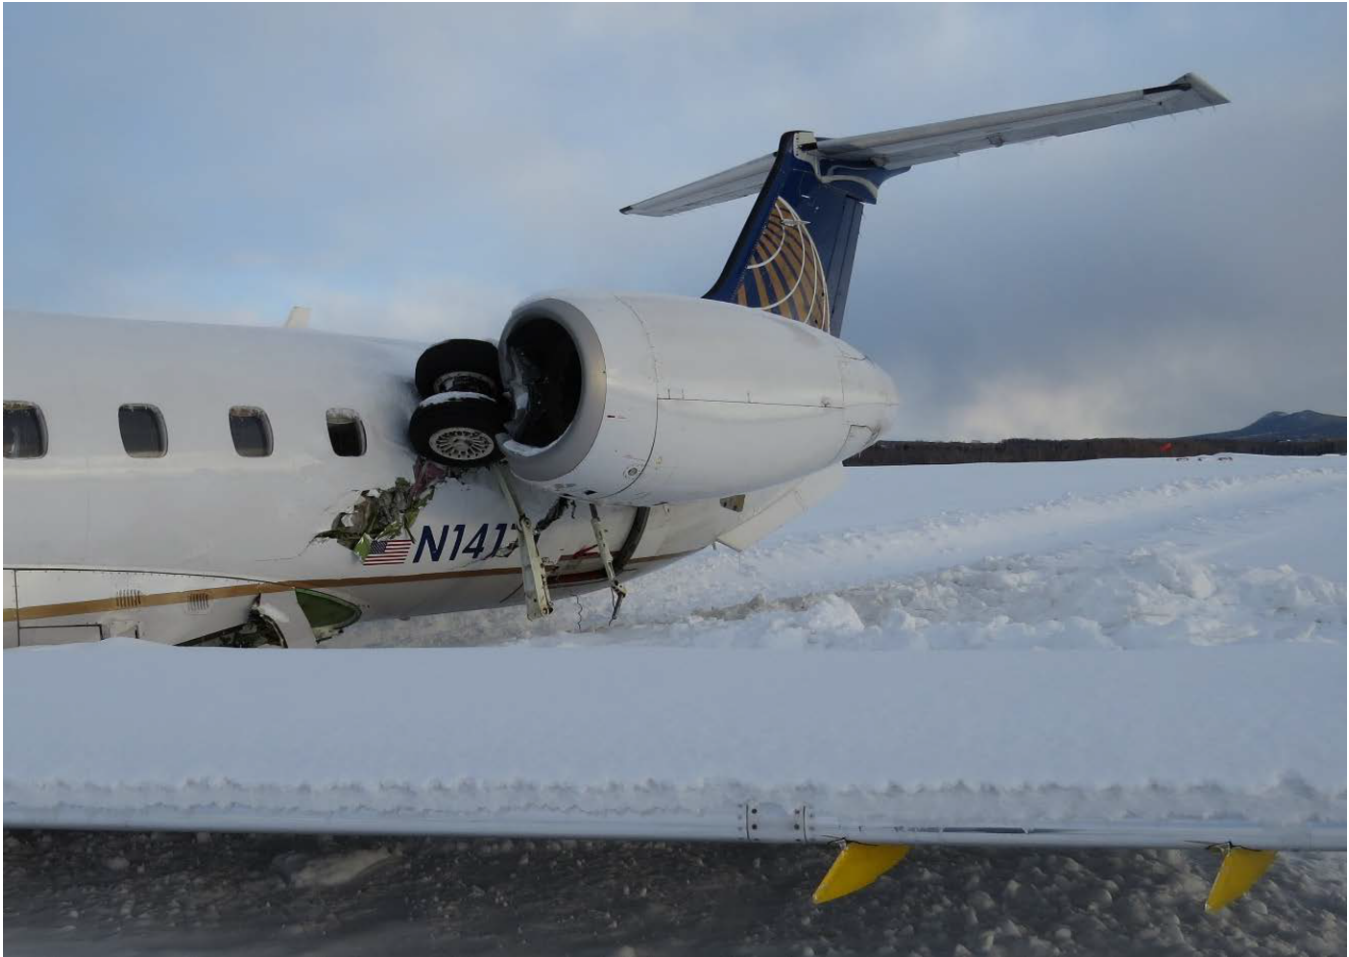
The left main gear was lodged between the left engine nacelle and fuselage. The fuselage structure in the area of the gear was ripped and damaged, and the fuselage around the gear wheels was distorted. The landing gear trunnion had penetrated the left engine gear box.

Figure 2: Left main landing gear lodged between left engine nacelle and the aircraft fuselage
