# Aviation Investigation Final Report

<b>Location:</b>	Forks, Washington	<b>Accident Number:</b>	WPR19FA091
<b>Date &amp; Time:</b>	March 8, 2019, 07:05 Local	<b>Registration:</b>	N64RA
<b>Aircraft:</b>	Bell UH1B	<b>Aircraft Damage:</b>	Destroyed
<b>Defining Event:</b>	Loss of engine power (total)	<b>Injuries:</b>	1 Fatal
<b>Flight Conducted Under:</b>	Part 133: Rotorcraft ext. load

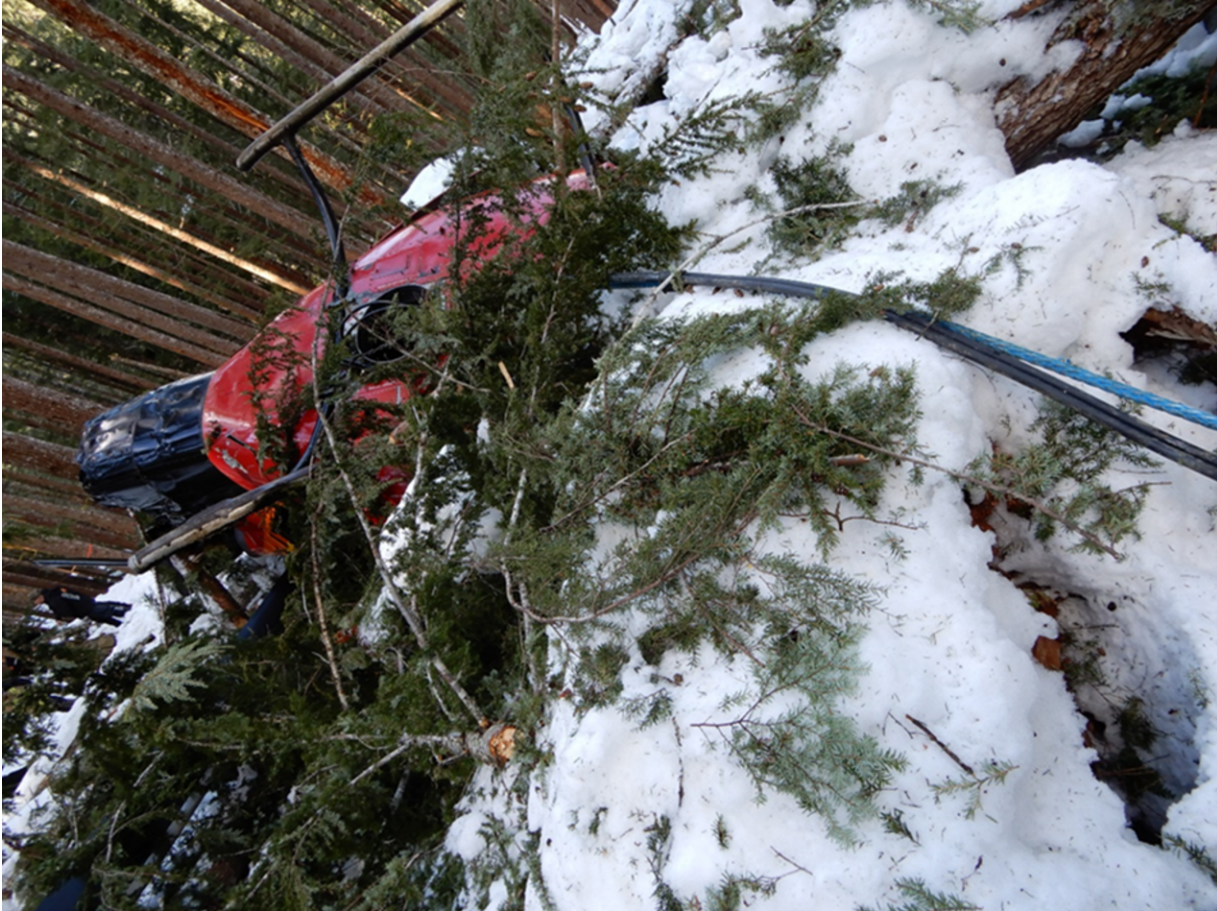
On the day of the accident, a helicopter mechanic located at the staging area assisted the pilot in the preflight inspection of the helicopter in preparation for a day of heli-logging activity. The mechanic stated that he observed a normal engine start, run-up and takeoff. The mechanic continued with his morning activities, and while walking into the maintenance support trailer, he heard three distress calls from the pilot over the company radio. Several coworkers heard the same distress calls on their radios, and they all began a search of emergency landing areas around the staging area. After finding the emergency landing areas empty, one employee hiked to the logging site and found the wreckage. (See figure 1.)

Figure 1. The helicopter at the accident site. A blue cargo line and two black hydraulic hoses can be seen running uphill to the grapple hook.

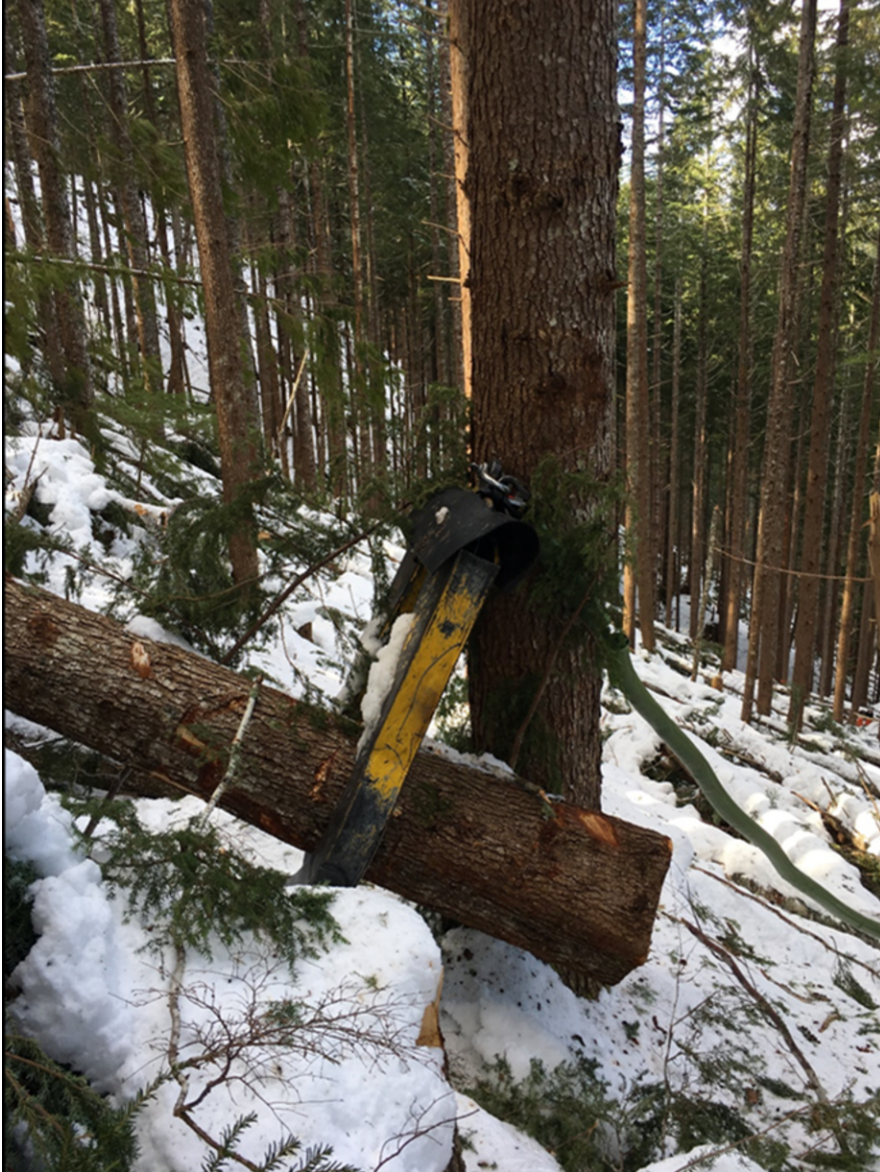
The helicopter came to rest on steep, mountainous terrain about 1/4 mile from the company's staging area. The area was covered with felled and standing trees. All major structural components of the helicopter were located within a very small debris field around the helicopter. There was no post-crash fire. A cargo line remained attached to the cargo hook and extended uphill 180 feet to a hydraulic grapple hook. Two hydraulic fluid hoses extended from the belly of the helicopter and followed the cargo line uphill and were attached to the grapple. The grapple was resting against a standing tree and held a log in its jaws. (See figure 2.) Visual examination of the area around the grappled log revealed the grappled log rested perpendicular to the cargo line running downhill to the helicopter, and a portion of the grapple had caught the standing tree consistent with establishing an anchor point.

Figure 2. The grapple hook, attached to a log, and leaning against a standing tree. The cargo line and two hydraulic lines are contained in a green protective sheath and run downhill to the helicopter.

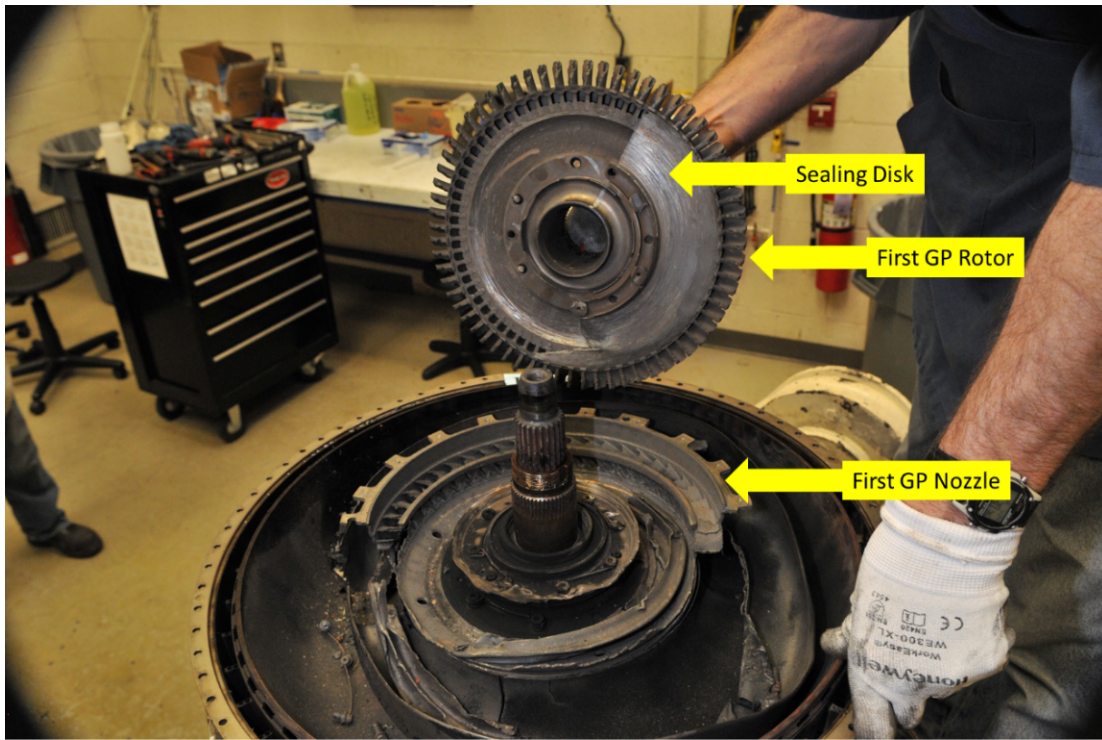
The engine was examined at Honeywell Aerospace on April 24, 2019; the following findings were noted. The first stage sealing disk mounted in front of the first stage gas producer turbine wheel had fragmented into three pieces and separated. Cracks were observed at all six cooling holes on the sealing disk. Damage was found on the four turbine wheels and other components downstream from the sealing disk. Magnified examination of the fracture surfaces on the sealing disk revealed multiple arc-shaped "beach mark" striations.

Figure 3. Engine showing first stage gas producer (GP) turbine rotor with sealing disk fragment attached.

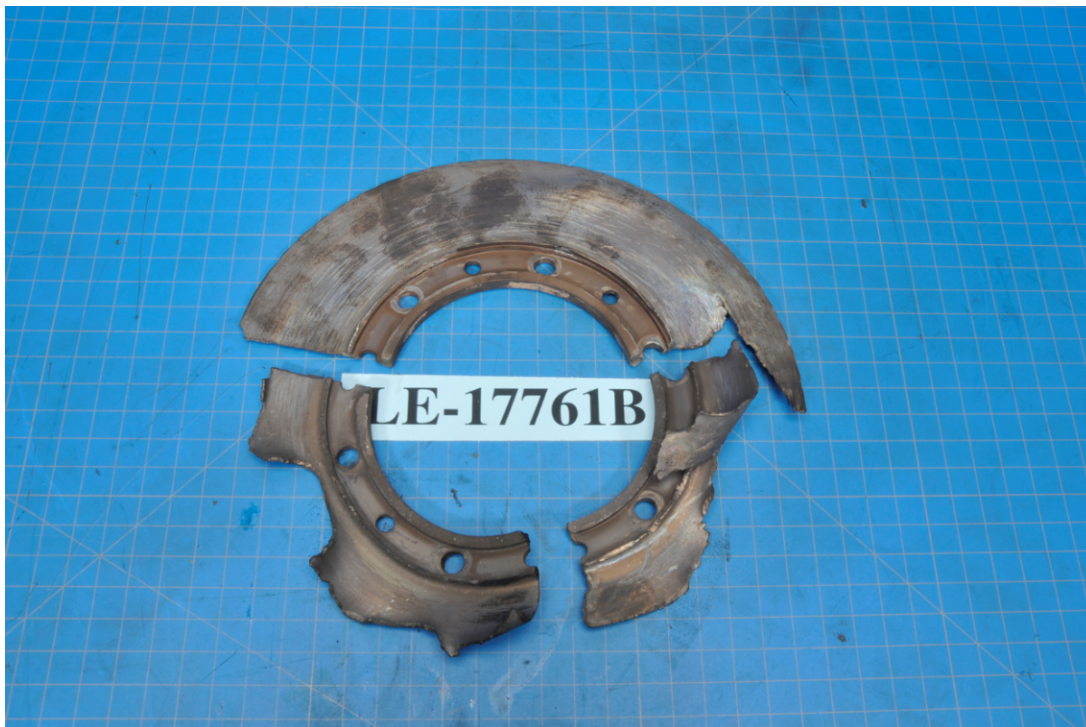
Figure 4. First Stage Sealing Disk. Photo courtesy of Honeywell Aerospace.

The sealing disk was further examined by Honeywell Aerospace. Microscopic examination revealed that the sealing disk separated in low-cycle fatigue. Both major and minor cycles were present on the fracture surface of the disk.

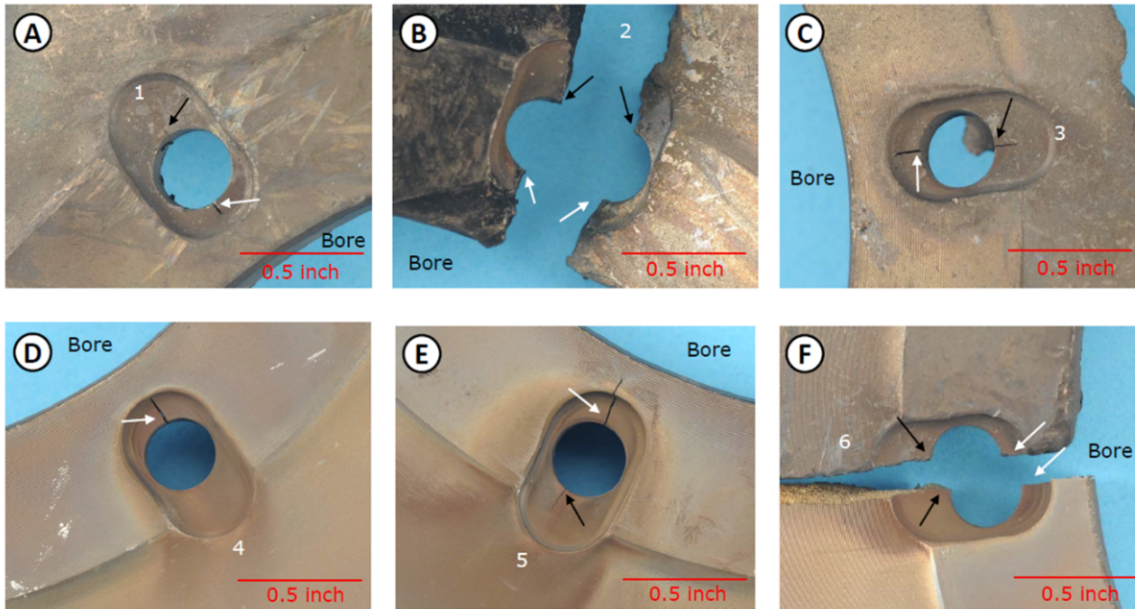
Figure 5. First stage sealing disk showing the six cooling holes, each with cracks formed. Photo courtesy of Honeywell Aerospace.

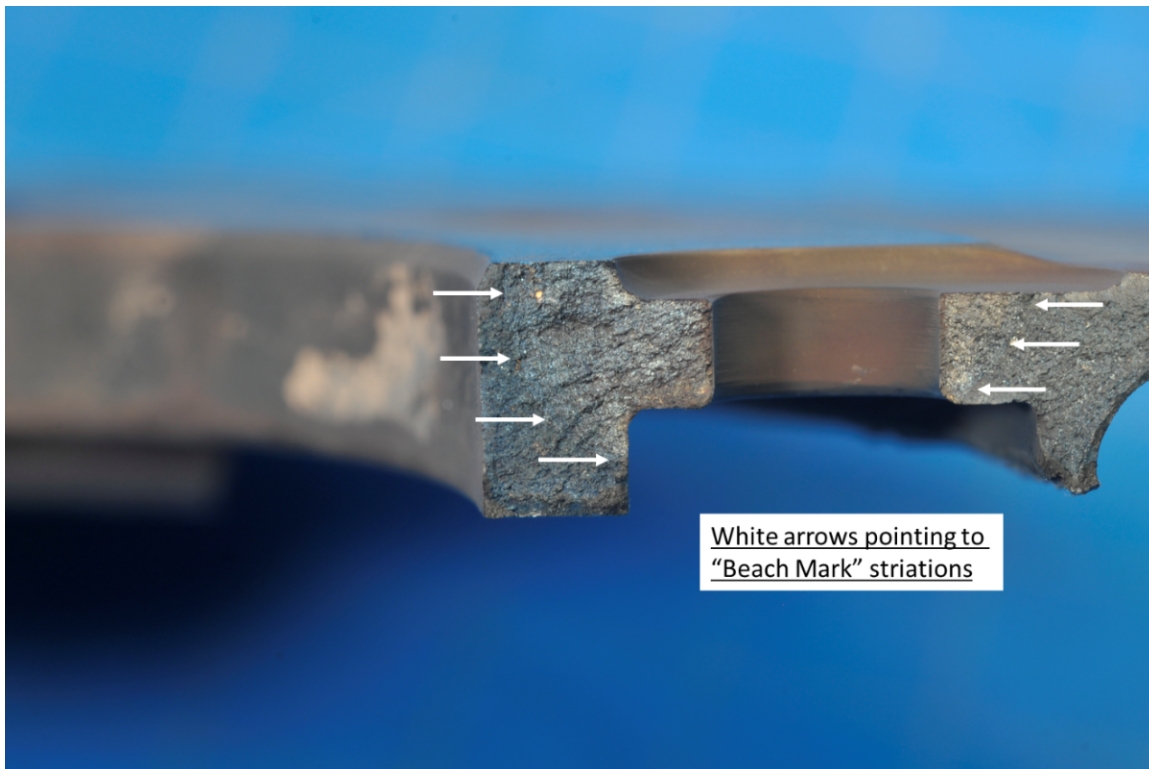
Figure 6. First Stage sealing disk, side view, showing beach mark striations. Photo courtesy of Honeywell Aerospace.
