Aviation Investigation Final Report

Location:	Compton, California	Accident Number:	WPR19FA095
Date & Time:	March 13, 2019, 18:50 Local	Registration:	N5440F (A1); N48962 (A2)
Aircraft:	North American T28 (A1); Cessna 152 (A2)	Aircraft Damage:	Minor (A1); Destroyed (A2)
Defining Event:	Runway incursion veh/AC/person	Injuries:	1 None (A1); 1 Fatal, 1 Serious (A2)
Flight Conducted Under:	Part 91: General aviation - Personal (A1); Part 91: General aviation - Instructional (A2)

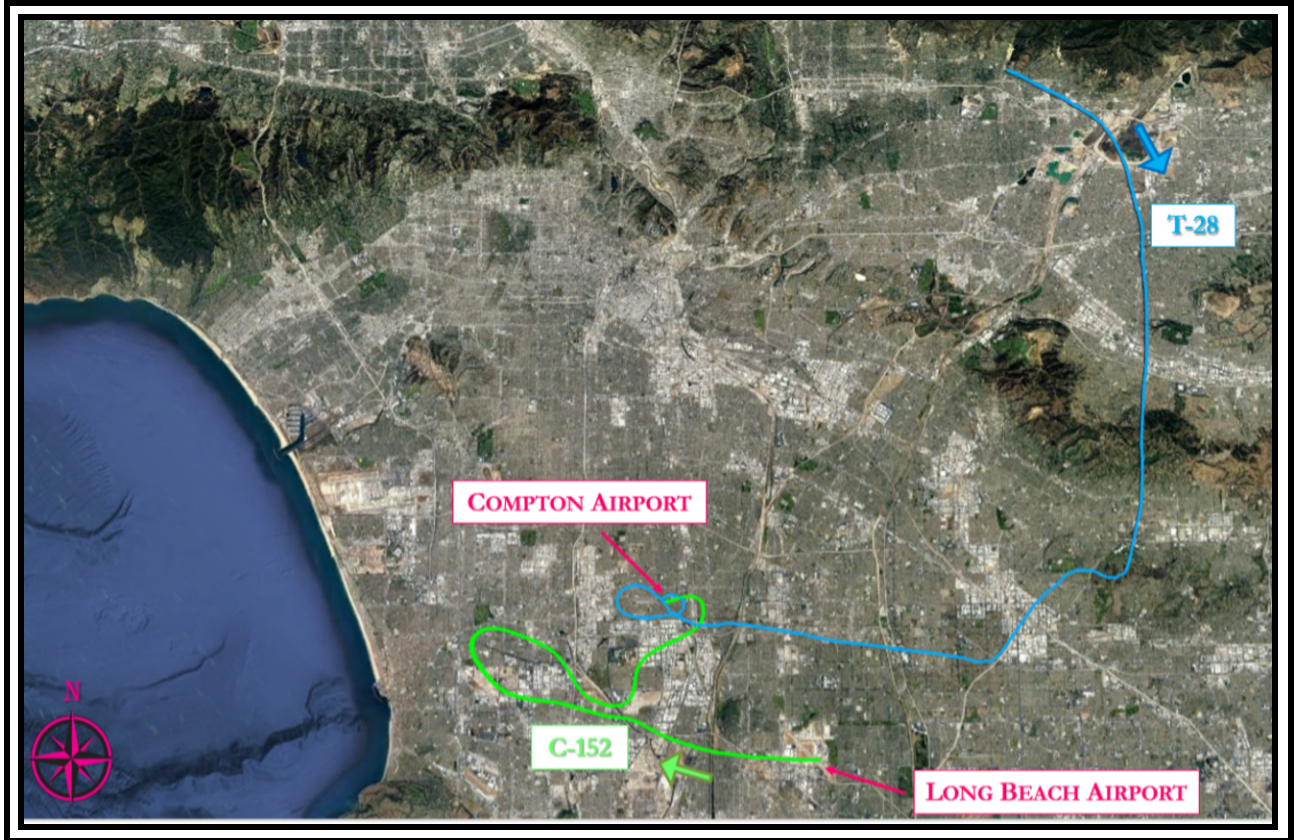
Figure 1. Recorded radar data of both airplanes

Review of radar data revealed two discrete secondary beacon code targets that were correlated to the two airplanes as they approached Compton/Woodley Airport (CPM); the Cessna from the south-southwest and the T-28 from the north/east. (See figure 1.) The instructor onboard the Cessna stated that he and the student were simulating a diversion to CPM. He was seriously injured during the accident and could not recall the details of the flight but stated that the student would have made all radio calls over the airport's common radio frequency. Radar indicated that the Cessna entered the airport traffic pattern on the downwind leg at an altitude about 950 ft above ground level (agl), then proceeded to fly the base and final legs of the traffic pattern for runway 25 left (25L).

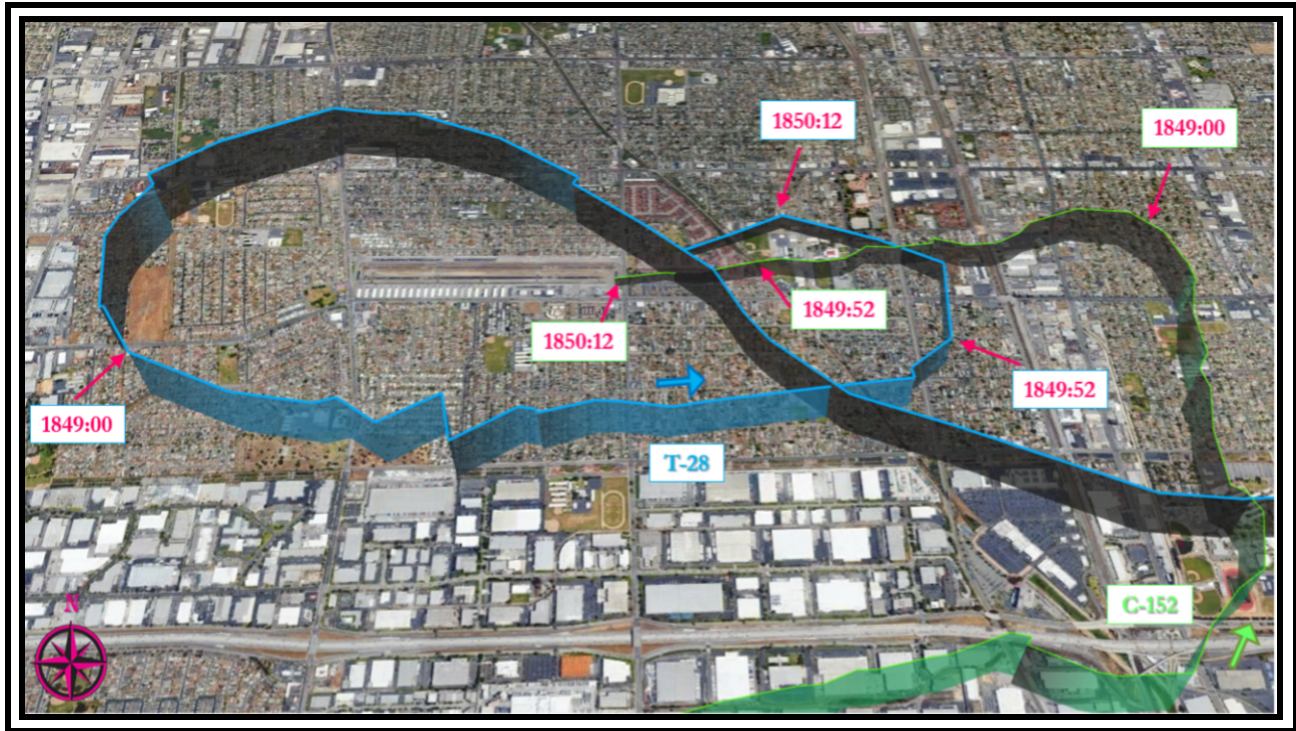
Figure 2. Radar data

Radar data indicated that the T-28 approached CPM from the east, overflew the airport about 700 to 750 ft agl, then entered the left downwind leg of the traffic pattern for runway 25L. (See figure 2.)

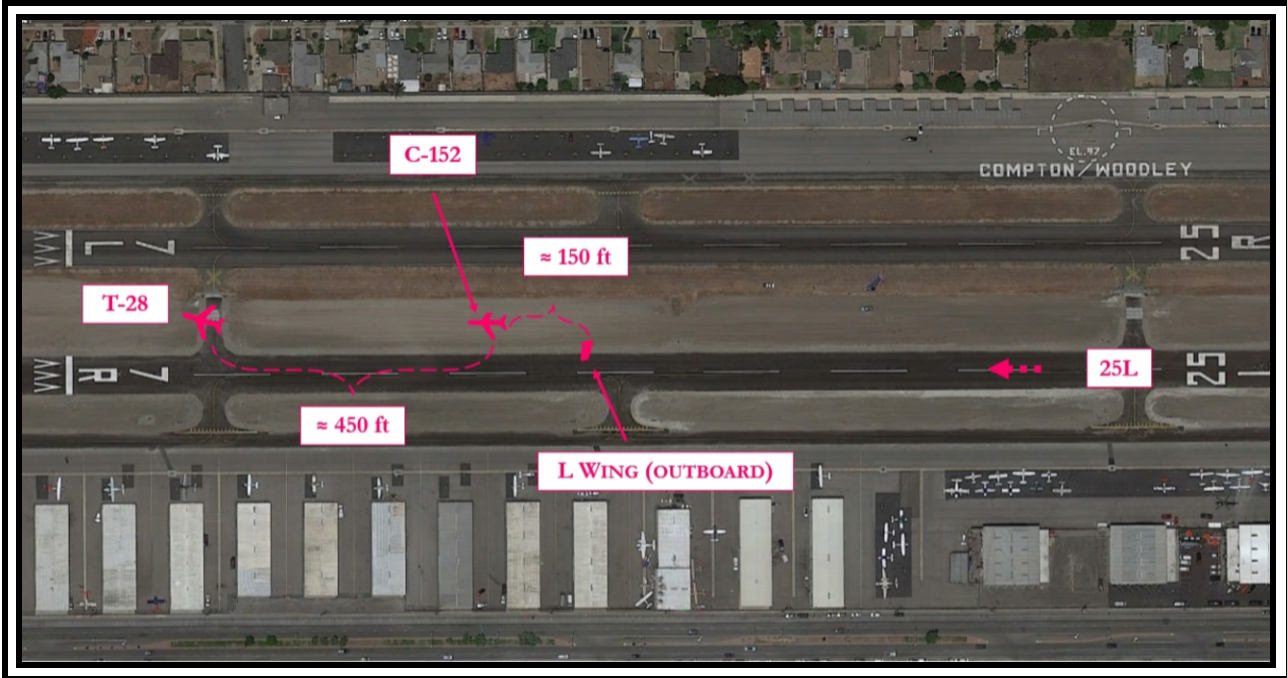
Figure 3. Compton Airport accident diagram

The T-28 pilot stated that as he turned from the base to final legs, the bright sun and the haze created a glare on the windscreen that obscured his forward vision, making it difficult for him to see directly ahead. As he descended toward the runway, the glare became worse and he realized he was between runways 25L and 25R. He side-stepped to runway 25L and the airplane touched down on the runway surface. Several seconds later, the pilot saw the Cessna on the runway ahead of him. He applied hard braking and felt the impact with the other plane and resulting explosion immediately thereafter. The T-28 continued about 1,000 ft before coming to rest off the right side of runway 25L. (See figure 3.)

The Cessna came to rest on the north side of runway 25L, about 150 ft west of the left outboard wing. The T-28 was 450 ft further west of the Cessna. The marks on runway revealed no indications of braking by the T-28 before the collision.

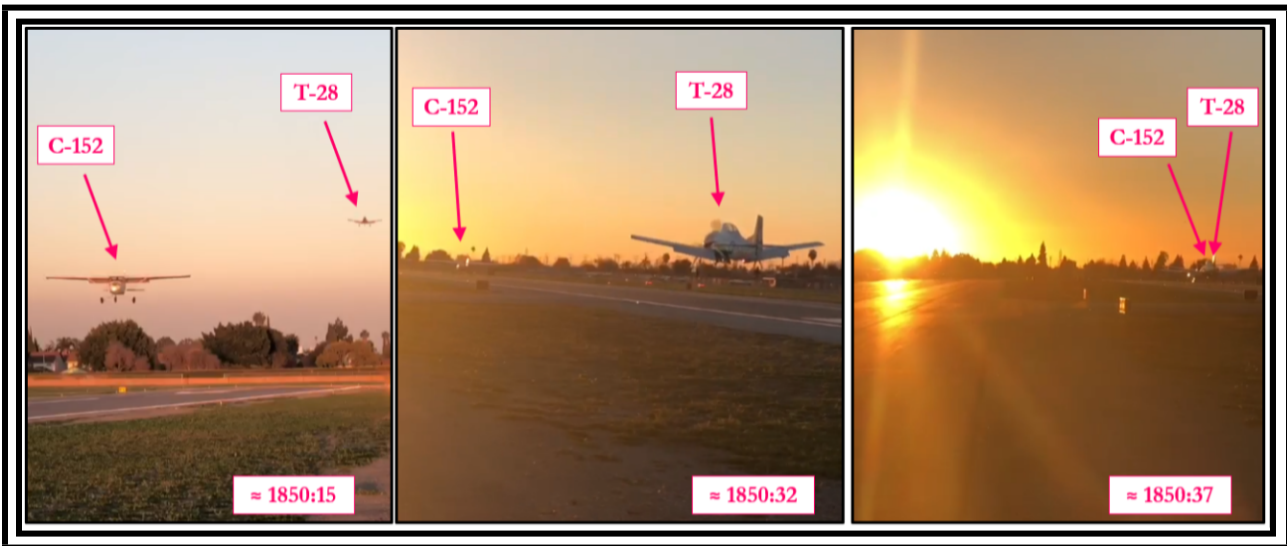
Figure 4. Video frames of the airplanes before impact

Multiple video recordings captured the accident (see figure 4); review of the footage revealed that the Cessna touched down on runway 25L and continued its landing roll. The T-28 crossed the runway threshold about 10 seconds after the Cessna and subsequently touched down about 1850:36. On the landing roll, adjacent to the runway halfway point sign, the T-28 impacted the Cessna.

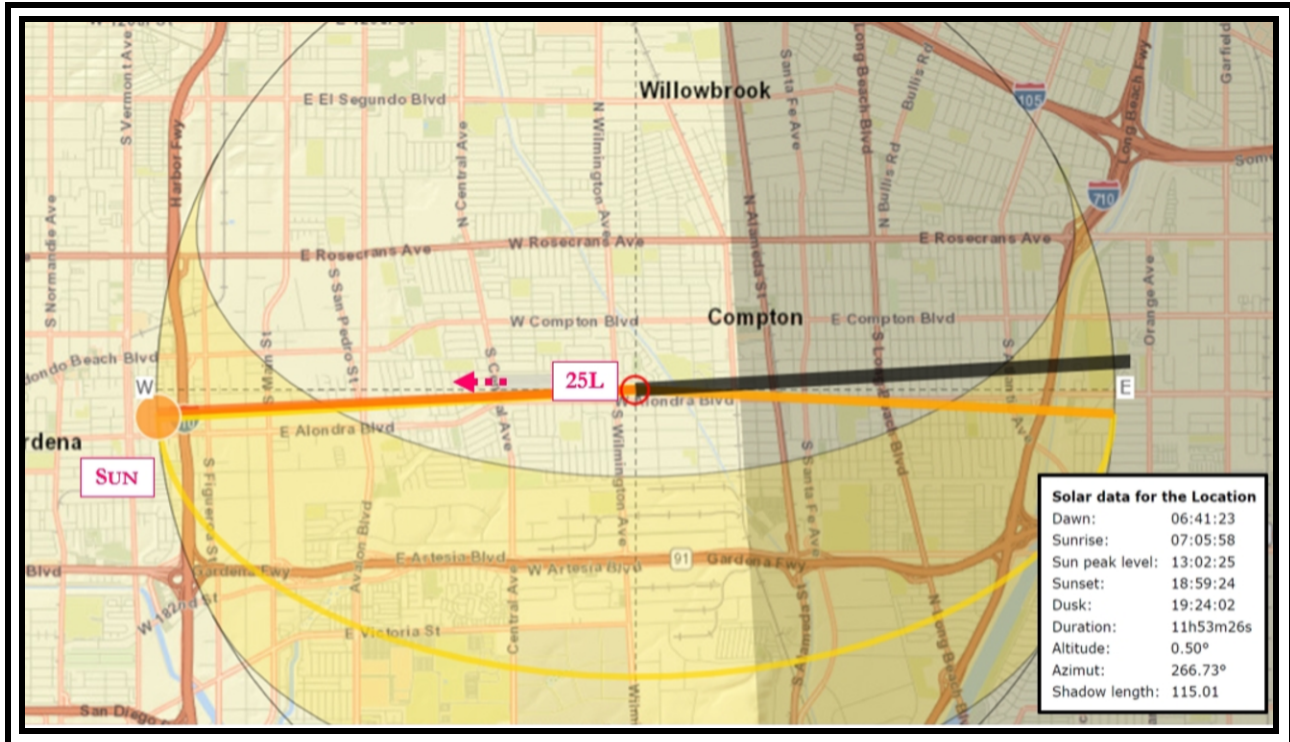
Figure 5. Sun information

The time of sunset was 1859:24. The sun's azimuth at the time of the accident was 267° (see figure 5) and the elevation was slightly above the horizon at 0.50°.
