Aviation Investigation Final Report

Location:	Reno, Nevada	Accident Number:	WPR19LA098
Date & Time:	March 17, 2019, 08:10 Local	Registration:	N5028P
Aircraft:	Piper PA 24	Aircraft Damage:	Substantial
Defining Event:	Loss of control on ground	Injuries:	3 None
Flight Conducted Under:	Part 91: General aviation - Personal

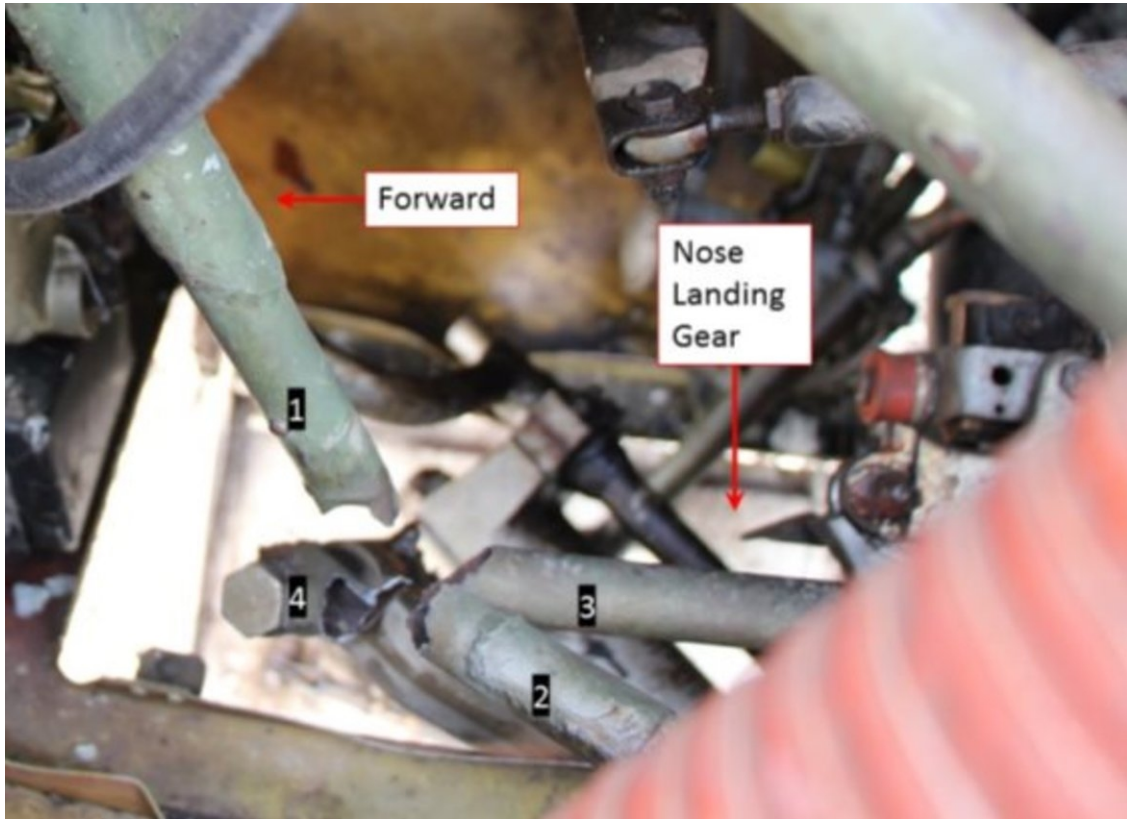
Figure 1: Nose Landing Gear Engine Mount Tubes and Trunnion

The engine mount connected both the nose landing gear and engine to the firewall, and the nose landing gear was connected to the engine mount through the oleo strut housing. Most of the nose landing gear assembly was intact with the exception of the left engine mount tubes, which were fractured. The tubes

are represented in Figure 1 as 1, 2, 3, and 4 (the trunnion). According to a representative of the airplane manufacturer, this engine mount supported the nose landing gear.

A visual inspection of the nose landing gear assembly showed that the nose bell crank and nosewheel steering rods were intact. Additionally, the shimmy dampener displayed a slight bend, but still provided resistance when actuated by hand.

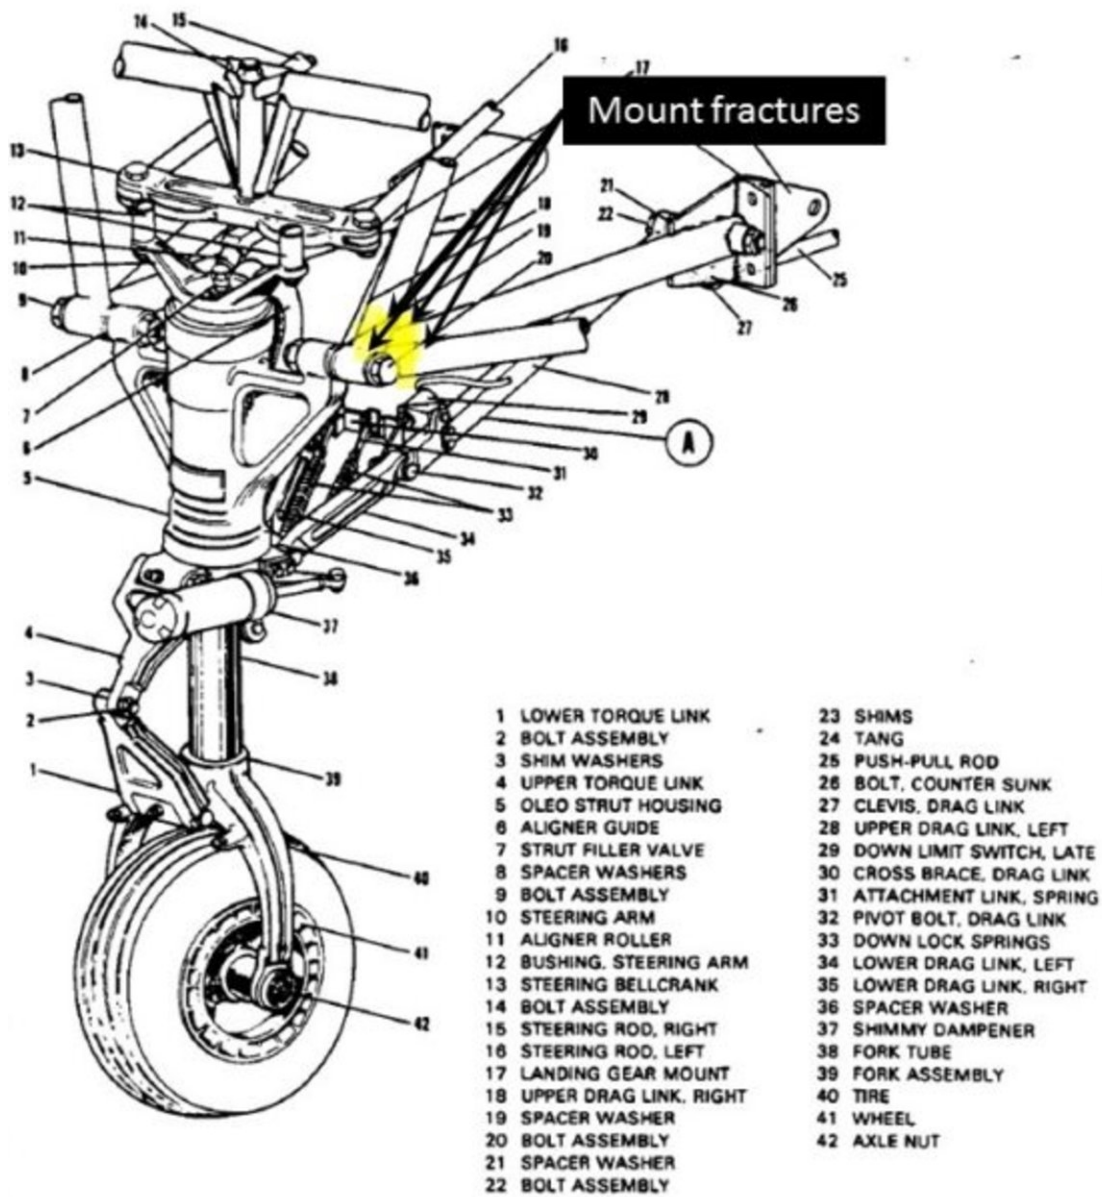
Figure 2: Location of Mount Fractures on NLG Assembly

Failure of the engine mount due to internal corrosion and wall thinning, which resulted in a loss of directional control and nose gear collapse during landing.

Portions of the engine mount were submitted to the NTSB Materials Laboratory for analysis. Each engine mount fracture surface was non-planar and rough, consistent with overstress. Moderate to heavy corrosion products were observed on the inner surfaces of each tube and several tubes displayed evidence of wall thinning from the internal corrosion. The exact order that the tubes failed could not be determined.
