# Aviation Investigation Final Report

<b>Location:</b>	New York, New York	<b>Accident Number:</b>	DCA19LA134
<b>Date &amp; Time:</b>	April 10, 2019, 20:40 Local	<b>Registration:</b>	N114NN
<b>Aircraft:</b>	Airbus A321	<b>Aircraft Damage:</b>	Substantial
<b>Defining Event:</b>	Abnormal runway contact	<b>Injuries:</b>	110 None
<b>Flight Conducted Under:</b>	Part 121: Air carrier - Scheduled

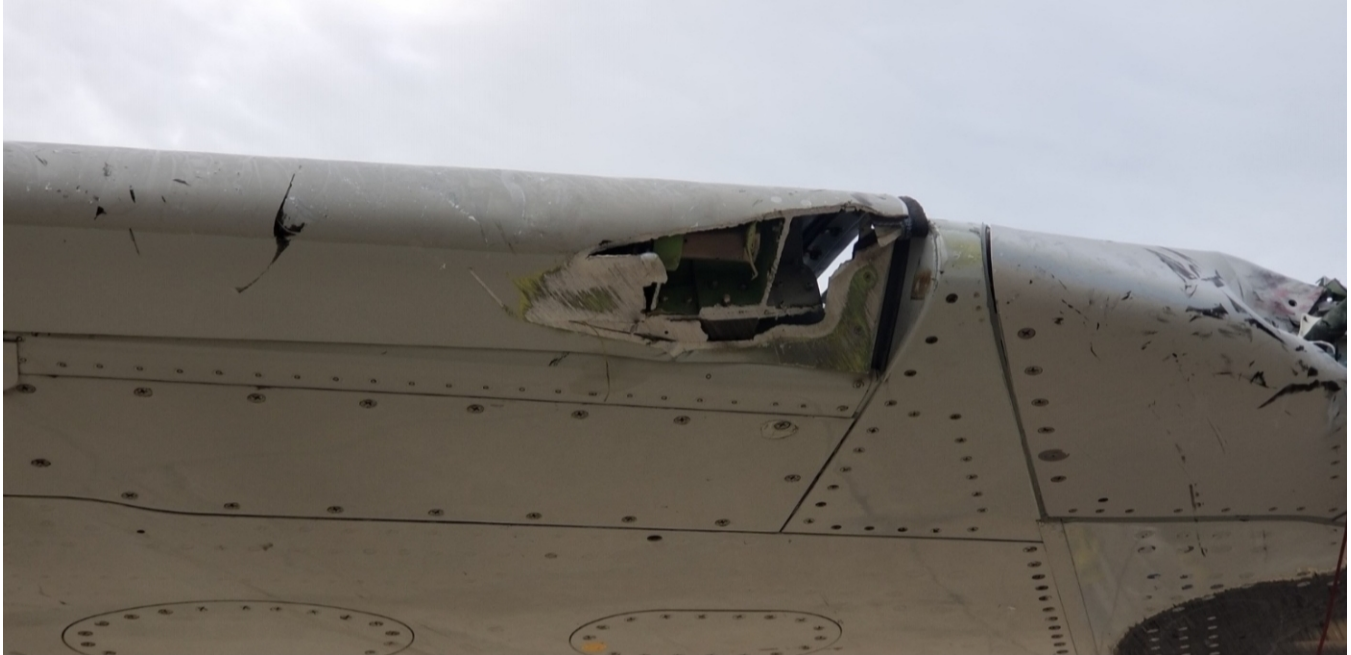
American Airlines' examination of the airplane revealed that a portion of the marker support structure was lodged in the left wingtip (see figure 1). The left wing outboard slat, left aileron, left outboard flap, and underside of the left wingtip sharklet were damaged (see figure 2).

**Figure 2.** Scrape damage to underside of left wing slat (Source: American Airlines).
