Aviation Investigation Final Report

Location:	New York, New York	Accident Number:	DCA19LA134
Date & Time:	April 10, 2019, 20:40 Local	Registration:	N114NN
Aircraft:	Airbus A321	Aircraft Damage:	Substantial
Defining Event:	Abnormal runway contact	Injuries:	110 None
Flight Conducted Under:	Part 121: Air carrier - Scheduled

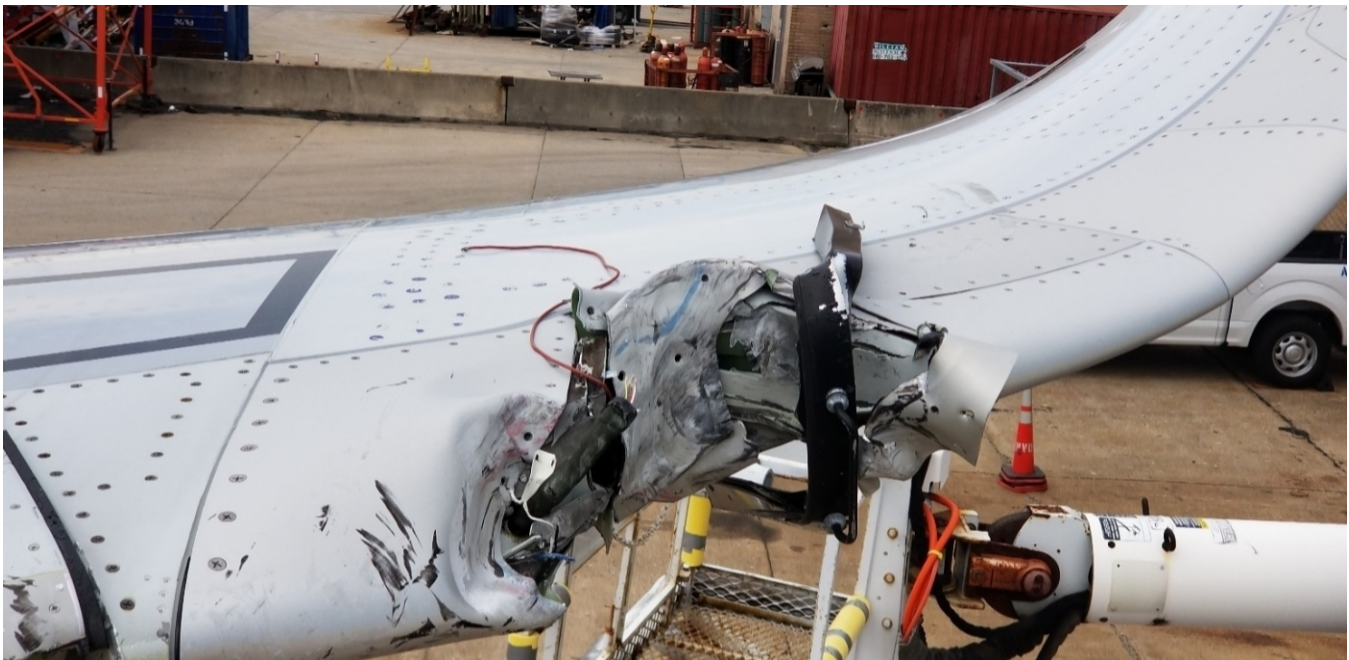
The large left roll angle immediately after liftoff resulted in the left wingtip striking the ground and a runway distance marker, part of which remained imbedded in the wingtip. Airbus engineering simulations performed as part of this investigation demonstrated that the several seconds of near-maximum left rudder generated a rolling moment after the gear had left the ground to impart the left roll rate that the DFDR recorded. No airplane flight control abnormalities were noted, except for a left aileron deflection as the left wingtip scraped the

After the accident, American Airlines examined runway 31L and documented a left main landing gear tire mark that was 564 ft long, a right main landing gear tire mark that was 216 ft long, and a scrape mark from the left wingtip that was 323 ft long. The wingtip scrape marks began to the left of the runway edge marking and extended to the edge of the paved surface. The airplane's left wing impacted a distance remaining marker on the left edge of the paved runway surface.

American Airlines' examination of the airplane revealed that a portion of the marker support structure was lodged in the left wingtip (see figure 1). The left wing outboard slat, left aileron, left outboard flap, and underside of the left wingtip sharklet were damaged (see figure 2).

Figure 1. Left wingtip damage and portion of distance remaining marker support structure lodged in wingtip (Source: American Airlines).

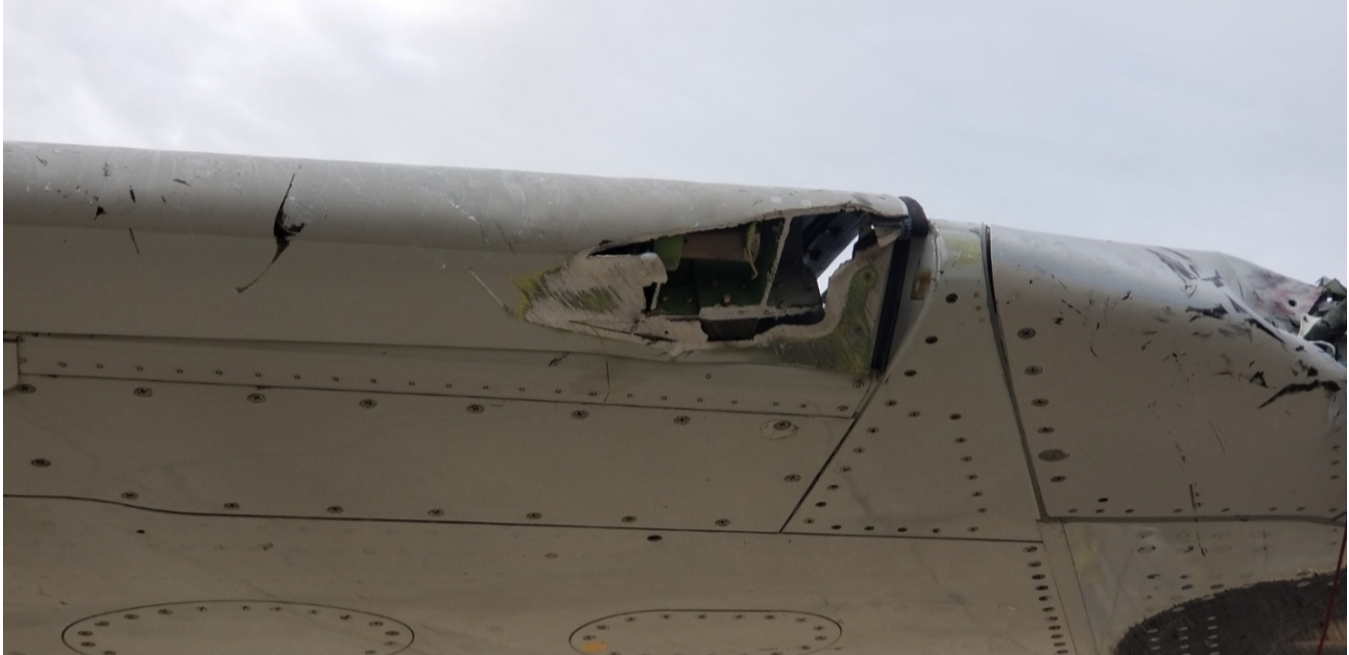
Figure 2. Scrape damage to underside of left wing slat (Source: American Airlines).
