Aviation Investigation Final Report

Location:	Norco, California	Accident Number:	WPR19FA118
Date & Time:	April 22, 2019, 12:09 Local	Registration:	N9MB
Aircraft:	Northrop N9M	Aircraft Damage:	Destroyed
Defining Event:	Loss of control in flight	Injuries:	1 Fatal
Flight Conducted Under:	Part 91: General aviation - Personal

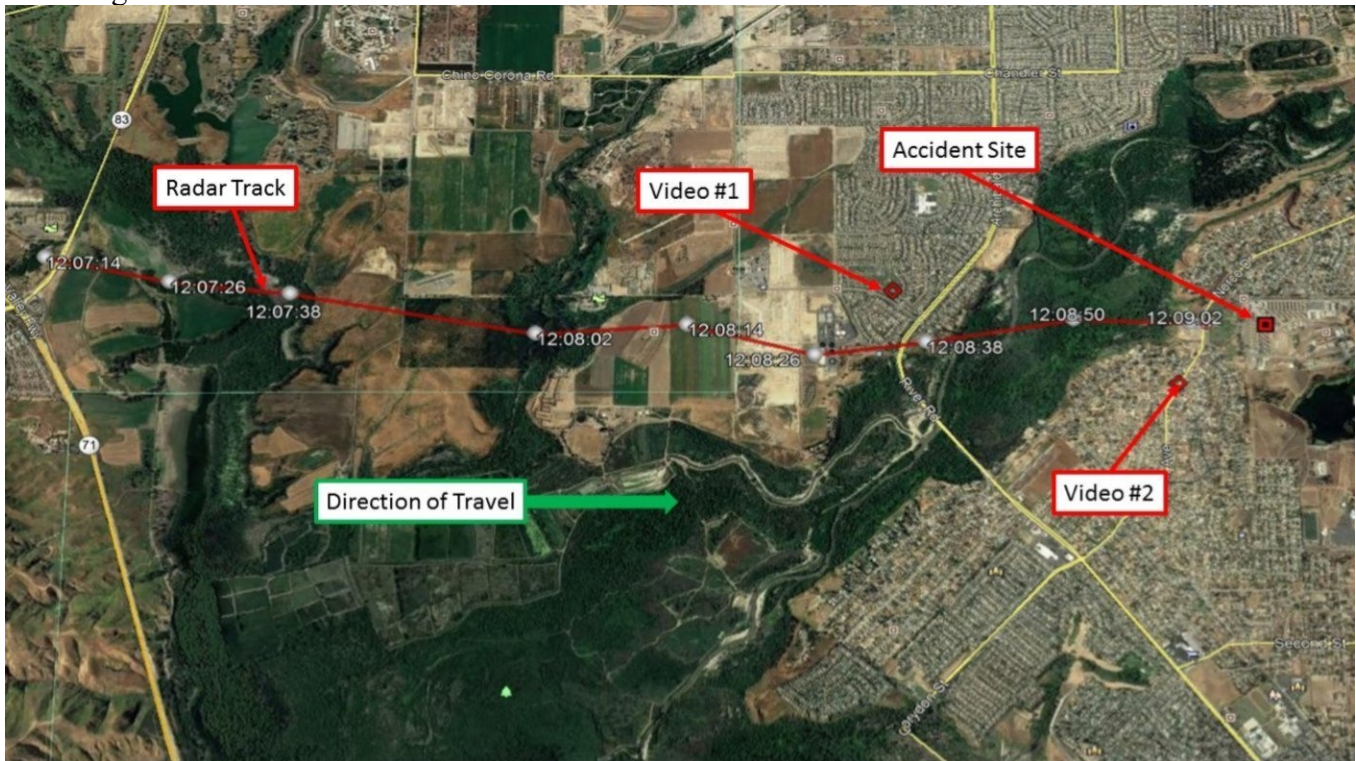
Review of radar data obtained from the Federal Aviation Administration (FAA) showed a primary radar target on an easterly heading about 3 miles south of Chino Airport, Chino, California, as seen in figure 1; no altitude information was available. The last return was about 0.3 mile west of the accident site.

Figure 1. View of radar track information, with witness video locations depicted.

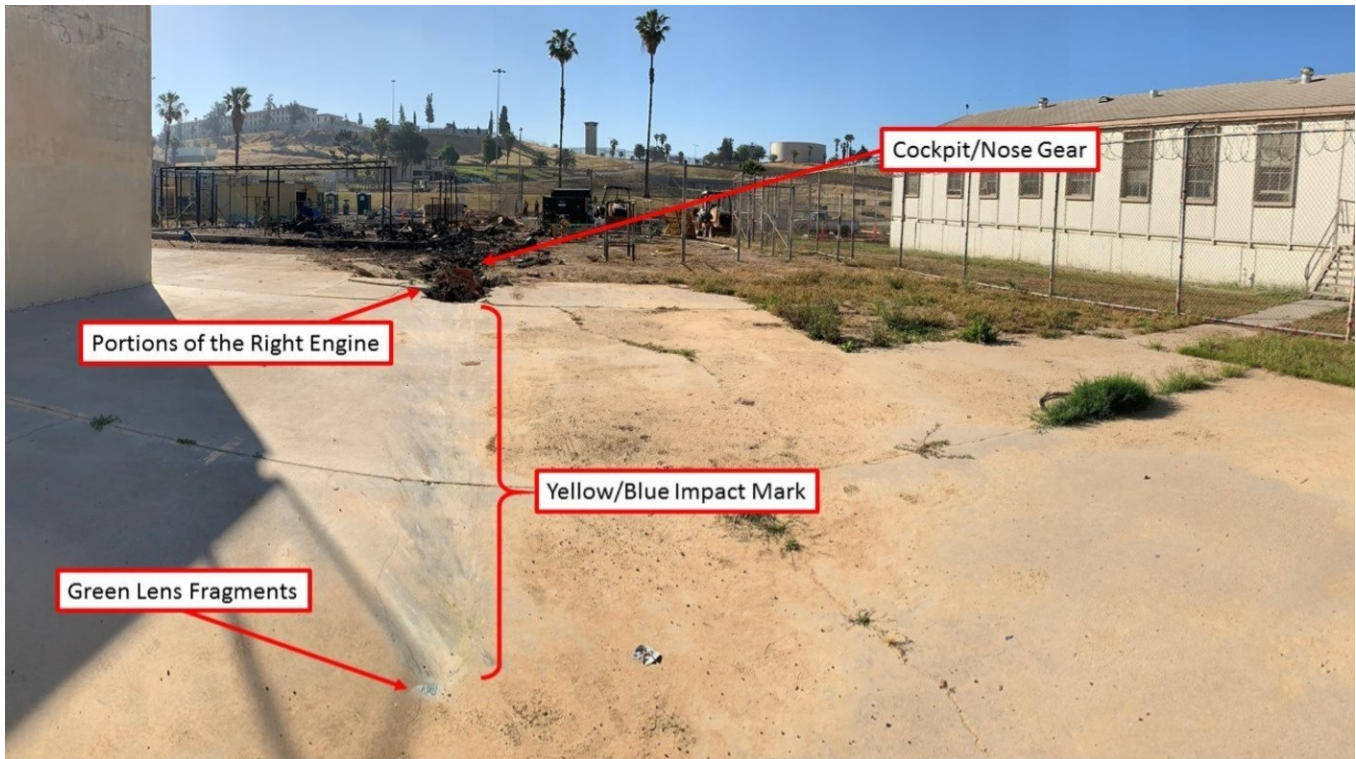
The airplane impacted the outpatient housing yard of the California Rehabilitation Center. The debris path was oriented on a heading of about 124° magnetic and measured about 474 ft long and 200 ft wide. The first identified point of contact (FIPC) was green lens fragments, consistent with the right wing navigational light lens, as shown in figure 2. From the FIPC, a blue-and-yellow colored mark extended about 32 ft to a large ground impression/crater that measured about 2 ft deep and 3 ft wide. Within the ground scar were remains of the right engine. The ground scar extended about 16 ft and contained portions of the cockpit, nose landing gear, and airframe structure. Wood debris, various fragments of both engines, and airframe structure were located throughout the debris path. The left and right propeller assemblies were located about 100 ft from the FIPC. The farthest portion of debris was a propeller blade tip, located about 474 ft from the FIPC.

Figure 2. Initial impact marks and start of debris path.

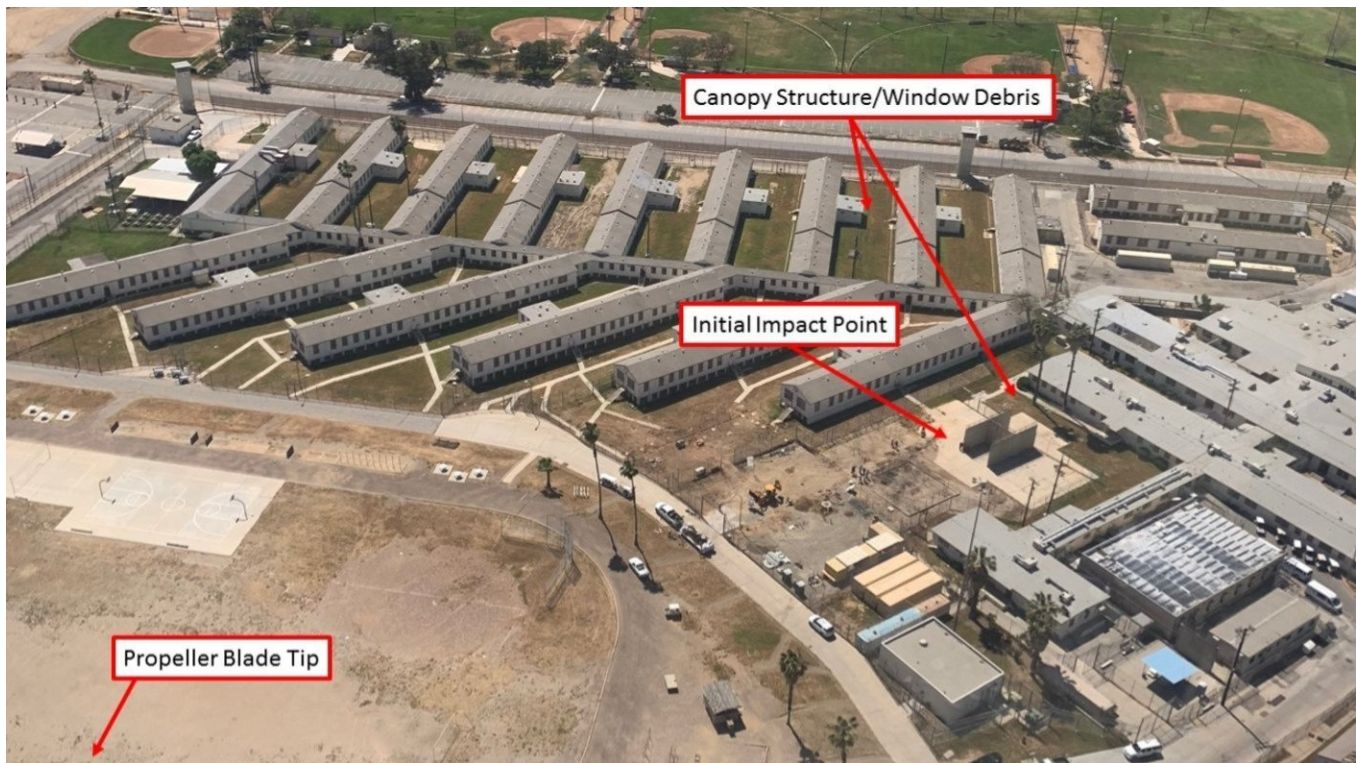
Canopy structure and window debris was located about 60 ft northwest of the FIPC and about 330 ft west of the FIPC. Both areas where window and canopy structure were located were in the opposite direction of the debris path, as shown in figure 3.

Figure 3: Accident site overview.
