Aviation Investigation Final Report

Location:	Norco, California	Accident Number:	WPR19FA118
Date & Time:	April 22, 2019, 12:09 Local	Registration:	N9MB
Aircraft:	Northrop N9M	Aircraft Damage:	Destroyed
Defining Event:	Loss of control in flight	Injuries:	1 Fatal
Flight Conducted Under:	Part 91: General aviation - Personal

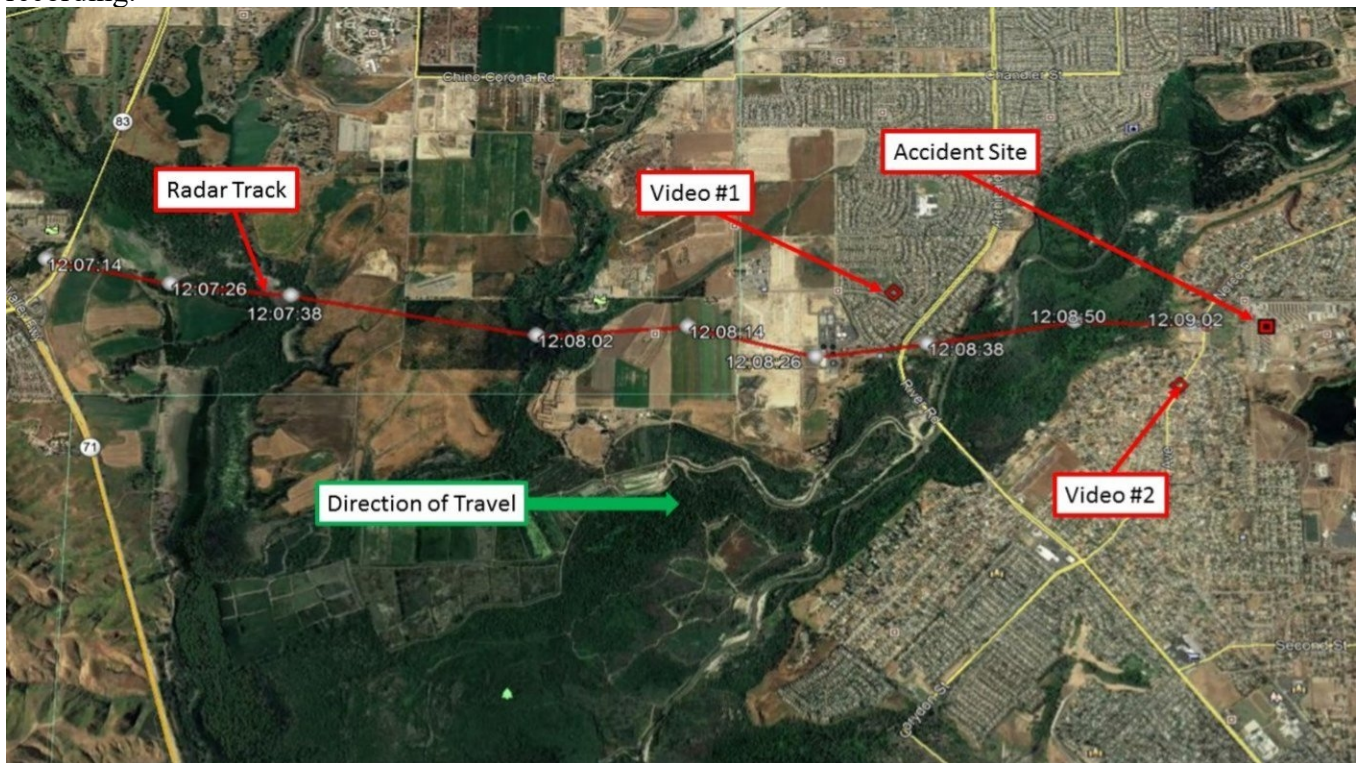
Review of radar data obtained from the Federal Aviation Administration (FAA) showed a primary radar target on an easterly heading about 3 miles south of Chino Airport, Chino, California, as seen in figure 1; no altitude information was available. The last return was about 0.3 mile west of the accident site.

Figure 1. View of radar track information, with witness video locations depicted.
