# Aviation Investigation Final Report

<b>Location:</b>	Jacksonville, Florida	<b>Accident Number:</b>	DCA19MA143
<b>Date &amp; Time:</b>	May 3, 2019, 21:42 Local	<b>Registration:</b>	N732MA
<b>Aircraft:</b>	Boeing 737	<b>Aircraft Damage:</b>	Substantial
<b>Defining Event:</b>	Runway excursion	<b>Injuries:</b>	1 Minor, 142 None
<b>Flight Conducted Under:</b>	Part 121: Air carrier - Non-scheduled

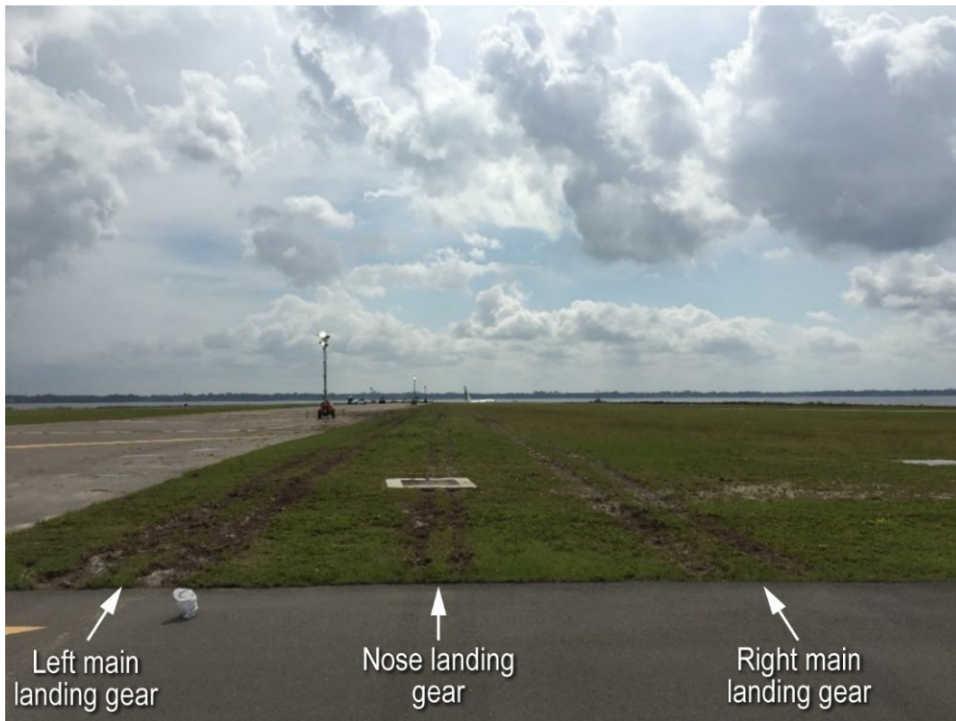
Light white landing gear track marks were visible on the pavement starting 1,592 ft from the displaced threshold (12 ft past the touchdown point of 1,580 ft computed by the onboard performance tool [OPT]) to the end of the pavement. The airplane's tracks showed variation in position relative to the right of centerline after touchdown and exited the paved surface about 55 ft to the right of centerline. The tracks continued in the grass area, deviating farther to the right of centerline and extending to the point at which the airplane struck the rock berm and entered the river, 90 ft right of centerline. Figure 1 shows the transition of track marks from the pavement to the grass and figure 2 shows the airplane at final rest in St Johns River.

**Figure 1.** Photograph of tire marks from the accident airplane's landing gear

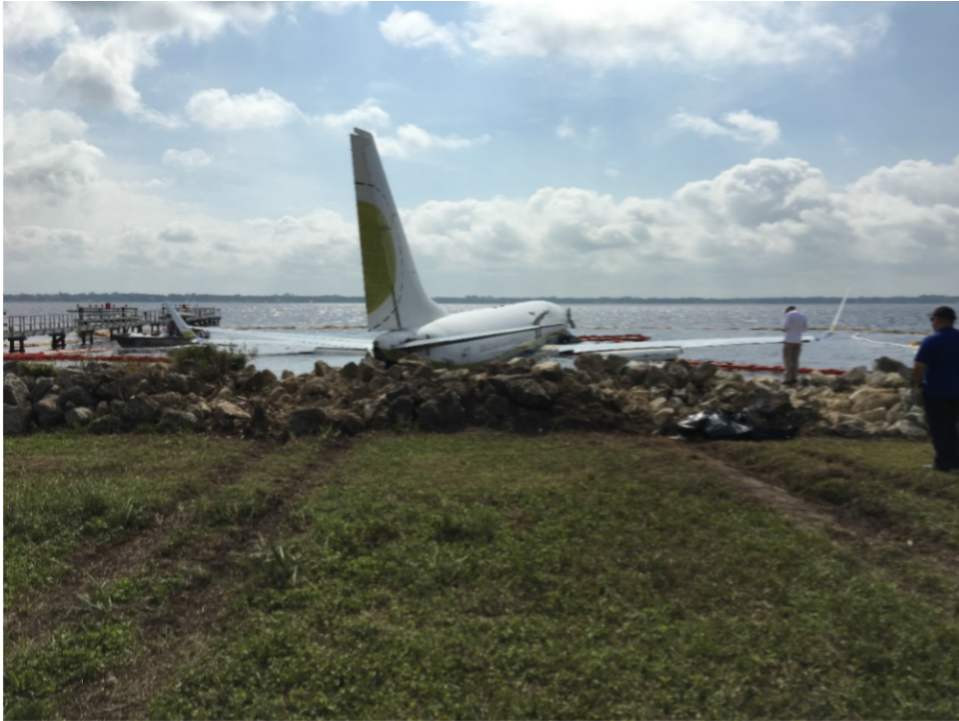
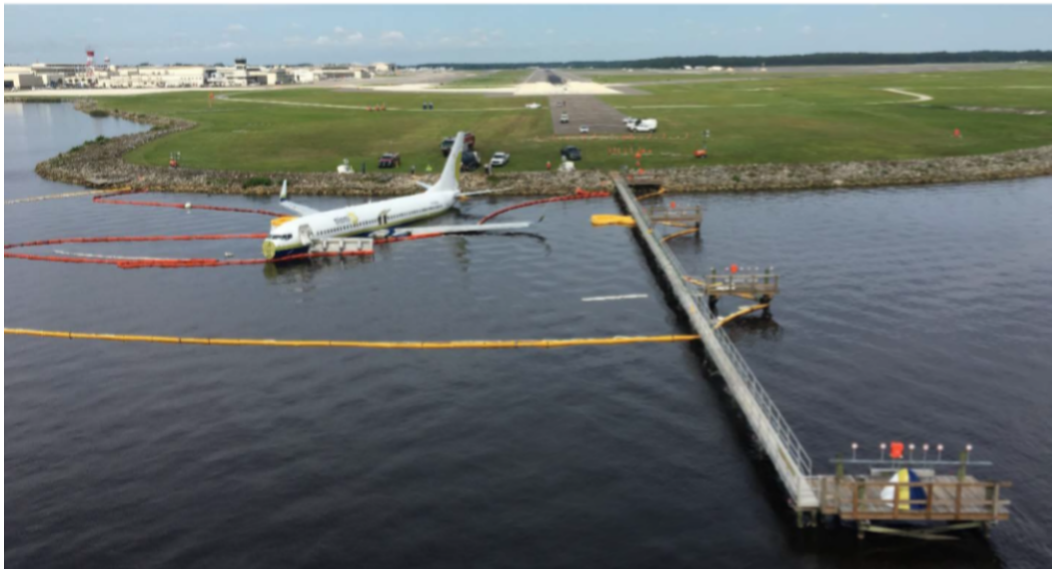
**Figure 2.** Photographs of accident airplane in St. Johns River

The airplane was mostly intact but sustained substantial damage. Portions of the engine cowlings, the radome, and both main landing gear separated during the accident sequence and were in the water adjacent to the airplane or on the rock embankment. Three life rafts were recovered in the water around the airplane. The L1 and R1 (forward) doors and the four overwing emergency exits were open. The L2 and R2 (aft) doors were closed. The L1 door
